## FAILURE MECHANISM OF KAMAISHI BREAKWATERS DUE TO THE GREAT EAST JAPAN EARTHQUAKE TSUNAMI

Keywords: Kamaishi breakwater; tsunami overflow; stability of breakwaters

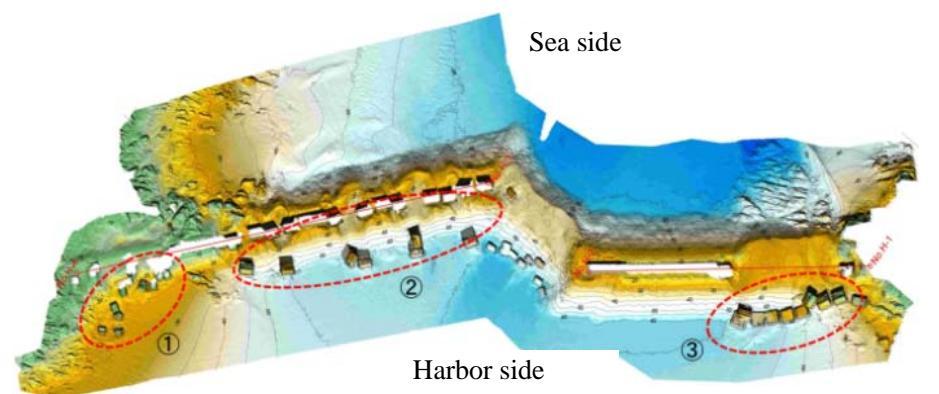
Figure 3. State of damage of breakwater

Fig. 3. shows the state of damage to all the breakwaters, Photo 2. shows the state of damage to caissons near the crest of the North Breakwater, and Fig. 4. shows the detailed state of sliding of the caissons in the deep part of the North Breakwater. This shows that in the deep part at the North Breakwater, many of them slid without leaning after sliding. And Fig. 5. shows the difference between the sections before and after the disaster. On the North Breakwater, the mound was scoured from 5m to 10m.

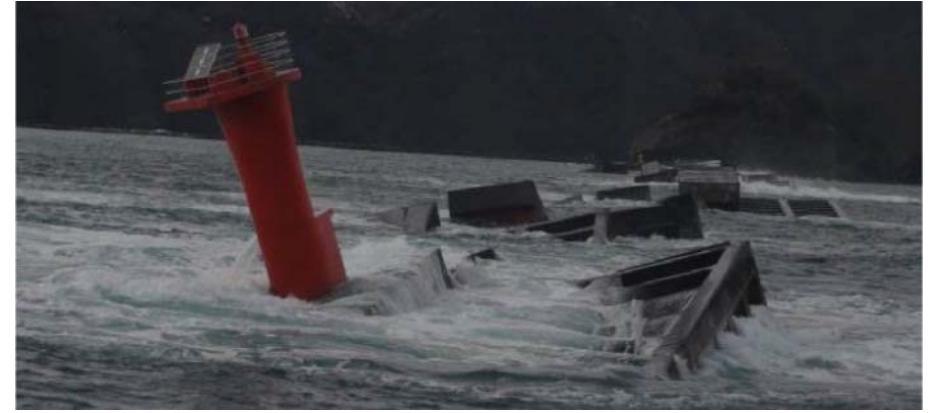
Photo 2. State of damage of North Breakwater

It shows that on both the North Breakwater and South Breakwater, the toe of the slope of the mound on the inside of the bay was not seriously deformed and the caissons slid on the mound. These facts suggest that the caissons could have been gently pulled back inside the bay

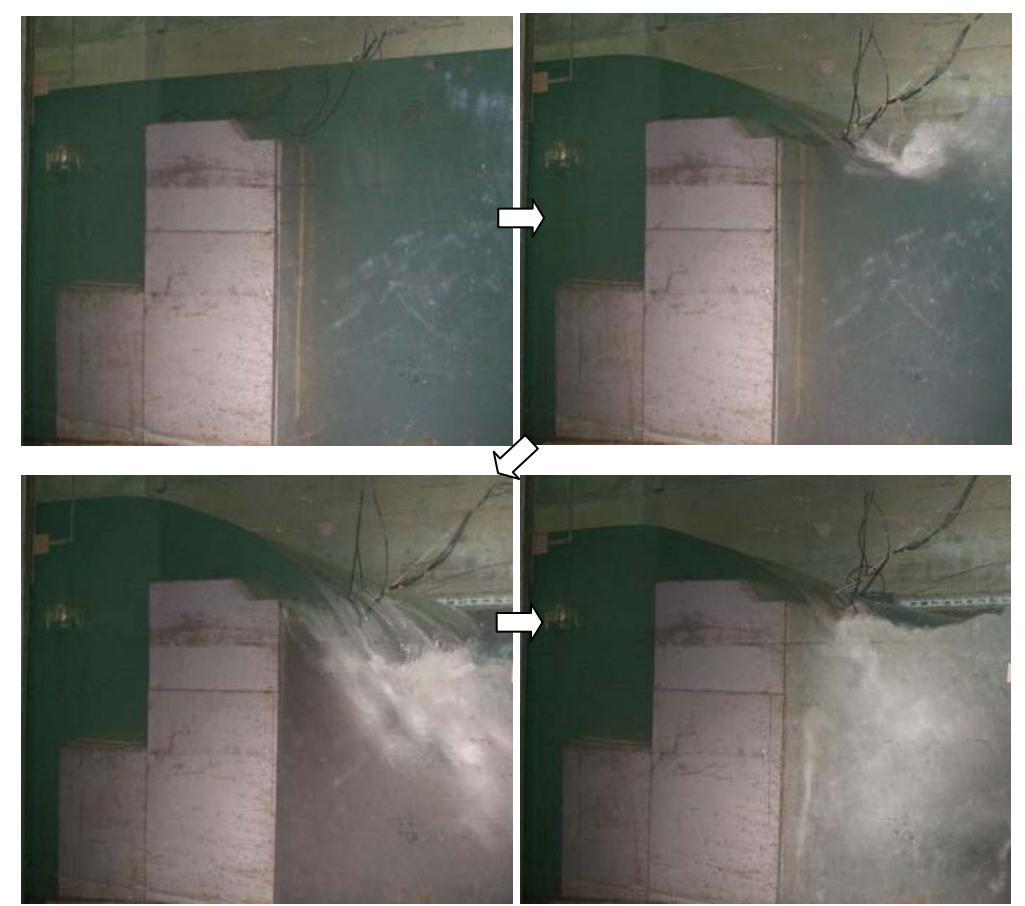
Photo 3. State of experiments (case 1 trial 3)

Photo 3. shows views of the third experiment in Case 1. It shows that as the water level difference was gradually increased from the initial water level, the impact of the overflow in the rear increased, the final state is the state after the caissons are pulled out, and when they were pulled out, the water level difference began its recovery. The caisson which can be observed from the window is the dummy caisson, so its weight is about 10% heavier and it did not slide.

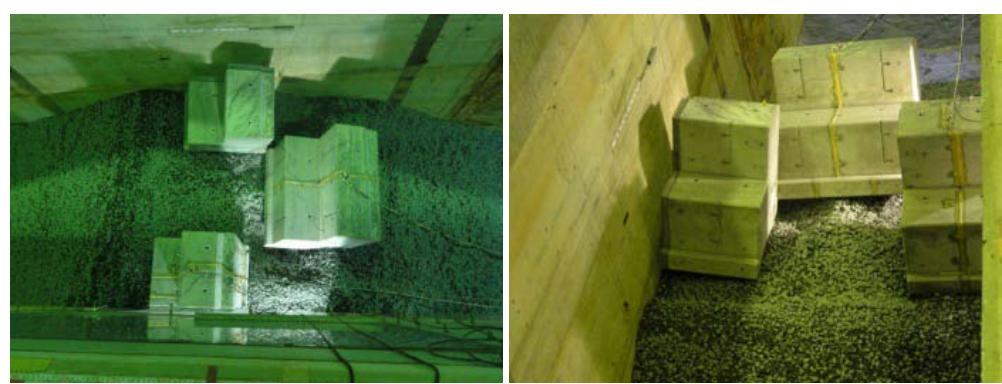
Photo 4. State of breakwater After Experiments (case1 trial 3)

Photo 4 to Photo 6 shows views before and after the third experiment in all cases. Because the water level difference is reduced by the pulling out of the main caissons, the distance it is displaced is shortened, and as shown by Arikawa et al., (2012), it did not slide to the bottom of the mound. The results of an in-site survey show that because the caisson slid to the bottom of the mound, it is possible that force sufficient to move the caisson for a long period of time acted. And even in case 3 where the mound was a small quantity of riprap, no traces of scouring of joints were seen. Observations during the experiments failed to show that the overflowing water mass caused scouring severe enough to reach the back toe of the caissons.

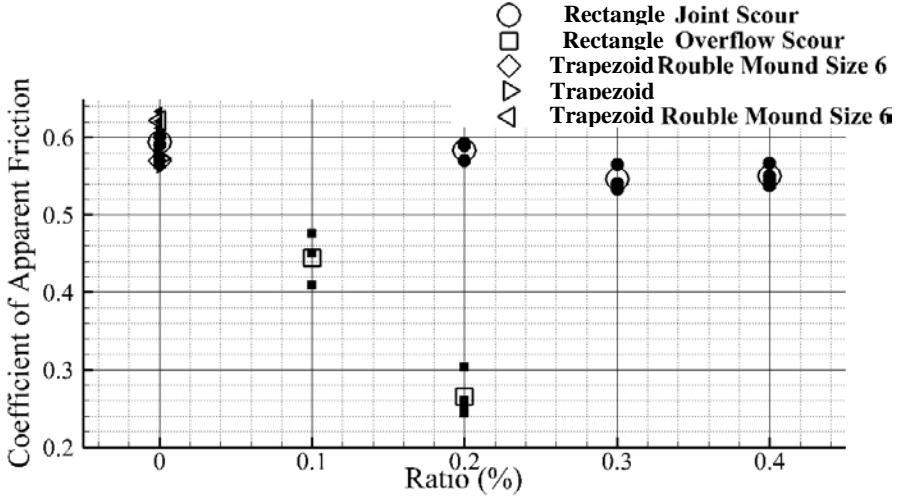
Figure 12. Relation between coefficient of apparent friction and scour ratio

Figure 12 shows the results of performing each three times. It was organized as the friction coefficient when, after being stable for a few centimeters, it started to move. It is assumed that because it moved very slowly, it is not a coefficient of dynamic friction. The friction coefficient itself is presumed to not depend on the installation surface area, but if the scouring width was increased, the friction coefficient changed, so it was organized as the apparent friction coefficient. The mechanism should probably be studied in detail in the future. The results are the average shown in white. It was done from 3 to 4 times, and the block spots represent each time, while the white spots represent the

averages. Examining this shows that the apparent friction coefficient is also impacted by the joint scouring width, but that it is impacted even more by the overflow scouring width, which declines about 25%, even at 10%.
