Testing of Partially Constructed Breakwater Damage

David Todd, Consulting Engineer, Perth, Western Australia
John Schepis, WorleyParsons, Perth, Western Australia

Summary

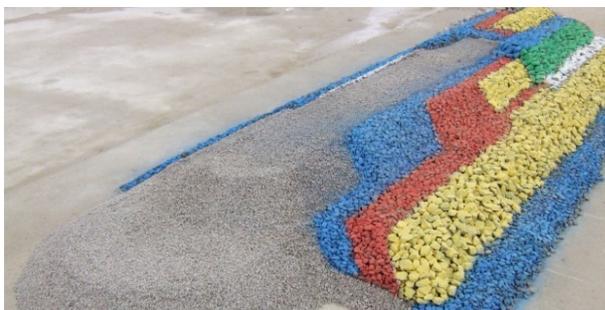
An understanding of the likely damage to the partially constructed breakwater was developed through a 3D basin test at a scale of 1:55. The testing consisted of three simulated construction faces along the breakwater in a large (30m x 50m) wave basin. These included the shore-normal causeway (subject to end-on wave attack) and the shore-parallel trunk and roundhead (both subject to normal wave attack). Typical pre- and post-test images of the breakwater trunk are shown in Figures 1 and 2.

Figure 1. Trunk, Pre-Test

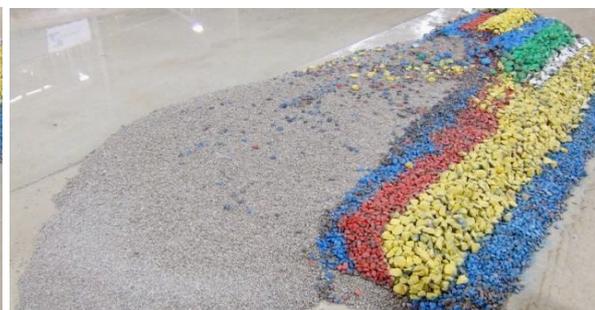
Figure 2. Trunk, Post-Test

It was observed that the breakwater underwent significant erosion of the unprotected core. This is a damage level beyond reshaping and is more akin to progressive ongoing erosion, depending upon the wave conditions. Accordingly, the primary aim of the testing was to provide information for the construction contractor on partially constructed breakwater stability and repair rework quantities for the range of ambient and storm conditions. For the project manager the same information allows planning and management of the projects remedial work requirements and overall risk and schedule

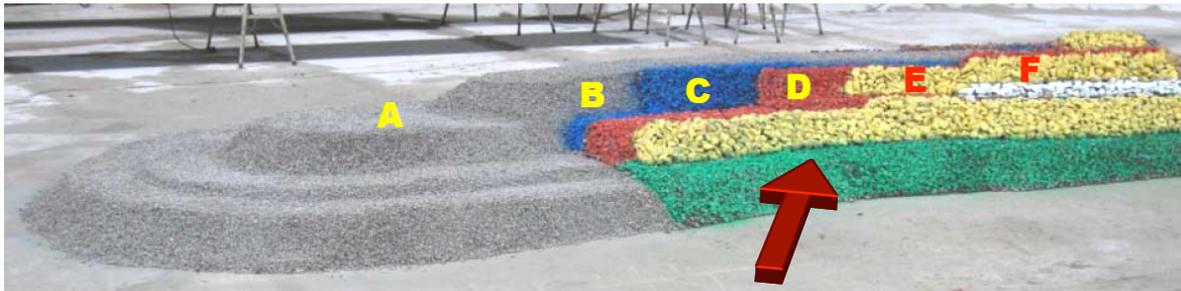
- Roundhead at -23m CD, shore parallel and subject to normal angle wave attack,
- Trunk at -16m CD, shore parallel and subject to normal angle wave attack, and
- Causeway at -12m CD, shore normal and subject to end on wave attack.

Figures 4-6 (HRWallingford, 2011) show these test sections and associated construction phases, as described above. The arrow indicates approximate angle of wave attack.

Figure 4. Roundhead, Pre-Test

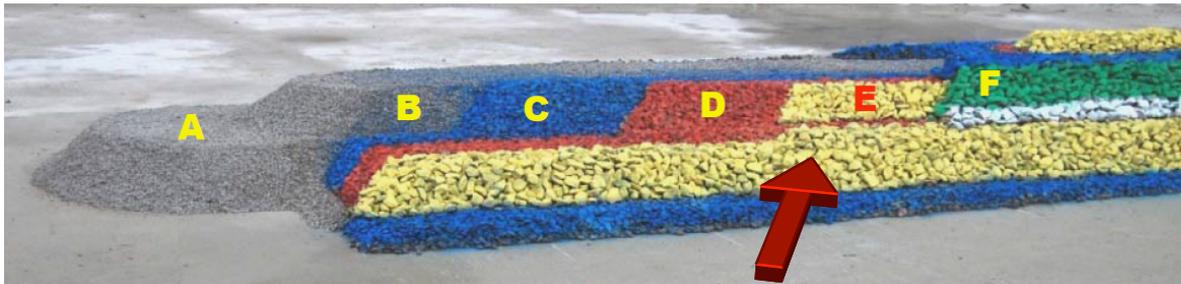
Figure 5. Trunk, Pre-Test

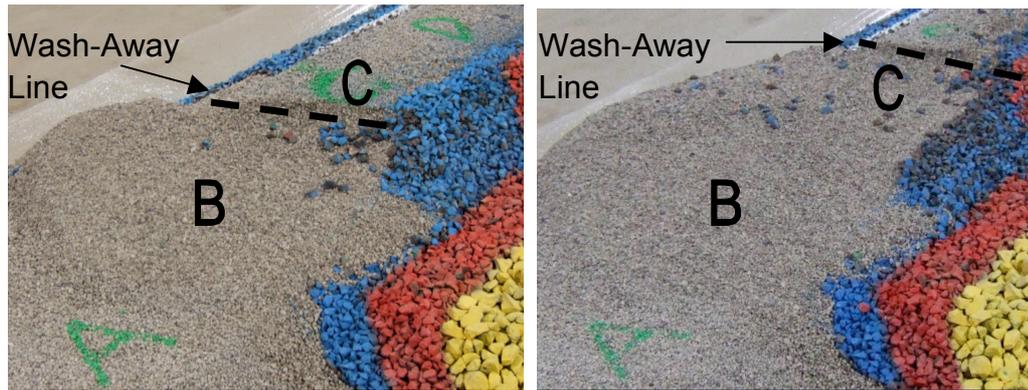
- The patterns of material loss and accretion conform loosely to the banana shaped pattern identified by Burcharth and Frigaard (1988), especially at lower levels of damage.
- The complete loss of core and subsequently any protective armour stone correlate with the observations of Hendry (1983), with additional definition and better volume data now available due to improved laboratory tools, such as laser scanning.
- The loss of core material occurs at the exposed construction face, with a distinct wash away line that cuts across the breakwater in the direction of wave propagation, as shown in Figure 9 for Ambient 2 and Storm 1 post-test conditions. The location and progression of the wash-away line is shown as a dashed line.

Figure 9. Core loss undermining armour layer, Trunk - Phase B and C.

- Core is lost along this wash-away line, rapidly undermining any suitably sized filter or armour rock on the exposed seaward face of the breakwater.
- The filter and armour stone, once displaced from the seaward face of the breakwater, mix with the core material and are transported across the breakwater to the lee side. They do not provide any noticeable stability to the top of core area.
- The loss of core from the -5mCD level was limited, at least until the most severe storm conditions, thus allowing increased flexibility in construction scheduling with marine based plant.
- The angle of wave attack is also clearly important. In this test program, only one angle of attack was tested (correlating to most frequent ambient and winter storm direction). The differing damage evolution on the Causeway Section provides an indication of erosion patterns during end-on wave attack.
