History of Alderney and Jersey "harbours of refuge" –why did they fail?

William Allsop, PhD student, School of Engineering, University of Edinburgh; Honorary Professor, University College London; Visiting Professor, Southampton University; Technical Director, Maritime Structures, HR Wallingford, UK

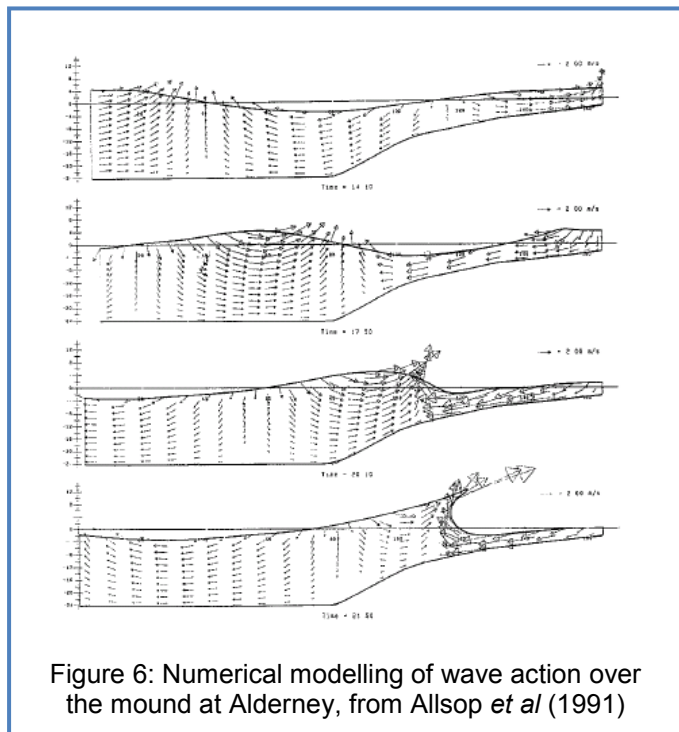
Figure 6: Numerical modelling of wave action over the mound at Alderney, from Allsop *et al* (1991)

The conditions at Alderney could hardly be more different. The tidal range is less at 5.2m, but tidal currents may exceed 7-8 knots in the Race of Alderney. Numerical modelling of waves and currents discussed by Allsop *et al* (1991) show that waves are refracted by these currents in somewhat surprising fashion. It is often expected that tidal currents are greatest at mid-tide level, with slack water at high and low tide levels. At Alderney the contrary is true with tidal velocities being greatest around high and low water. Those high currents reduce wave heights at the breakwater at high and low water, but no wave-current refraction applies at mid-tide so wave attack is greatest. Modelling in 1989 (see Allsop *et al*, 1991) gave a 1:50 year condition of $H_s=11.0\text{m}$ offshore reducing to $H_s=8.0$ to 8.5m at the breakwater. Sadly the combination of direct wave attack at mid-tide, and the attendant depths over the submerged mound, have the malign effect of shoaling waves to break impulsively onto the breakwater wall, Figure 6.

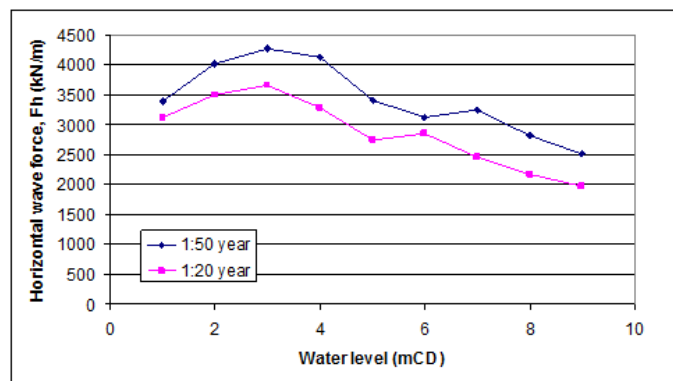
Figure 7: Simplified Goda / Takahashi forces on the Alderney breakwater wall

The effect of this on wave forces on the wall calculated using the simplified Goda – Takahashi method in Figure 7 show greatest forces around mid-tide rather than at high tide. This method does not try to calculate impulsive loads *per se* (see Allsop, 2000). For that, the more complicated approaches of Cuomo *et al* (2010, 2011) would be needed, but the simplified calculation illustrated here suffices to illustrate that forces are not maximised by considering only the highest water levels.

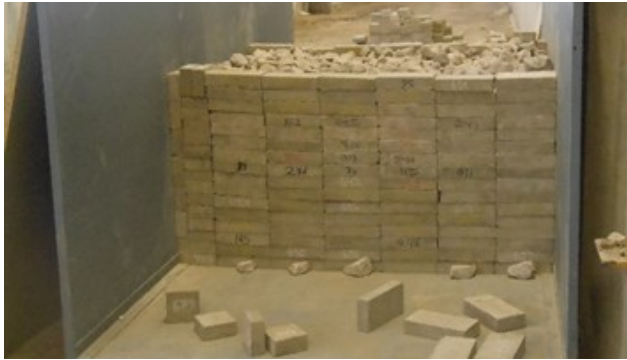
Figure 3: Dry-build timber frame with partially constructed dry-build test.

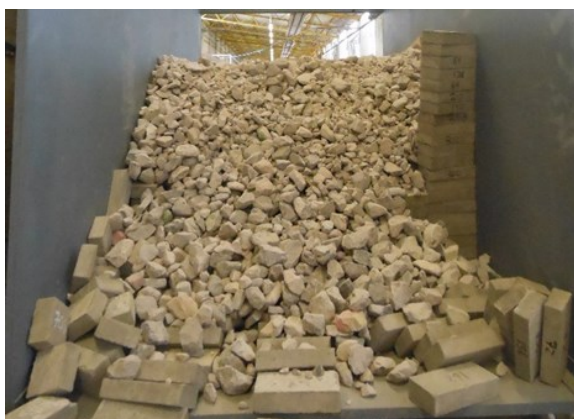
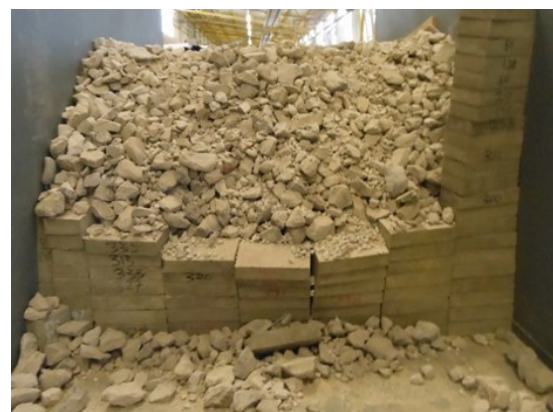
Figure 4: Failed dry-build. Left - immediately after collapse. Right - failed structure with spilled core removed to reveal arched (but still intact) wall toe.

It is noted that an overturning section in the model always rotated about the toe of the wall, or the bottom row. The difference of behaviour in the dry-builds may be in part due to the arching effect

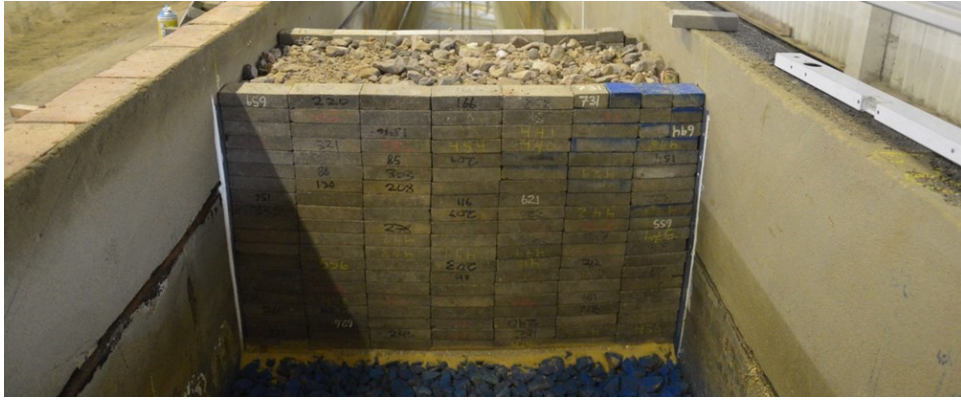
Figure 6: Example test structure in flume.

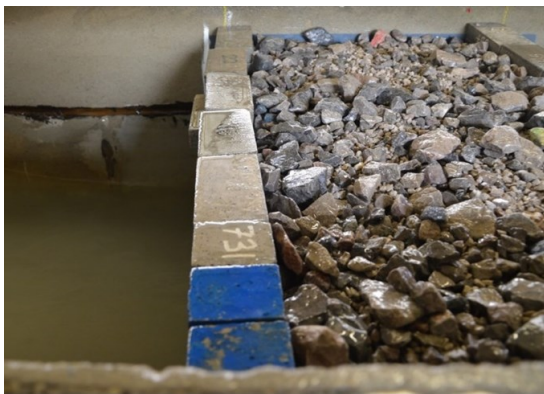
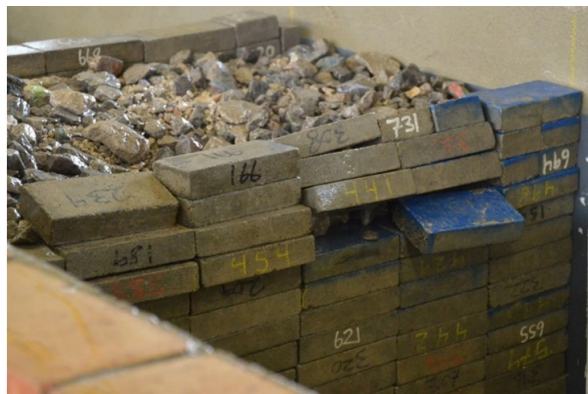
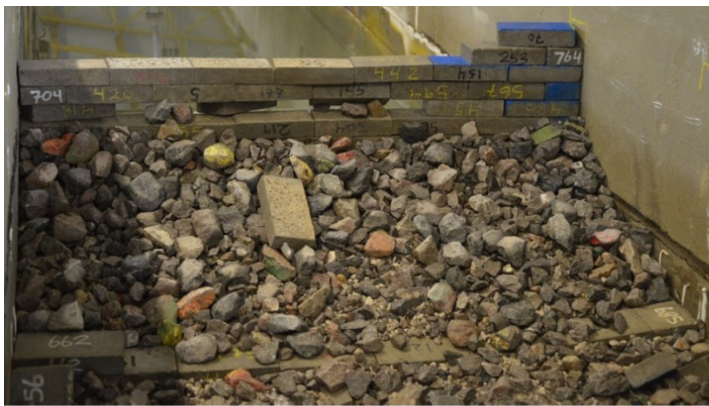
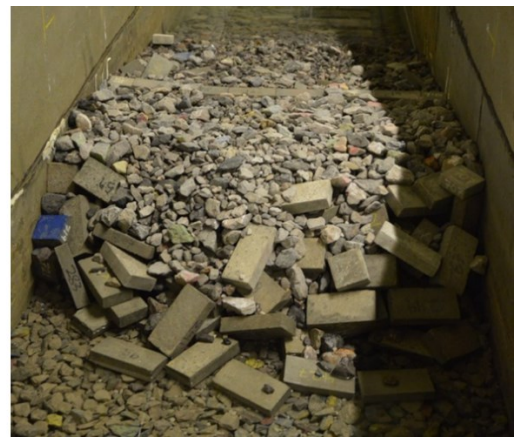
Figure 7: Progressive failure of Series 1.

Multiple blocks were extracted seawards from the front face as overtopping and local wave pressures opened multiple gaps in the blockwork at a high level. Some courses resisted further due to arching of the blocks against the sides of the flume, clearly a model effect. As more blocks were extracted, more overtopping penetrated into the rubble fill, forcing out further blocks. Once the front wall had failed at about $H_s=7.2\text{m}$, wave backwash steadily washed fill out until the seaward blocks and rubble fill were graded to a relatively shallow slope angle down the front of the structure. With the front wall down, waves broke onto the new rubble beach, attacking the rear wall significantly less. The rear wall itself again showed considerable arching, probably leading to the wall staying intact to $H_s=8.7\text{m}$, much longer than might be expected without lateral restraint. Photos of this progressive type failure are shown in Figure 7. Measurements of front and rear wall crest heights are shown in Figure 8. It is noted that crest level is defined as the highest point of the structure; after the rear wall failed the core was often higher than the remaining wall sections.

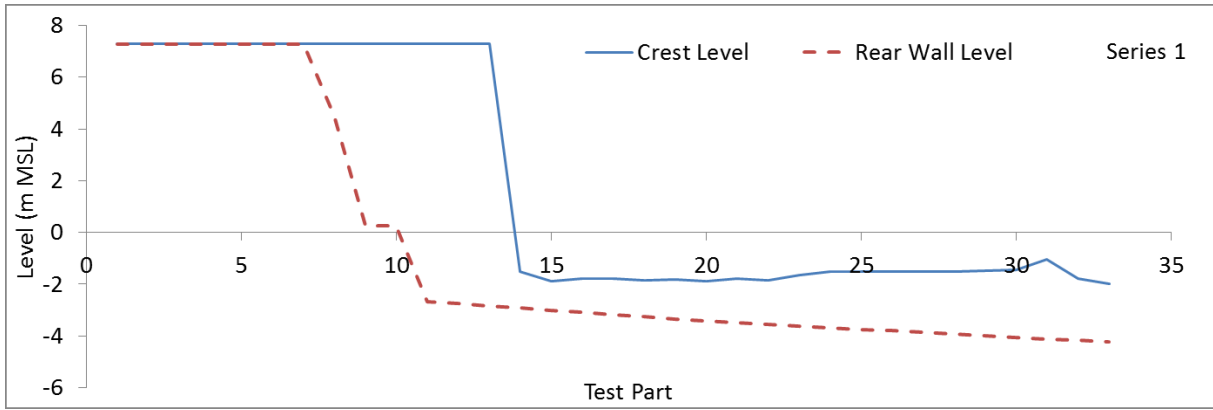
Figure 8: Progression of Test Series 1, test parts 1-33.

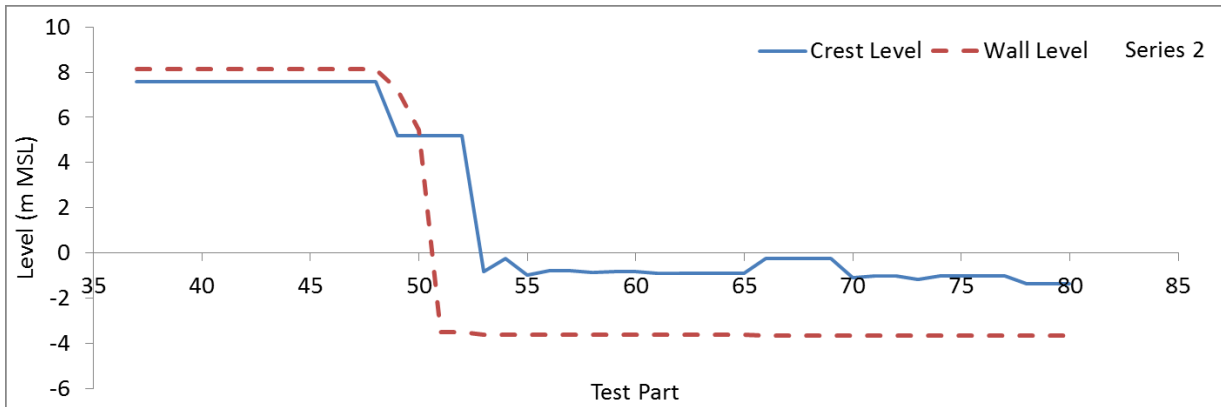
Figure 9: Progression of Test Series 2, test parts 37-80.

The wall in Series 2 was constructed 18 blocks high on the front, but fill and back wall were taken only to 16 courses. Blocks were again laid in bond. The geotextile in Series 1 was omitted as it was not useful. Sixteen test parts (each 500 waves) were required, failure occurring over test parts 48-52 ($H_s=8.6-8.9m$), illustrated in Figure 9.

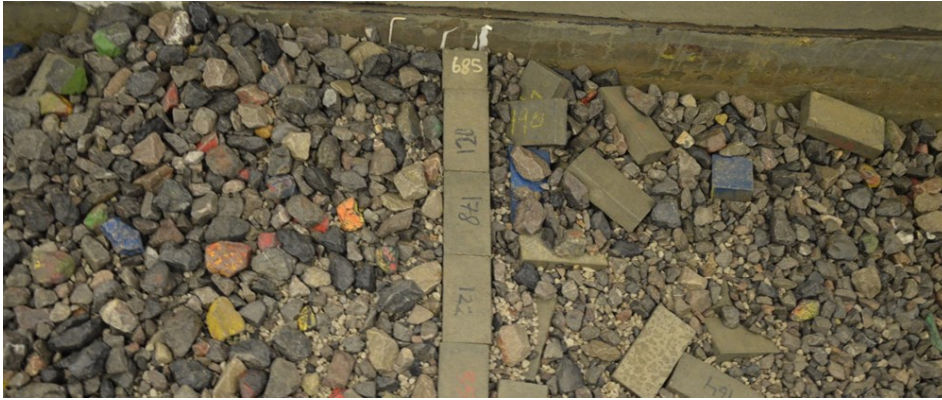
Figure 10: Post collapse view of Series 2, seaward side to right. Note the intact remnant of the wall toe.

Again the speed of wall collapse was probably delayed by arching effects giving artificial restraint. As seen before, the front wall mostly collapsed seaward. The remaining courses of toe blocks acted to reduce erosion of fill material, a process that has been seen on site for collapsed walls. Measurements of rear wall and crest heights are shown in Figure 9. The eroded profiles (see Figure 10) were very similar to those seen for Series 1.

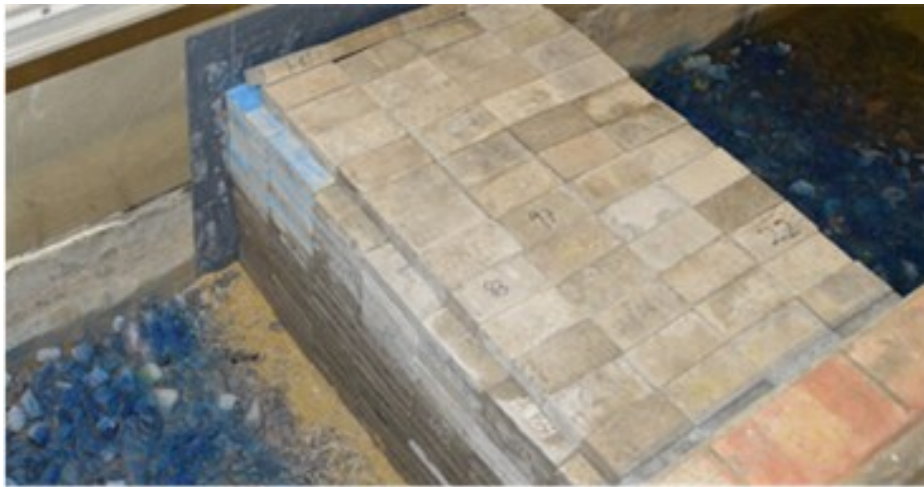
Figure 11: Series 3 with protected crest.

The wall in Series 3 was built 15 blocks high in columnar bond with standard fill. A layer of fines allowed placing of a blockwork 'capping' layer bringing the section height to 16 blocks all the way across, see Figure 11. With the lower initial crest level, the wall in Series 3 suffered increased overtopping. At $H_s=7.05\text{m}$, the front edge of the capping layer began to lift by up-rushing waves. This caused the crest protection to deform, continuing until the row had been either thrown backwards onto the structure or washed forwards creating a gap in the front of the wall. Once this gap had been opened, waves were able to penetrate under the cap, washing individual blocks off relatively quickly. This allowed waves to pull the fill and front wall down within 500 waves, forming a profile similar to those seen in Series 1 and 2. Measurements of rear wall and crest heights are shown in Figure 12.

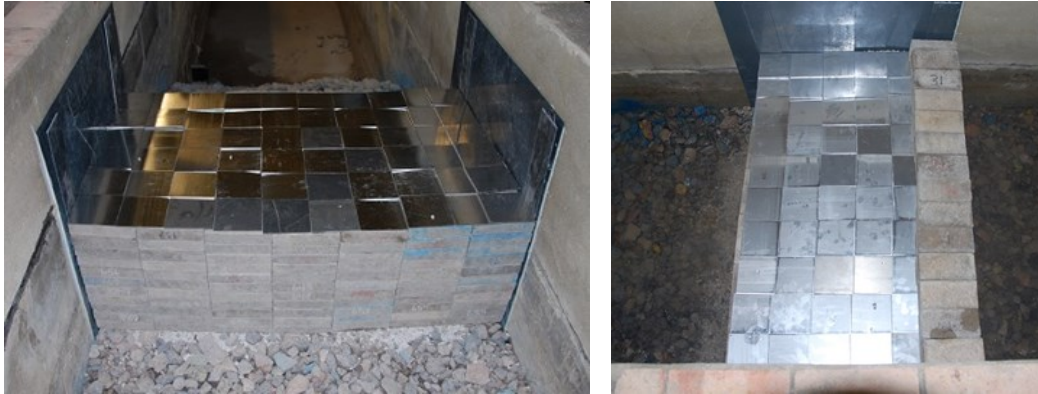
Figure 14: Test section for Series 5, showing crest slabs and parapet wall.

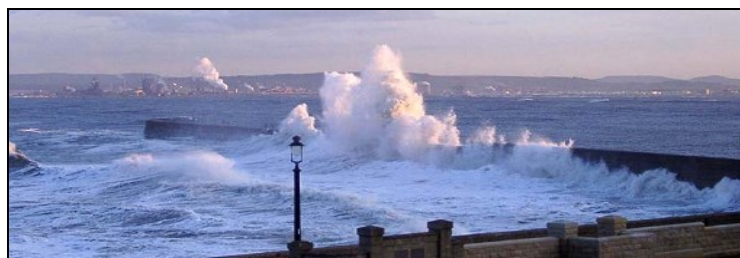
Figure 1: Wave attack on the Heugh breakwater at Hartlepool

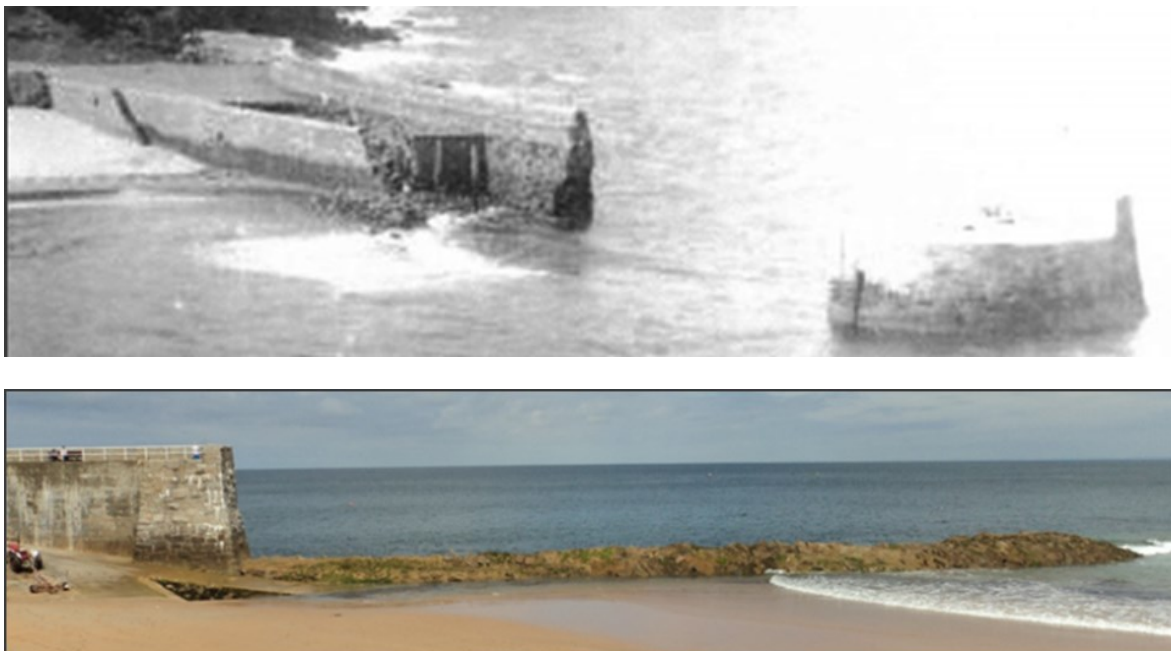
Figure 4: Greve du Lecq, Jersey: (top) after collapse in 1879; (bottom) recently, 2014

In the initial Test Parts, Storm waves ($s \sim 0.06$) were used to fail the structure. Then once collapse had been initiated (or for most cases – completed), subsequent Test Parts used Persistent waves ($s \sim 0.035$), and then Swell waves ($s \sim 0.01$) to measure transmitted (and reflected) waves. As well as the wave transmission performance, collapsed structure profiles might later be compared with the collapsed profiles of known breakwaters, e.g. Greve du Lecq (Figure 4).

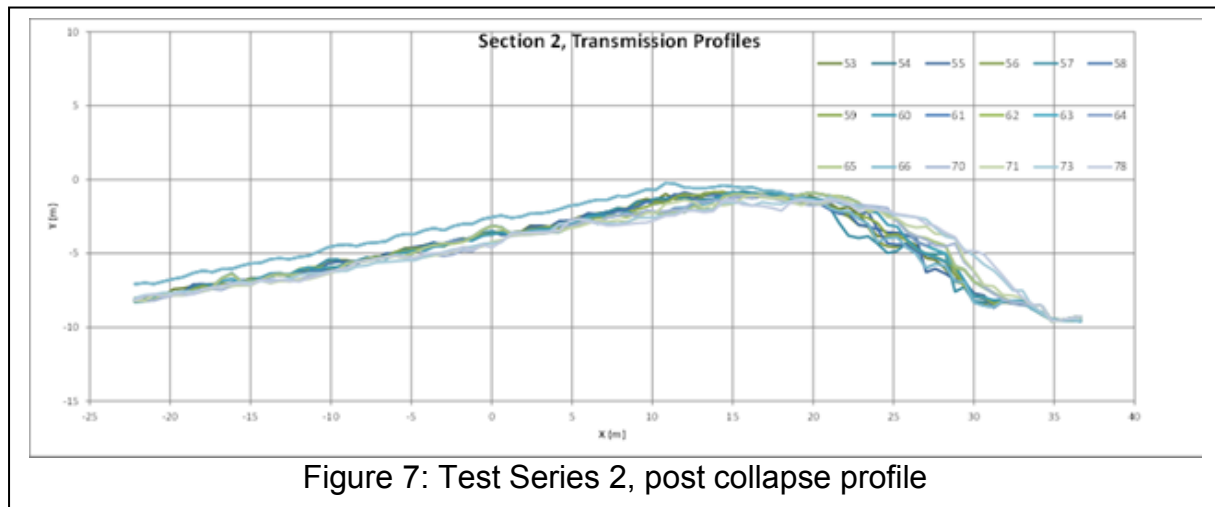
As before, the seaward wall mostly collapsed seaward. The remaining courses of blocks acted to reduce erosion of fill material, a process that has been seen on site for collapsed walls. The eroded profiles (Figure 7) were very similar to those seen for Series 1.

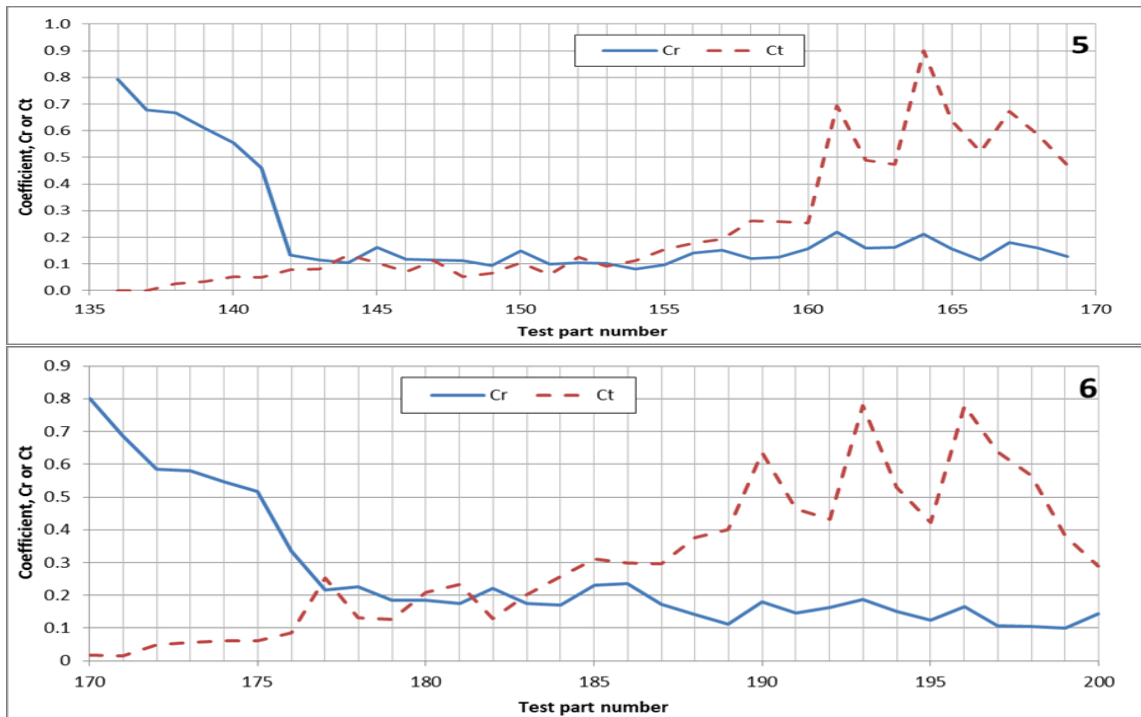
Figure 10: Reflections and transmission, Series 5 (top) and Series 6 (bottom).

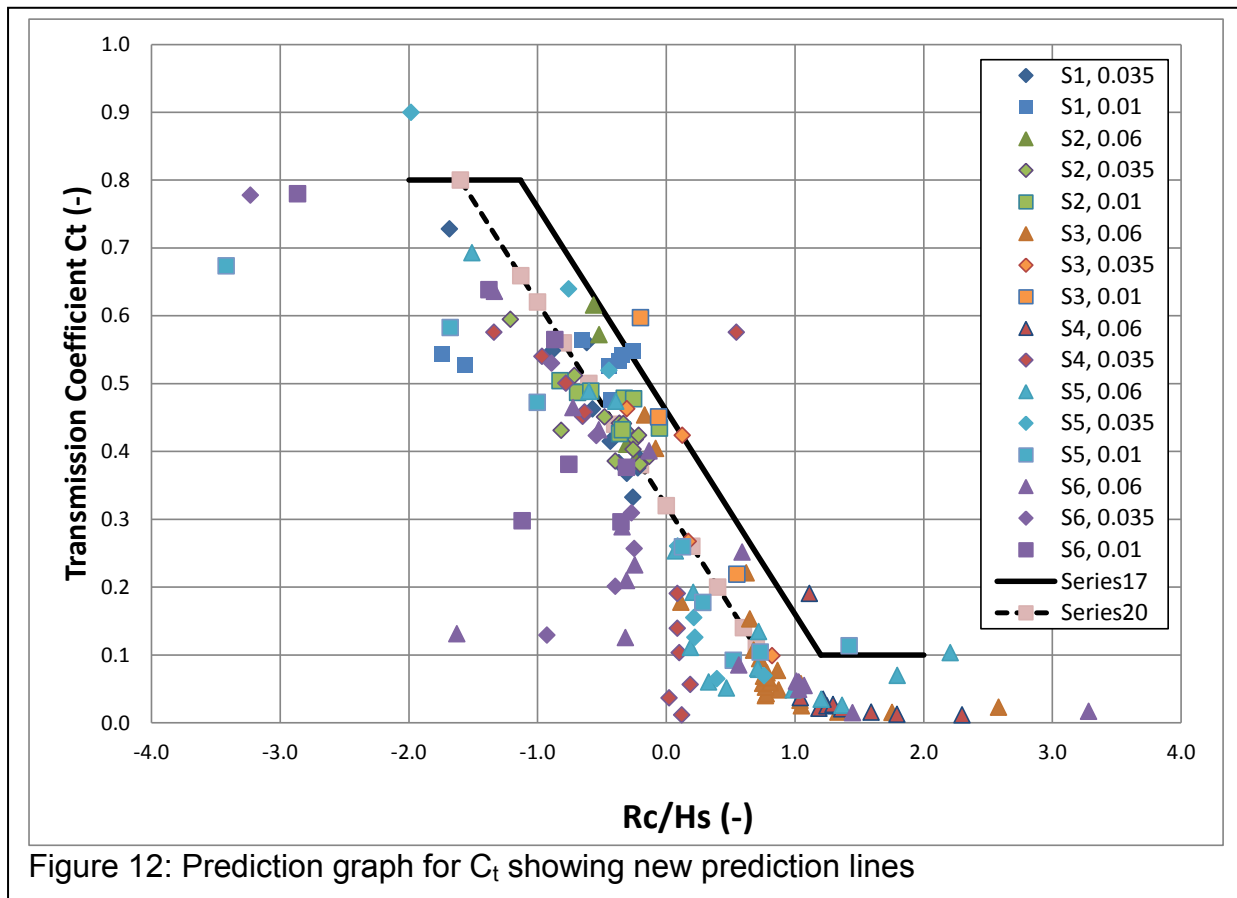
Figure 12: Prediction graph for C_t showing new prediction lines
