English Channel 'harbours of refuge': a discussion on their origins and 'failures'

Nigel William Henry Allsop BSc, MICE, CENG

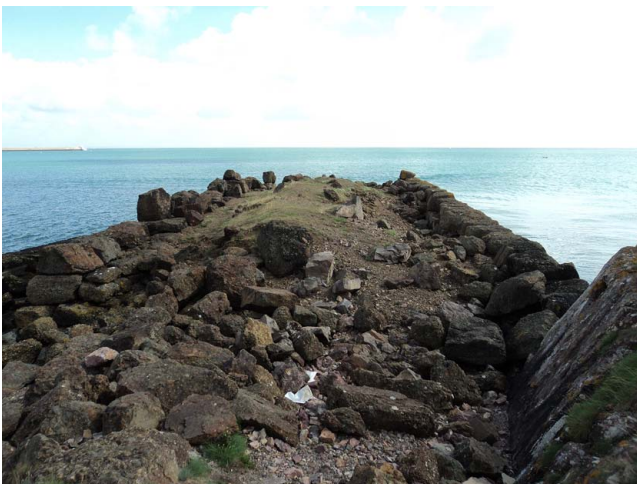
Figure 11. Archirondel breakwater stub in 2014 (author's own photograph)

Walker's breakwater design for St Catherine's (Figure 10) is very similar to that for Alderney, and its construction was relatively straightforward. Even if St Catherine's harbour could have been maintained, its utility would, however, have been severely limited by tidal conditions for which it could be accessed and by the sailing space between Jersey and France. The second threat was siltation, particularly sand driven by the northward-running tidal flows, depositing over slack water, made worse by the cancellation of Archirondel breakwater. The stub of that breakwater probably remains much as it was left (Figure 11).

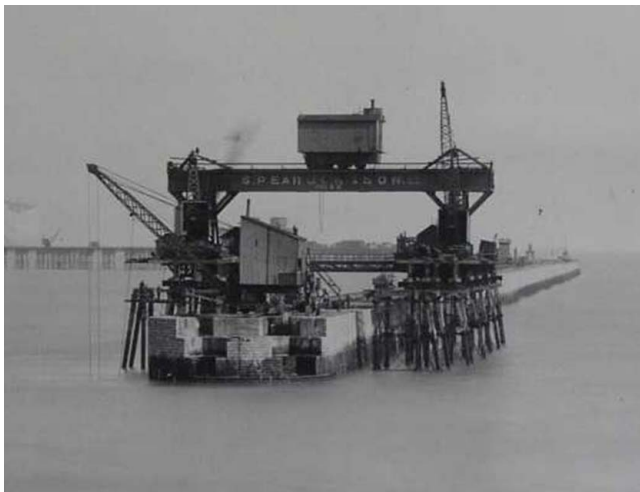
Figure 14. Construction of the south breakwater using a Goliath crane on staging (courtesy of DHB)

Pearson eschewed the use of Titan block-placing cranes that would run along the constructed works in favour of temporary staging above and beyond the works, supporting steam-powered Goliath travelling cranes (Figure 14). The rail level for these cranes was generally above +8.2 m HWOST. Tasmanian blue gum piles were heavier than water, but Oregon pine required weighting by old iron rails to sink them. Staging piles were reused as the work progressed, extracted by winch from a floating hulk. After use, piles were spliced to ensure availability of an undamaged head for driving.
