Design and Construction of a Submerged Breakwater and Terminal Seawall for Beach Stabilisation

Conference Paper · September 2015

L. Angus Jackson¹, Bobbie B Corbett¹, Martin Mulchay¹ and Aaron Salyer¹

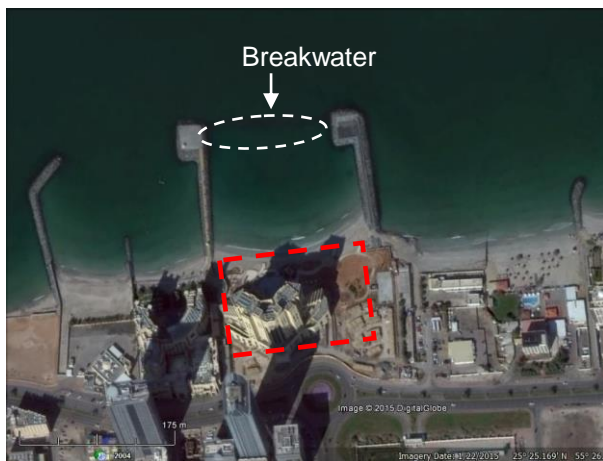
Figure 1 Site with existing groynes and low crested submerged breakwater

The site is a large 5 star beach resort in the United Arab Emirates on an exposed section of the Arabian Gulf coastline (Figure 1).

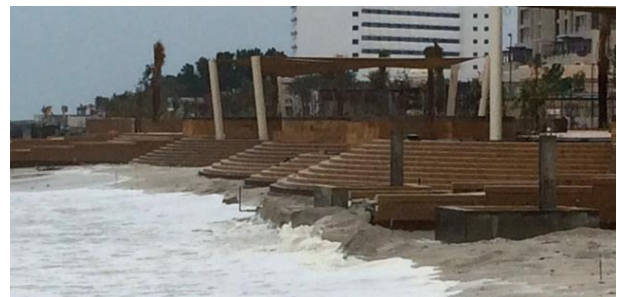
Figure 2 Storm (shamal) wave in January 2015 eroding recently nourished beach up to hard landscaping.

A low crested rip rap breakwater had been constructed between the boundary groynes to protect the hard landscaping and beach nourishment works. These structures did not provide sufficient protection during storms (shamals) to support the wide stable beach envisaged for the resort or to protect the hard landscaping of the resort itself from storm erosion (Figure 2).

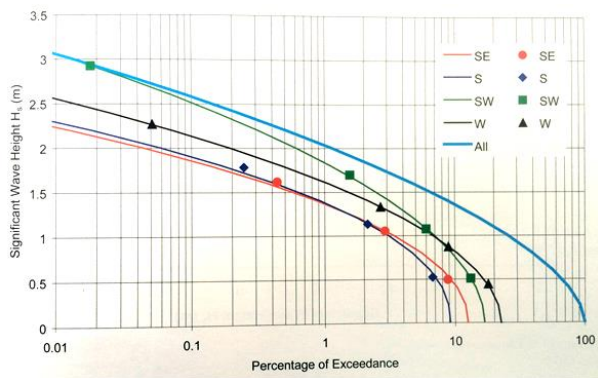
Figure 3 Hs vs % exceedance (Coastal Development Guidelines for Dubai Coastline, 2010)

Local wave climate is typically mild with larger shamal events giving a 100 year ARI wave height (Hs) of approximately 2.6m (Figure 3) with a 100 year ARI surge level of approximately 2.6m above Lowest Astronomical Tide (LAT). [1]

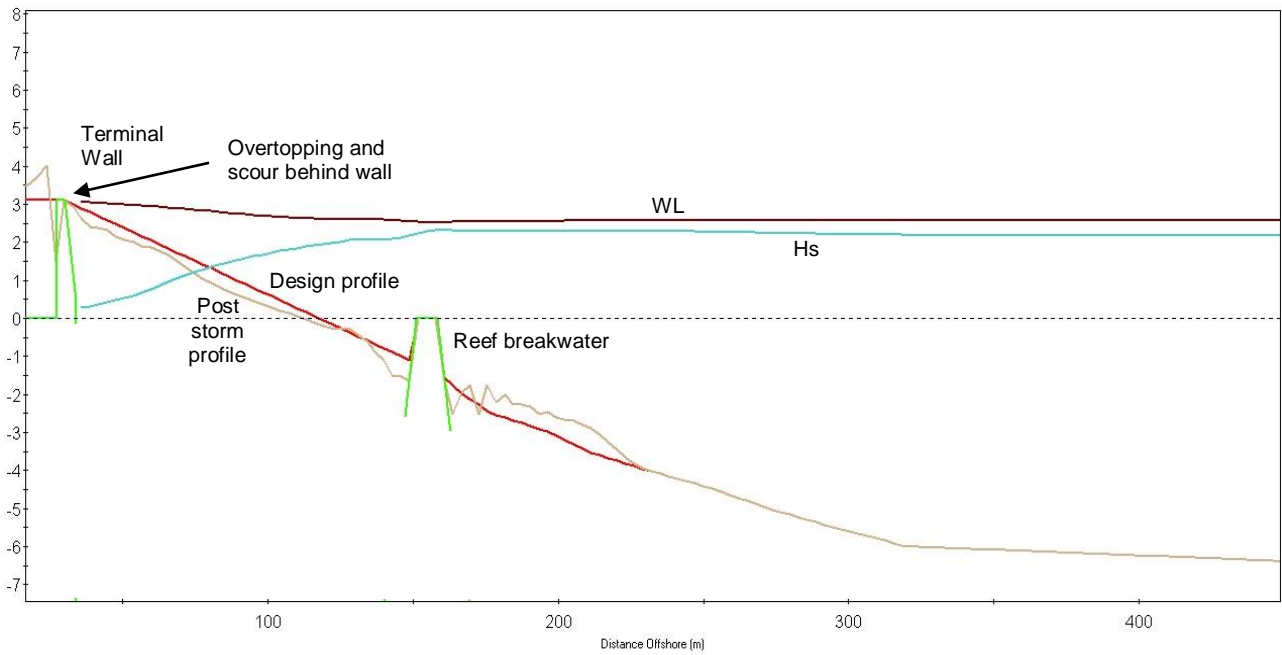
Figure 4 S-Beach modelling output of profiles with reef breakwater at MSL and terminal seawall in 100 year ARI Conditions

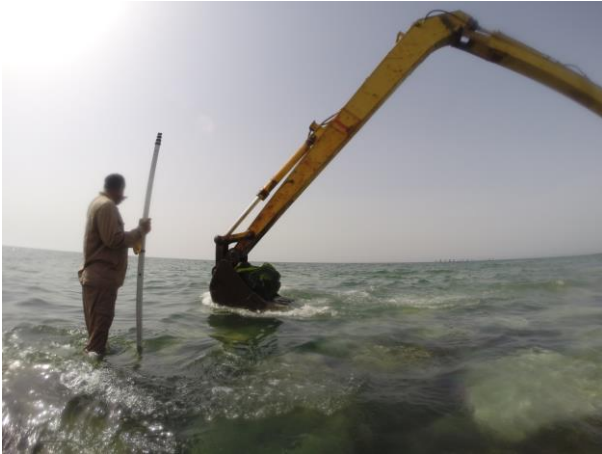
Figure 7 Placing 3-6t armour rock tightly at low tide

- Progressively place armour underwater to required crest levels and fill large voids with core rock. (Figure 7).

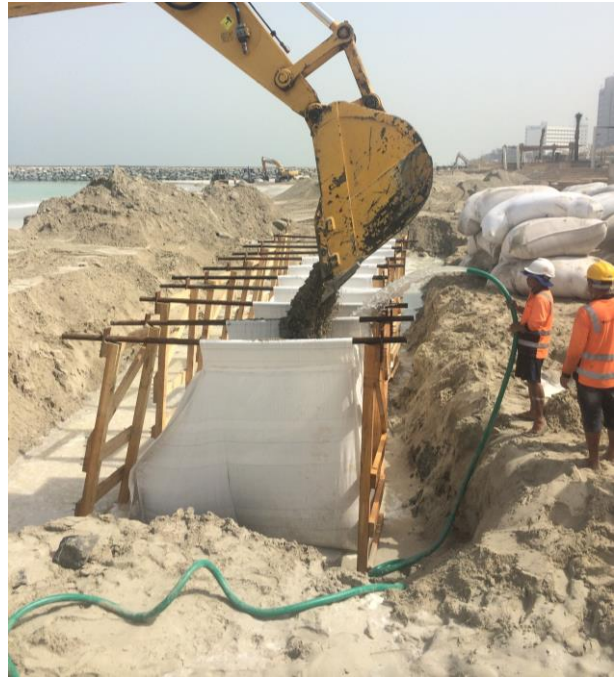
Figure 8 Filling “Trapbags” containers as freestanding core

The Trapbags were placed and filled first as the stable core (Figure 8) and subsequently armoured with the ELCOROCK® 2.5m³ sand-filled geotextile containers (Figure 9). The system proved to be rapid and easy to construct with relatively unskilled labour.

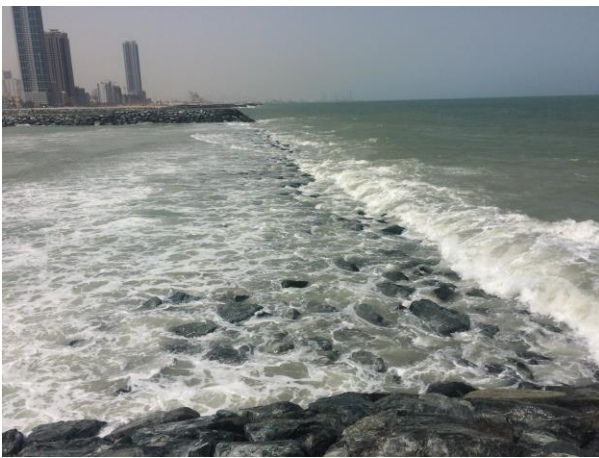
Figure 10 Photo of performance of submerged breakwater during low tide (0.1m LAT) with wave breaking ($H_s \sim 0.7m$)

- Wave heights > ~1m break on the submerged breakwater across the full tidal cycle (Figures 10 and 11).
- As expected, greatest wave dissipation is observed at low tide when essentially all of the wave energy is dissipated.
- Wave transmission at high tide appears to be lower than modelling indicated.

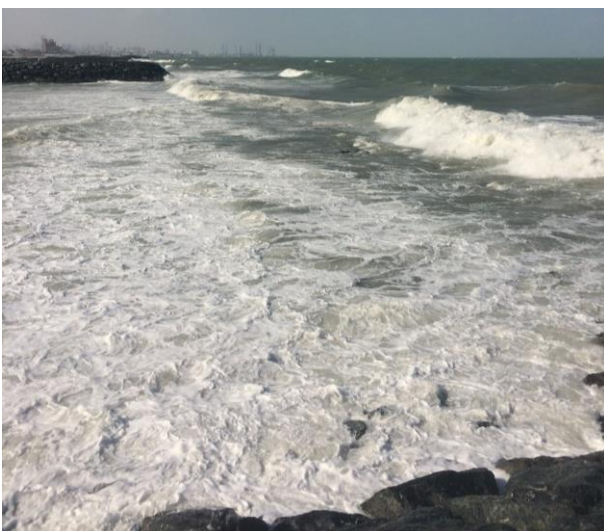
Figure 11 Photo of performance of submerged breakwater during mid-tide (0.9m LAT) with wave breaking ($H_s \sim 1.5m$)

- Wave heights ~1.5m at mid-tide break on the submerged breakwater, subsequently breaking directly on the shoreline ($H_s < 0.5m$) (Figure 11)
- Nearshore waves are much smaller compared with the adjacent unprotected beaches (Figure 12).
- Flushing appears adequate.

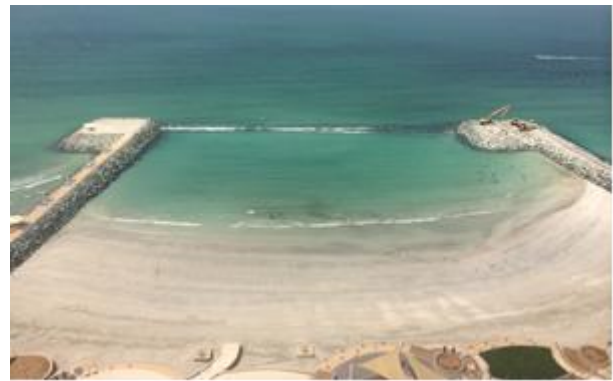
Figure 13 Completed works with waves breaking on breakwater and terminal wall buried under nourished beach.

For 5 star resorts, ensuring continuous beach amenity regardless of erosion events can be critical to commercial operations. In this case, a suitable solution was effectively provided using an integrated management strategy that included the existing boundary groynes, a submerged rock breakwater, beach nourishment and a buried "soft" terminal seawall to limit landward erosion in the most severe events (Figure 13).

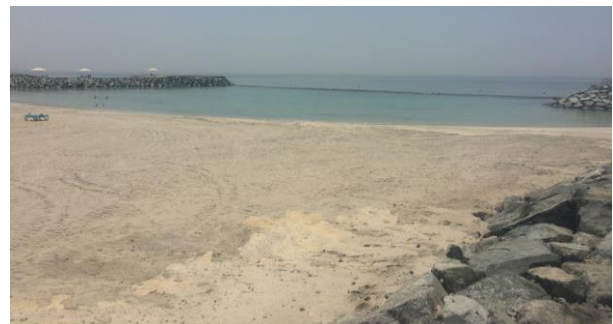
Figure 14 Wide stable beach at low tide, submerged breakwater visible through water on clear day

Monitoring indicates that the submerged breakwater is dissipating wave energy even more effectively than anticipated and is successfully providing a wider, stable beach and safe lagoon swimming area (Figure 14).
