JIYEH (PORPHYREON) 1975 EXCAVATION SEASON. ROGER SAIDAH'S ARCHAEOLOGICAL WORKS IN THE RESIDENTIAL SECTOR D.

ISSUE 50-51
AUTUMN-SPRING 2019-20, Pp.
164-198.

MARIUSZ GWIAZDA & TOMASZ WALISZEWSKI | AHL

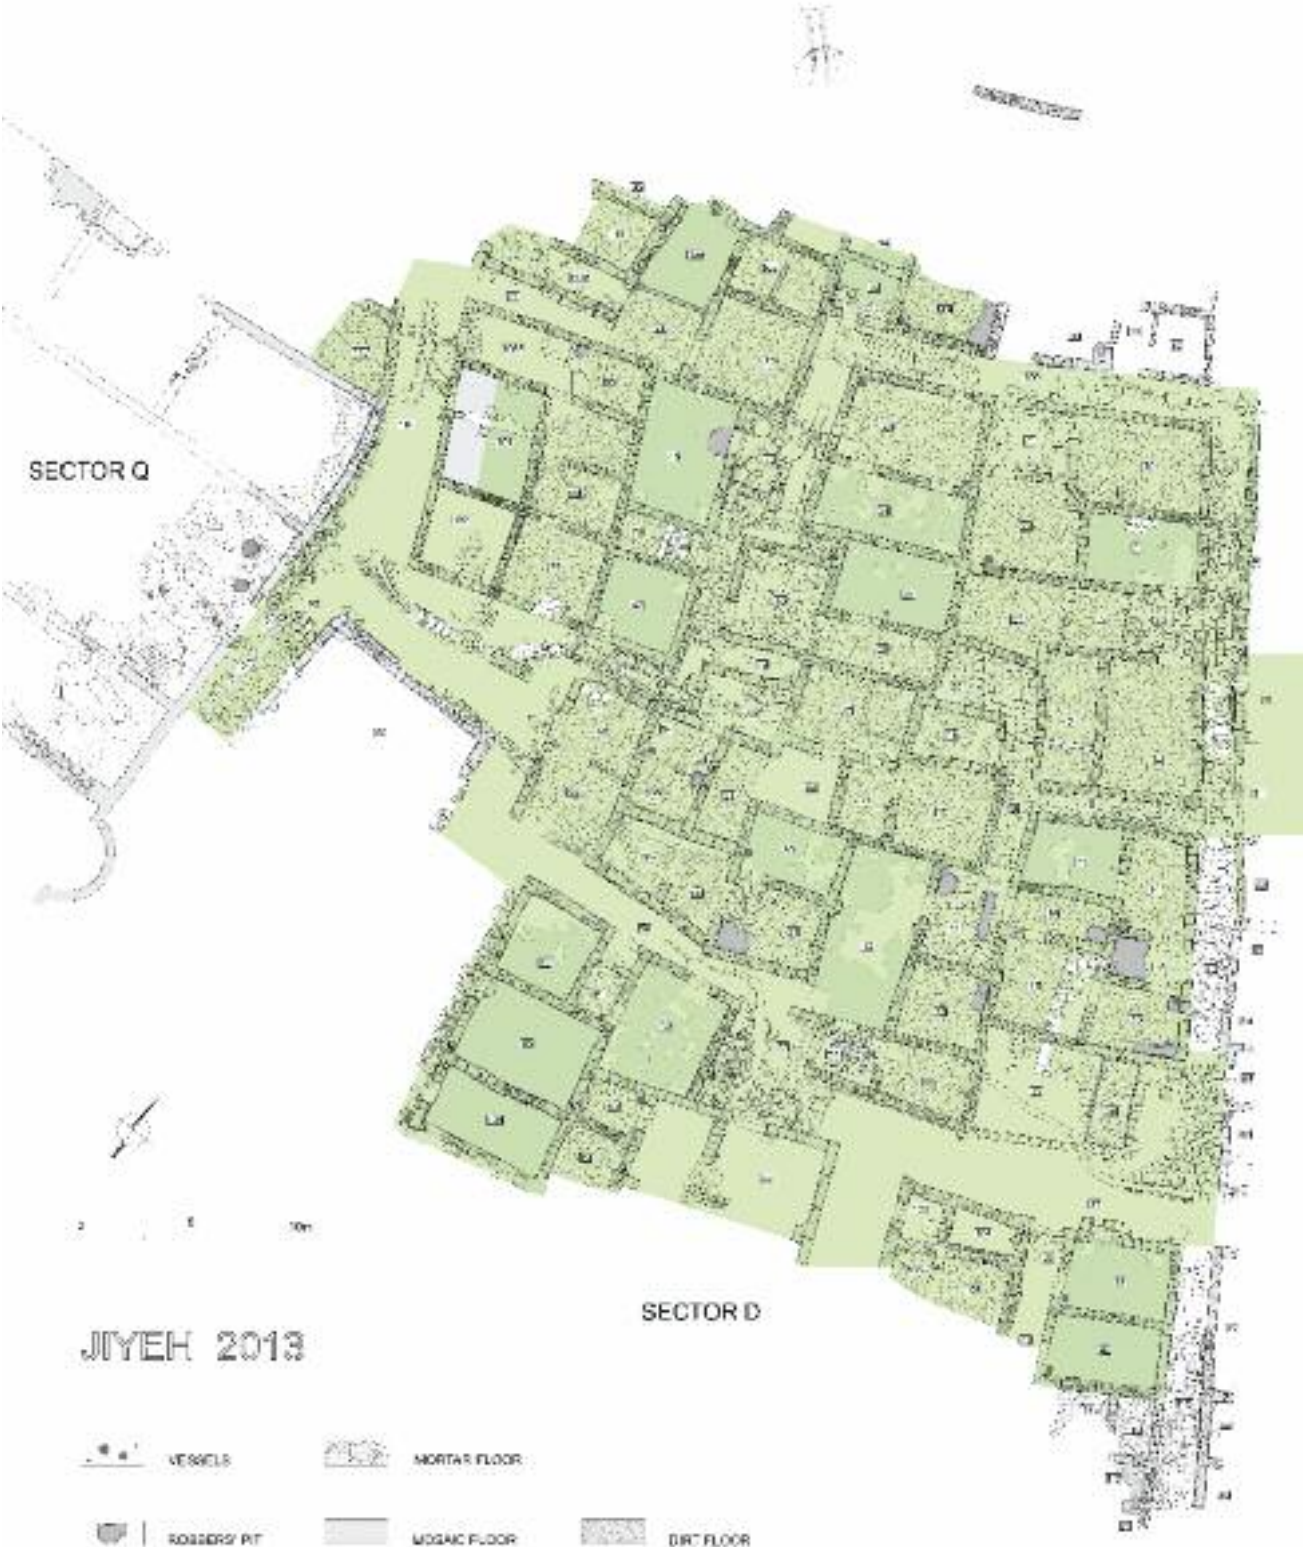
2 Plan of sector D with the areas R. Saidah excavated in 1975 marked in green (drawing by M. Puzskarski).

During the Polish-Lebanese excavations, a wall was encountered in room 17 made from stone ashlar unbound by mortar. Its function remains unknown, but the fact that it was not marked on the 1975 plan indicates that this structure is most probably a modern addition ²⁹. The structure ran along a north-south axis and was located in the eastern part of the room (fig. 2).

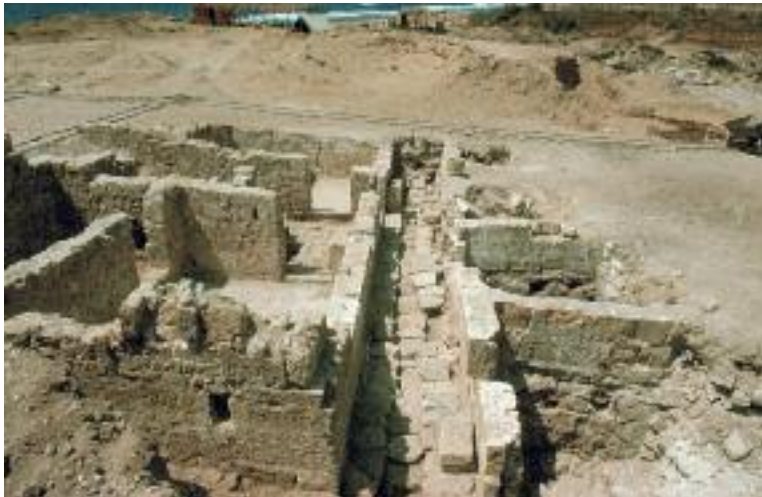
7 View from the south of the cleared buildings by street 8E and the sand dune on the outskirts of sector D. The photo also depicts the rail tracks running along an east-west axis. Rooms 5 and 81 along with their basements are visible on the right side of the photograph (R. Saidah's archives).

Tracked wagons were used during excavation work. One of the main railway lines ran from the east to the west north of rooms 1, 22 and 24 (figs. 7-8). From there, other tracks went southward. Thus, it can be concluded that in the initial phase of excavations, work was conducted on the street 8, after which they moved to the north. After clearing the row of rooms there, they moved further west, and the procedure was repeated, involving first the clearing of the rooms on the south side and then moving gradually to the north.

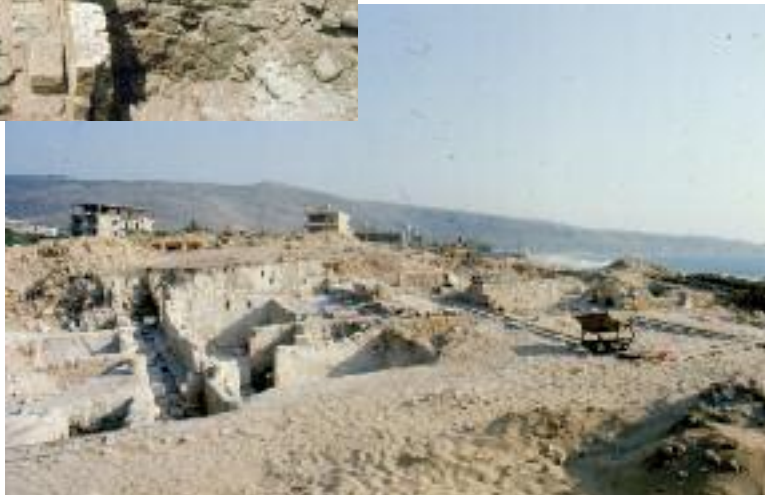
8 View from the north-eastern side of sector D with the as yet uncovered southern part of the building complex and the mound on its eastern side. In the foreground, tracks and the wagon used to remove earth (R. Saidah's archives).

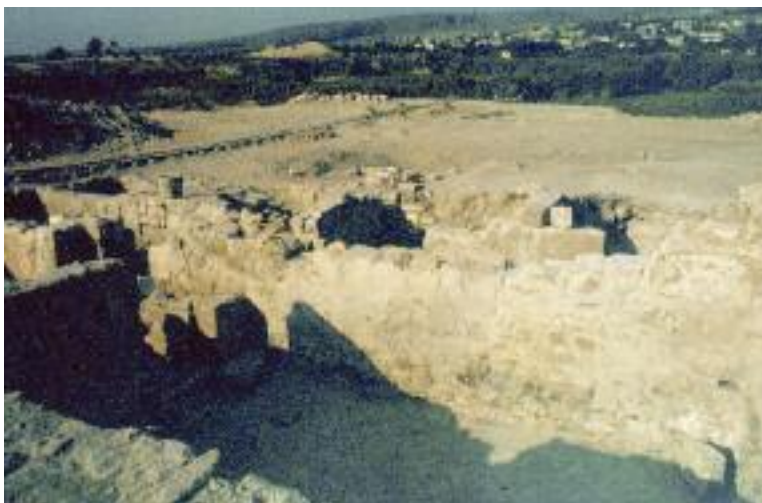
9 View from the south-western side of room 4 on the rail tracks in north-eastern part of sector D (R. Saidah's archives).

The sand and rubble were taken by wagon and dumped in the east at a distance of about 30 m, where a considerable depression is still observable today (fig. 9). In the course of the Polish-Lebanese research, such heaps most likely resulting from R. Saidah's excavation methods were also identified as located between sector D and the basilica, as well as to the south of room 90.

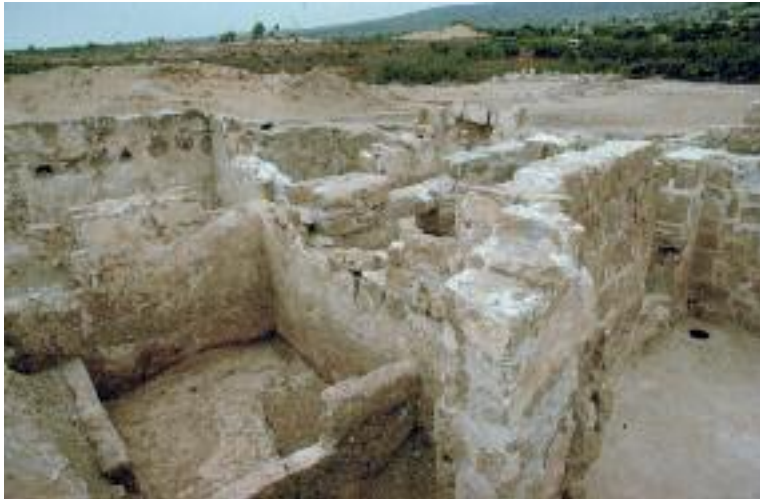
10 View from the southwestern side of the cell filled with lime or gypsum in room 27. On the left side of the photo, a row of holes for floor beams is visible in the northern wall of room 26 (R. Saidah's archives).

Probably due to the quick pace of the 1975 excavations, some architectural structures were partially damaged. This is especially true of certain thin partition walls located in some of the rooms. These types of structures have only been preserved fragmentarily around the balk in room 101. The walls extending further to the east were destroyed to the foundation level. This must have resulted from the inattention of the workers at Jiyeh¹⁰. A similar situation must have occurred in the case of a large cell in the north-east corner of room 27, where the ashlar from the upper row were also damaged as indicated by the single ashlar in the upper row by the eastern wall of the room (fig. 10).

One of the archival photographs shows the well-preserved northern wall of room 26 along with the plastering on its southern face (fig. 10). It reached a height of at least 230 cm above floor level. A row of holes for ceiling beams is visible just below the wall's crown. More importantly, the same plaster layer used to cover the inner sides of the walls can be observed just below and just above this height. This indicates that the upper storey consisted not of a roof but of a roofed room. It was most likely accessed through atrium 48, using some sort of wooden structures. The holes for wooden beams visible in the southern part of this room may be traces of this structure (fig. 18).

8. In the photos of rooms 7 and 27, layers of pure lime or gypsum (fig. 10) are shown lying in cells located next to the walls. Such material was used by the residents of the ancient settlement to repair various architectural features or during the frequent reconstructions of the buildings ³³. During the excavations conducted by the Polish-Lebanese mission, these containers were found to be empty; however, traces of their original fill were visible on the surface of the walls.

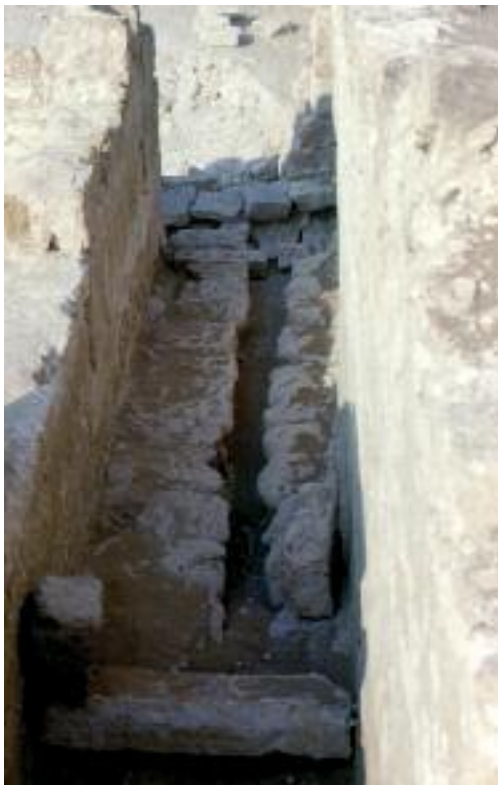
11 View from the west of street 8 with an excavated water channel (R. Saidah's archives).

In addition to clearing individual rooms and streets, the excavations in 1975 also included the partial exploration of the fillings of some of the sewage canals. This included the investigation of those located in street 8 (between 9 and 8E) (fig. 11), and in areas 35 and 37, 59. This was also the case for the section of the duct located below pavement level in the interconnected streets 57 and 73. In all these cases, removed slabs were frequently encountered with empty spaces underneath, while in other parts of the site the ducts had both covers and soil fillings. R. Saidah must have attempted to obtain material that would enable establishing a dating of when such hydraulic systems had stopped being used at the settlement.

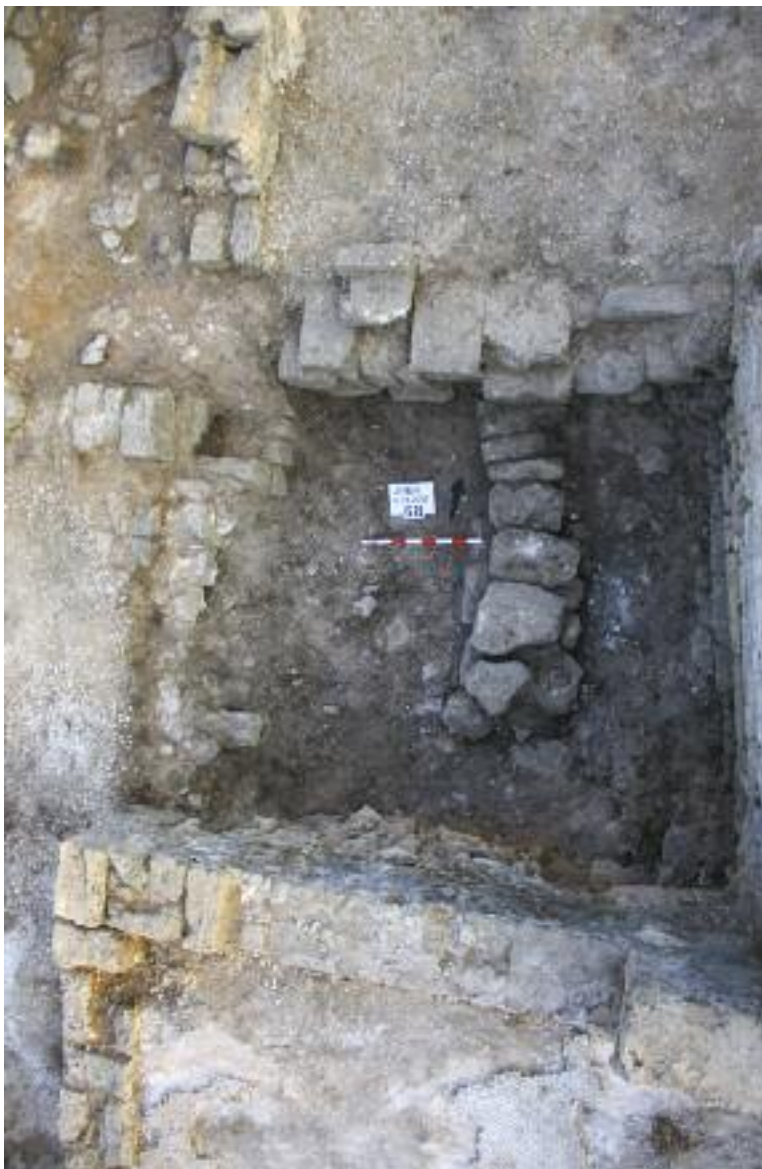
12 View from above of R. Saidah's test trench in room 68 (photo by K. Trela).

The remnants of a stone wall running in a north-south direction were also exposed in this test trench (fig. 12). It is marked on the 1975 plan (fig. 6). Its top was at an elevation of 7.9 m asl, a metre lower than the floor of early Byzantine room 51. The construction technique involving the use of unworked stones unbound with mortar would indicate that we are dealing with a structure from the Iron Age or the Persian period ¹³. However, this hypothesis should be treated with some caution, as no finds of artefacts have been made that would enable determining the approximate time of founding the wall.

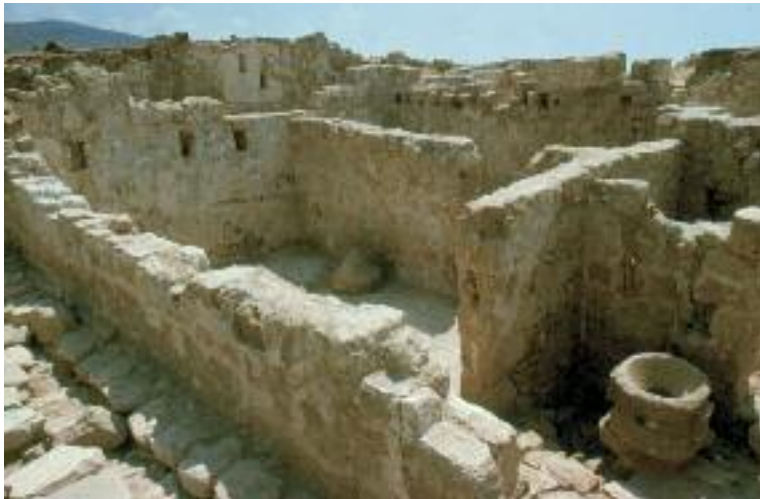
13 View from the north-east of rooms 2 and 4. Next to the walls of both areas, there are elements of Pompeian-type millstones. Behind one of them, there is a test trench done in 1975. The picture also shows the western wall of room 7 with a row of holes for the ceiling beams. The photo also portrays the southern wall of room 2 with a diagonal negative left after a wooden structure enabling entry to the higher storey of the building. On the north face of room 13's north wall, one can observe rectangular plastering around two small windows, which is not continued on the rest of the wall (R. Saidah's archives).

A second test trench was opened in the south-west corner of room 2. It was much smaller than the previous one, measuring about 1 m by 0.9 m, and of an unknown depth (figs. 13, 19). The pit was made after the stone pavement in the room had been documented in a drawing, after which the pavement was partially removed during the next stage of excavations¹⁴. We may assume that the purpose of the excavations in this place might have been obtaining material dating the foundation of this floor. It is also likely that R. Saidah wanted to expose the foundations of the room's southern wall in order to identify the spolia used to build it. The reused object in this case is a large round press bed placed upright and joined with the remainder of the wall using mortar¹⁵.

A similar dense array of holes intended for ceiling beams can be observed in the photographs showing the eastern face of room 7's western wall (figs. 13, 16). In this case, the plastering has not been preserved well enough to provide any clear evidence of a room on the upper floor. However, in the northern part of the western wall and in the western part of the southern wall, it can be observed that the wall extended further up above the ceiling by at least 131 cm. Based on R. Saidah's elevation measurements, we can state that the floor of the upper storey was located at a height of 1.99 m, and thus the room below must have been such a height. The highest preserved part of this room's walls is 3.3 m above floor level. Thus, we can presume that the wall extending up higher above the wooden beams of room 7's ceiling could have been part of a roofed room located on the upper storey. Nonetheless, we cannot exclude that the upper storey had in fact not been roofed and that the wall was there to prevent access from the neighbouring streets 8 and 9 as their elevation was 1.6-1.8 m above the ground floor of room 7.

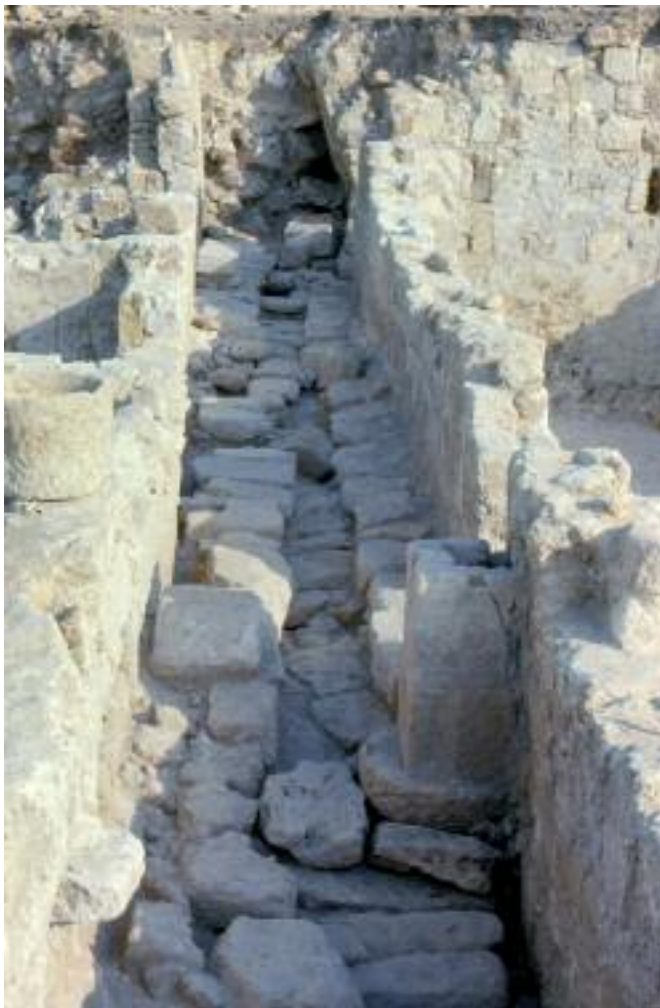
15 View from the north of street 8E and its backfill located at the same height as room 14 (R. Saidah's archives).

thickness on the streets excavated in Sector D, which most certainly had not been roofed (cf. fig. 15).

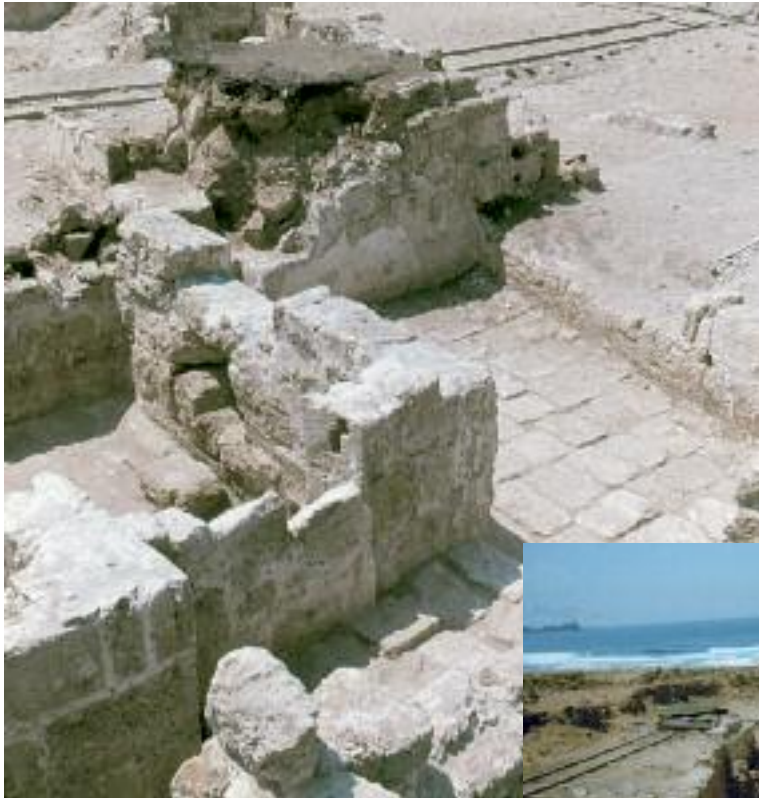
16 View from the south-east of room 26 before it was cleared of the rubble fill. In the right bottom corner of the photograph, one can observe holes for ceiling beams in the western wall of room 7 (R. Saidah's archives).

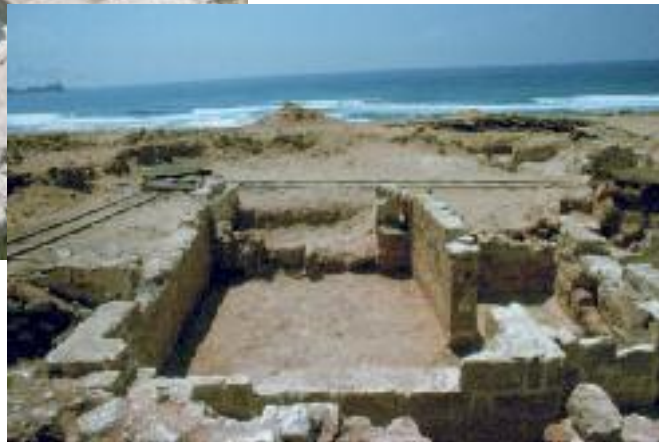
Fig. 17 View from the east of the cleared room 10 and partially cleaned-up room 28. The remains of a partition wall can also be observed in the photo (R. Saidah's archives).

9. Photographs taken after the clean-up of the rooms in sector D show that most of the floors were in very good condition (figs. 9, 17, 23, 27, 28, 29). This is important as during the Polish-Lebanese works most of them had been severely damaged by vandals and plants. This observation allows us to conclude that at the end of early Byzantine or during early Islamic period there was no drastic degradation of the house floors. The photos show no signs of burning, which could have indicated the occurrence of violent events preceding the abandonment from the village.

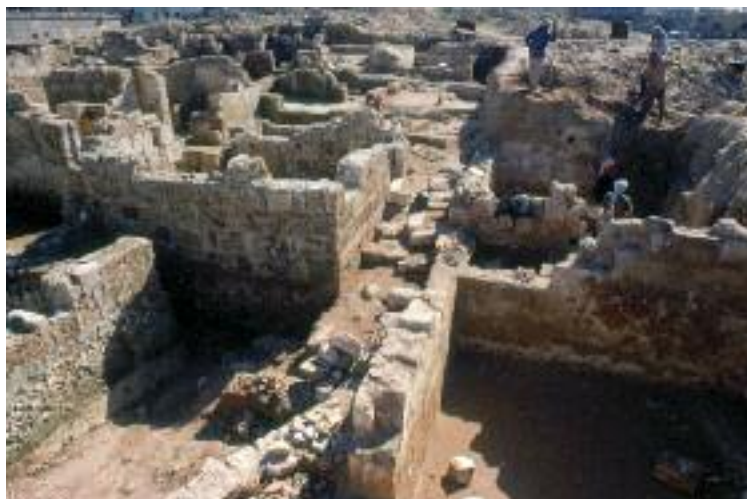
18 View from the north-west of the buildings in sector D. In the middle of the photograph, one can see room 48 and the inner face of its south wall with holes for wooden beams. At the bottom edge of the photograph, it is possible to see the gathered artefacts consisting of ceramic vessels, roof tiles, stone blocks with paintings (R. Saidah's archives).

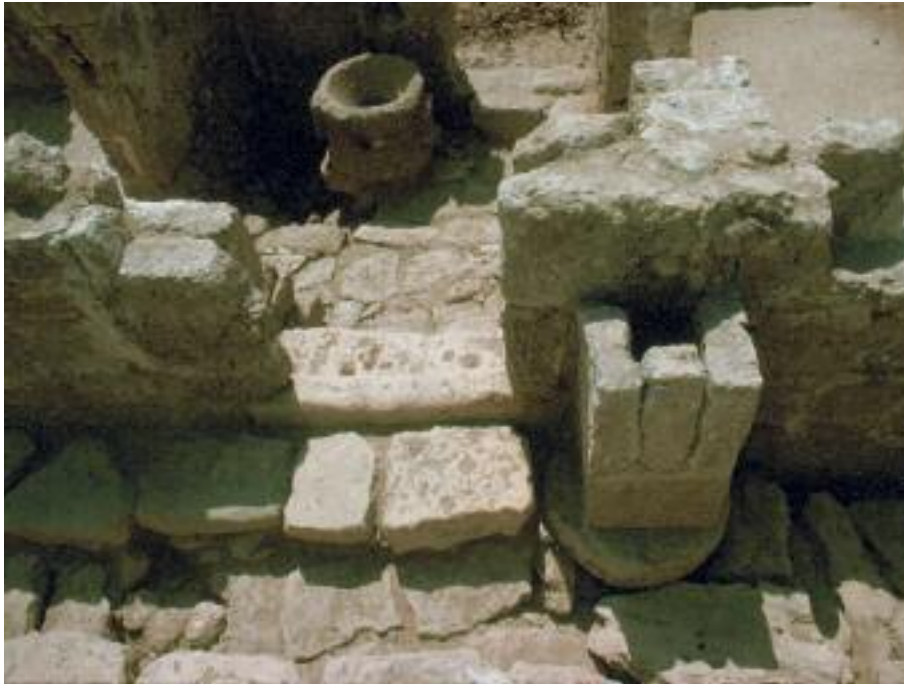
19 View from the east of street 8E and the gutter's stone casing (R. Saidah's archives).

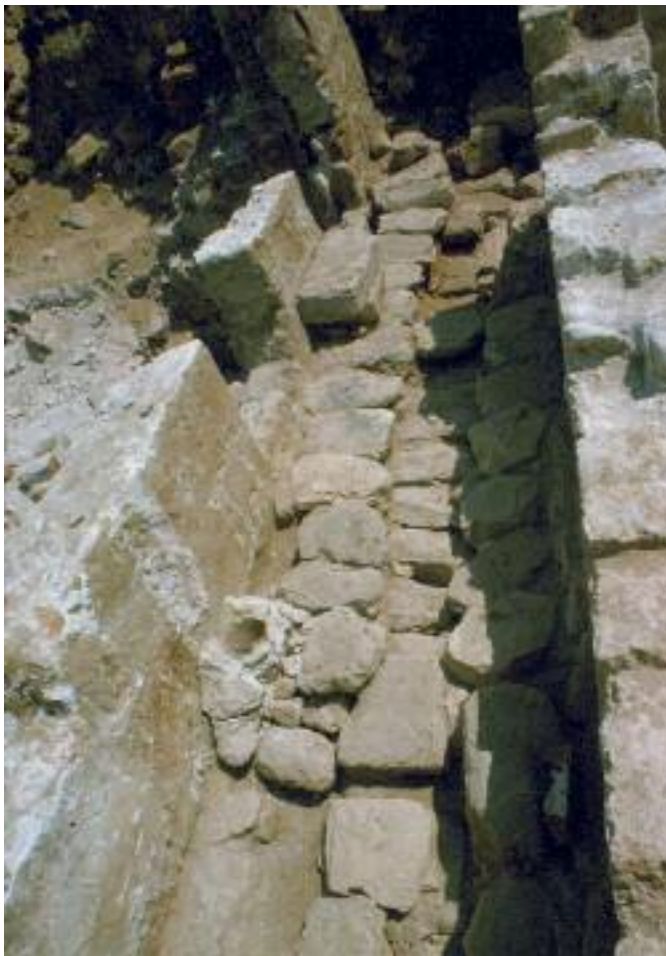
20 View from the north of street 8E and the remains of a gutter adjoining the wall in room 5 (on the left side of the photo) (R. Saidah's archives).

Some other elements that have been strongly damaged and are difficult to identify include the remains of vertical gutters²⁴. They drained water from the roofs of the buildings, from which they ran down to the canals beneath the streets²⁵. The remains of such installations are visible on street 8E next to the walls of rooms 2 and 5. Only the first of these was marked on the 1975 plan. This is a small casing made from small ashlar that protects a ceramic pipe running along the wall of room 2 (figs. 15, 19). Further one, the pipe reaches a secondarily used semi-circular stone used for crushing olives (orbis), which is connected to the canal under the street. The second gutter running along the wall of room 5 consisted exclusively of a ceramic tube covered with a very large amount of

mortar (fig. 20). It has been preserved to a height of several centimetres above the street level.

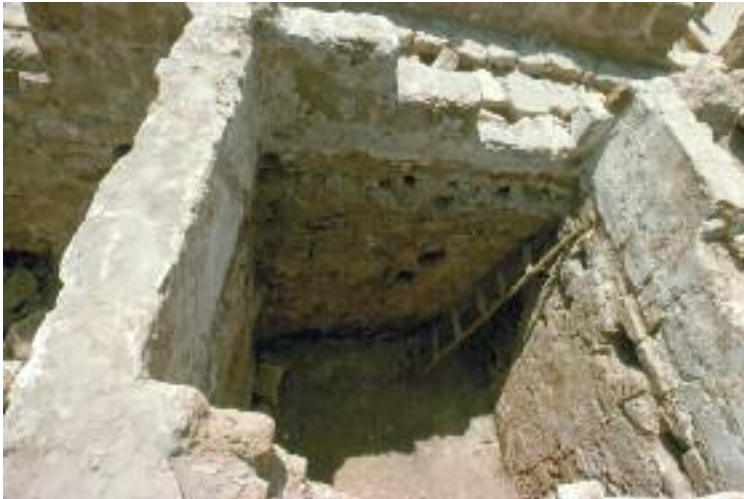
21 View from the eastern side of room 5 and its basement. In the walls, one can observe holes linked to the construction of the floor on the higher storey of the building (R. Saidah's archives).

Some interesting architectural structures that have not been cleaned yet by the Polish-Lebanese mission include two rooms (5 and 81) with basements located next to street 8E (figs. 7, 21, 22). Currently, they are very damaged and buried under rubble. Only one of them is visible on the 1975 plan, while the archival photographs show that both were cleared out at the time. In both cases, holes in the walls are visible for the beams on which the upper floor was placed. This level was in both cases accessible through a door from street 8E.

Based on the elevations, the supposed basement floor in room 5 can be reconstructed as having been located about 2 m below the level of street 8E. In turn, the floors above the ceiling beams were about 20 cm thick, which is indicated by the negatives on the walls in the form of plaster ²⁶. In addition, it can be observed that the walls of the basement had not been plastered as opposed to the walls of the rooms above. The use of basements in ancient Near Eastern architecture is not a common occurrence. However, this kind of space has been identified in the nearby village of Chhim, which was contemporaneous to Porphyreon. At this settlement, at least one basement is known to have existed underneath an olive oil press ²⁷. It is difficult to establish in the case of Jiyeh whether we are dealing with storage spaces in a building that had been used for production purposes or something else.

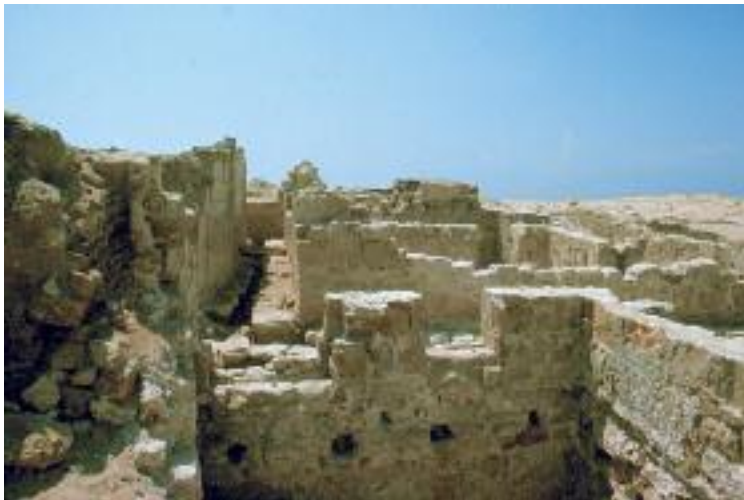
22 View from the east of room 81 and its basement. In the walls, one can observe holes linked to the construction of the floor on the higher storey of the building (R. Saidah's archives).

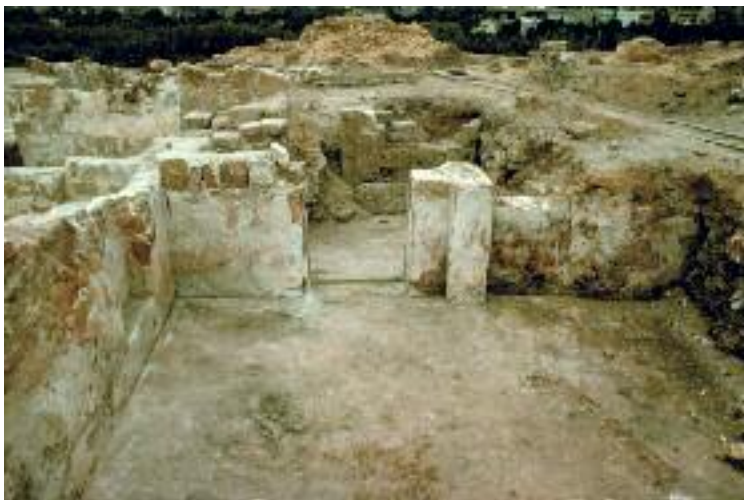
23 View from the west of the northern part of room 12 and room 11 situated behind it. The remains of a staircase resting on a layer of rubble are visible in this second area (R. Saidah's archives).

Yet another interesting structure in light of R. Saidah's archives would be the stairs located between street 9 and room 11 (figs. 23-24). They are currently in rather poor condition (fig. 25). However, the 1975 plan and photos enable making some very important observations. Firstly, at that time the stairs were at least 1 m longer and occupied this much more space in room 11. Based on the photos, we can state that the staircase was built on top of a layer of rubble, which indicates that the space behind the stairs could not have been in use at the time. The highest preserved step is located at a height of 1.8 m above room 11's floor and 1.7 m above the level of street 9. Based on one of the photographs, it is possible to state that the stairs were built at a time when part of street 9 was covered with sediment and stone rubble (fig. 24). All these observations indicate that as the ancient settlement slowly neared its end, the standards of cleanliness in public space became much lower on the one hand. On the other, some of the premises seemed to have no longer been in use, and the inhabitants in that part of sector D moved to higher levels of the buildings, which was linked to at least a partial resignation from the use of space on the ground floor.

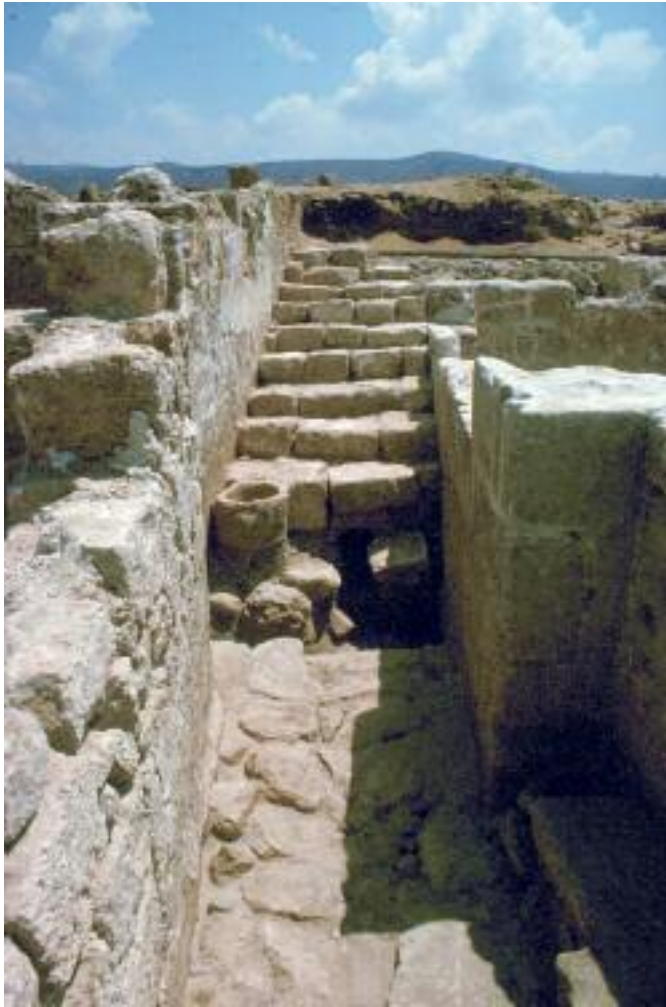
24 View from the north of the stairs between street 9 and room 11 (R. Saidah's archives).

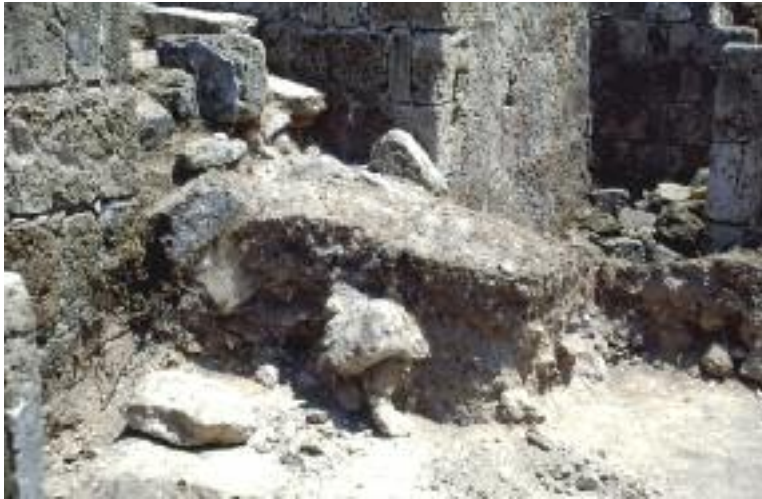
25 The remains of stairs and the heap of rubble underneath in room 11, view from the south-west (PCMA archives).

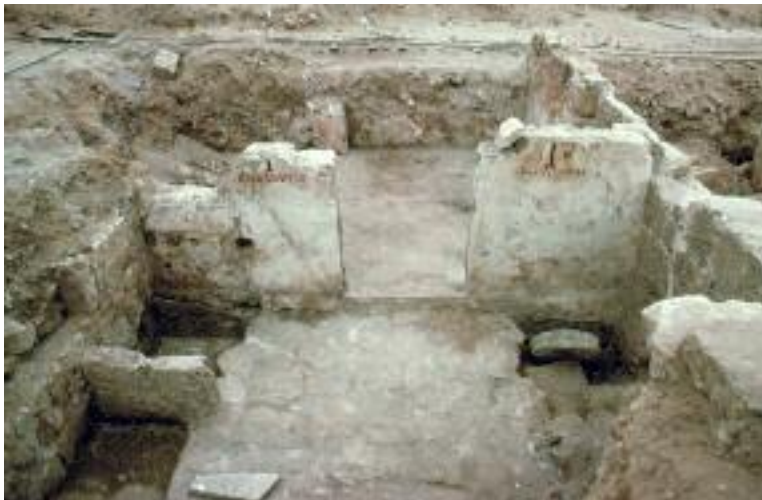
26 View from the east of room 11. There is a low wall visible in the southern part, which has since been destroyed, and holes for wooden beams are also visible in the western wall. On the western wall, it is also possible to see partially preserved red painted crosses and Greek inscriptions (R. Saidah's archives).

Room 11 was furnished with other structures, destroyed after 1975. In the southern part of this area, there was a low thin wall running in a north-south direction (fig. 26). Holes for wooden beams were located in the western face of this room's western wall. These two elements could have been linked and formed a wide raised surface with some sort of central support or perhaps could have been part of a wooden staircase leading to a higher level. Currently, this low wall is no longer visible. It was also not included in the 1975 plan.

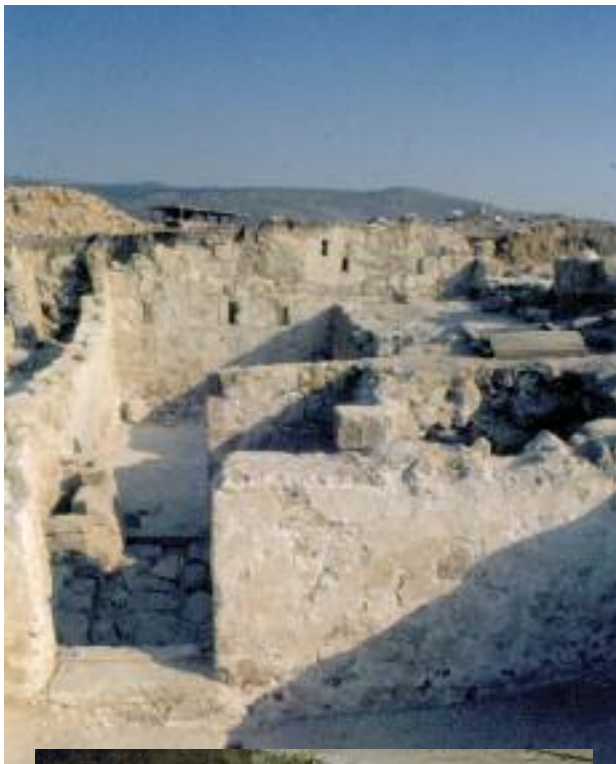
27 View from the north of room 1 and of room 2 located behind it. There is a basin-like structure visible in the south-eastern corner of room 2 (R. Saidah's archives).

Another unpreserved structure can be seen in a photo depicting room 2 (fig. 27). A pool-like structure is located in its south-eastern corner. The south and east parts of the structure are also the room's load-bearing walls. The west and north parts were built using at least three rows of small ashlar. Based on R. Saidah's plan, the structure's internal dimensions can be calculated, amounting to about 0.8 m in the north-south axis and 0.38 m in the east-west axis. The fact that this structure

partially obstructs the entrance to room 4 may indicate that it was a later addition. However, it was constructed before the pavement beneath it was covered with a layer of earth ²⁸. The structure is currently completely destroyed.

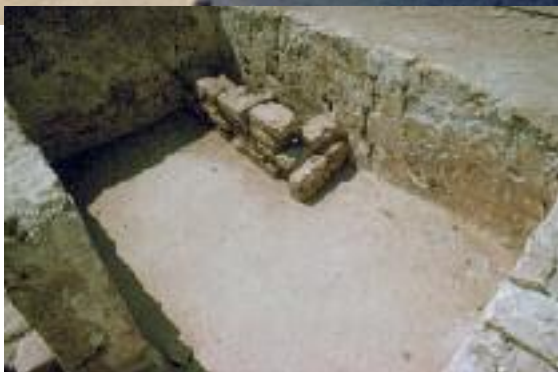
28 View from the east of room 19 and the rows of stones lying next to the northern and eastern walls (R. Saidah's archives).

3. In room 19, both in the archival photographs and on the plan, two rows of ashlars can be observed next to the east and north walls, arranged directly on the floor made of mortar (fig. 28). There was an additional stone ashlar next to the northern wall. There is no certainty that we are dealing with intentionally arranged objects or, perhaps, stones that have fallen from neighbouring walls. However, taking into account the reciprocal arrangement of these ashlars and their similar height, and the stonework used in adjacent walls, this second possibility seems unlikely.

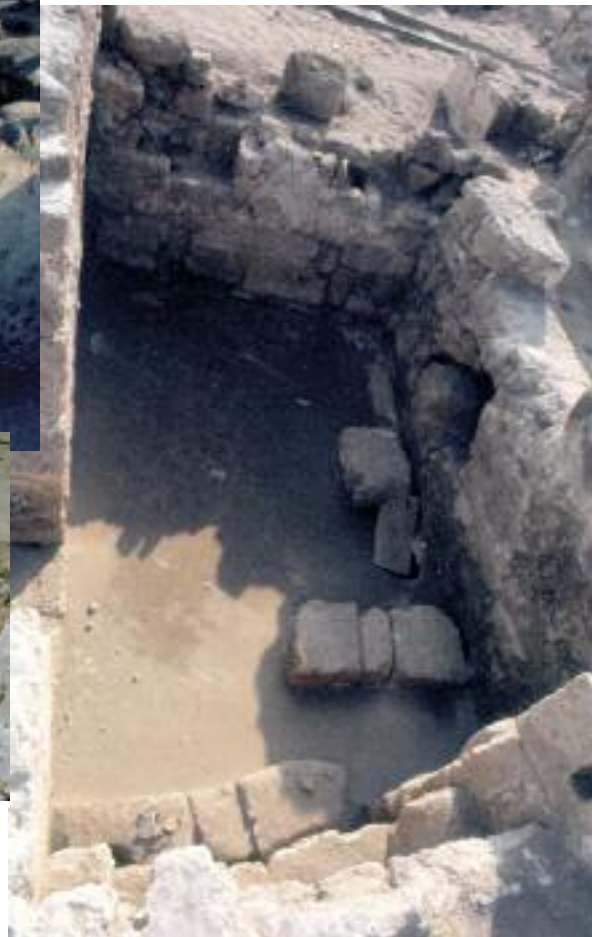
29 View from the south-east of room 1 with a structure adjacent to the wall in the north-eastern corner of the room (R. Saidah's archives).

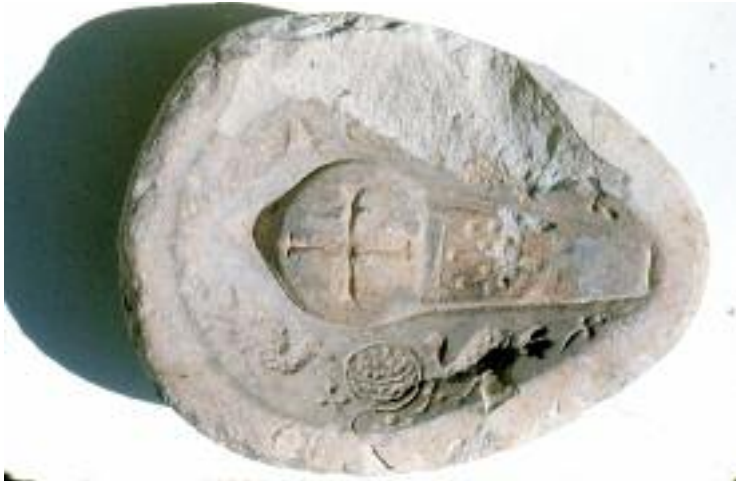
31 Mould for the production of ovoid-type oil lamps (R. Saidah's archives).

The photos also show moulds used for the production of ceramic oil lamps, of which one was published by R. Saidah³⁹. Until recently, we lacked information about the other mould. The photo depicts the upper part of the lamp's mould, partially damaged at the edges (fig. 31). It was used for the production of ovoid lamps typical for the early Byzantine/early Islamic periods⁴⁰. This one has an equilateral cross on its central part. A kantharos seems to be visible below, but this has not been confirmed due to the state of the lamp's surface. In addition, there were peacock images on both sides arranged antithetically flanking vessels most likely filled with round fruits (vine grapes?). Two small crosses are located underneath this central motif. This is at least the third oil lamp mould of the ovoid type found at this site, which indicates this was a developed production centre of such items during the early Byzantine or early Islamic period.⁴¹

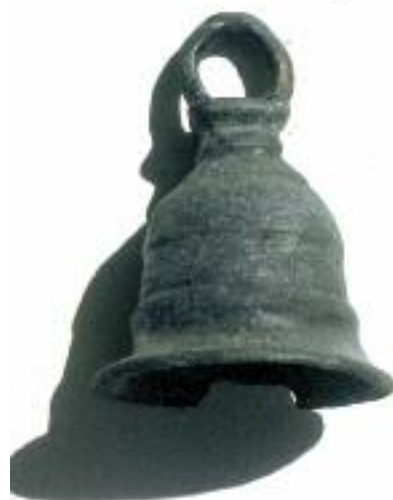
33 Most probably a bronze bell (R. Saidah's archives).

2. Probably a bronze bell with a rounded crown, a profiled mantle and partly chipped bottom edges (fig. 33). Similar forms of this kind originating from other sites are dated to the 3rd-6th centuries AD⁴⁴.

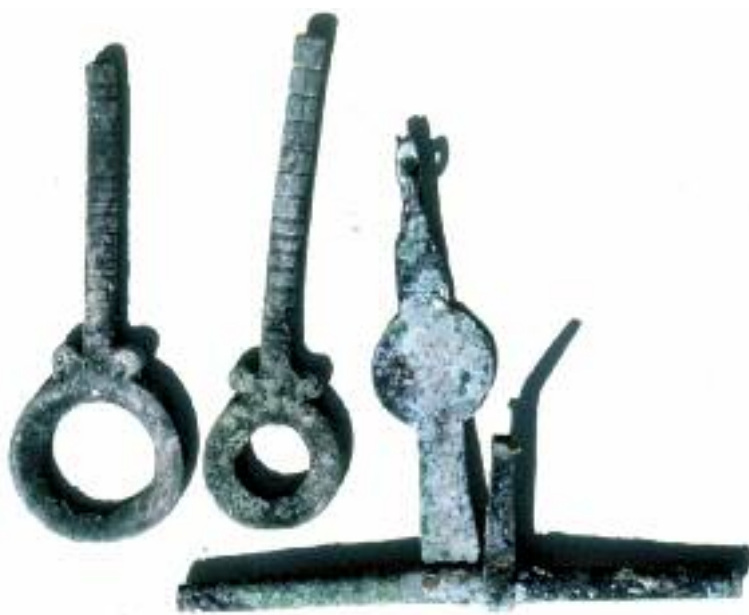
34 On the left side of the picture, probably two parts of a polycandelon. On the right side of the picture, probably part of a lock in the form of a hasp to a wooden chest (R. Saidah's archives).

3. Two objects in the form of bars marked with transverse notches and ending in round rings (fig. 34). Knobs are visible at the spots where these two elements come together. Due to the limited amount of information, identifying the artefacts can be difficult. It is possible that we are dealing with the broken arms of a radial polycandelon. In this case, the rings at the ends of the bars would be openings for glass lamps ⁴⁵.

4. An elongated thin object with a disc at the tapered end with a perpendicular ear (fig. 34). The other end is bent onto a bronze rod. Most likely, this was part of the lock in the form of a hasp to a wooden box ⁴⁶.
