Conference Paper · October 2015

## **The coastal fortification of Cape de Forma (Menorca, Spain): petrophysical characterization and alteration of stones and ancient mortars**

**Anna Depalmas<sup>a</sup>, Stefano Columbu<sup>b</sup>**

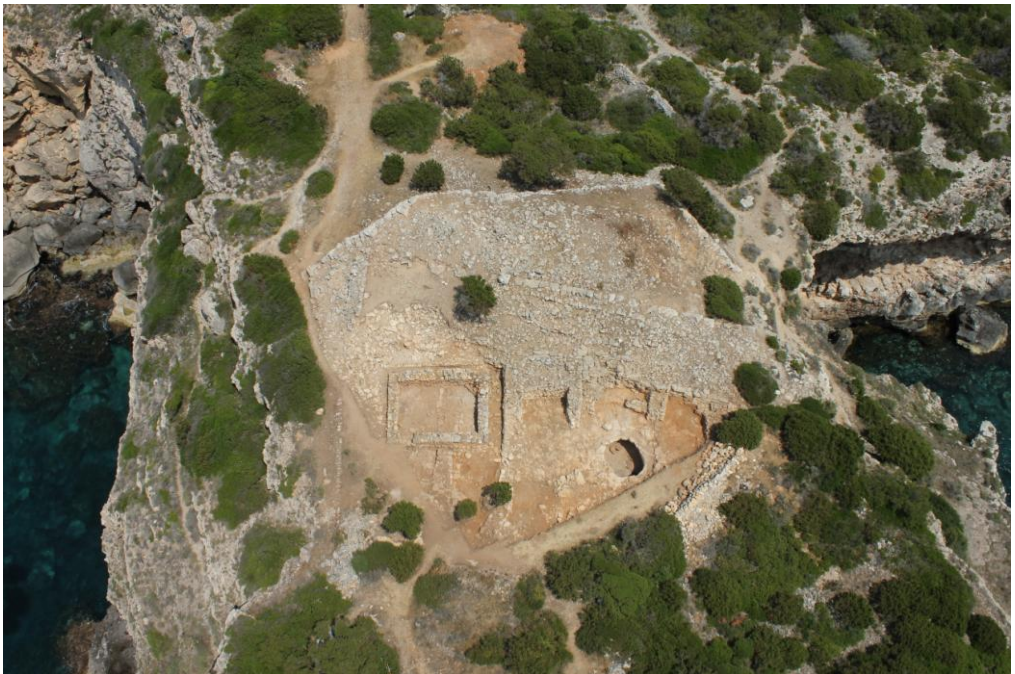
Fig. 4- Aerial view of the main monument, and of the excavated area. Here are clearly visible, on the left, the rectangular plan of the lookout and, on the right, the rounded perimeter of the cistern, by G. Taboad

The removal of the deposit allowed to highlight the presence of some segments of walls parallel and orthogonal to the external surface wall of the main structure, identified as some living spaces leaning against the monument (Fig. 4). These are:

- to the west, a space of elongated rectangular plan, not completely identifiable because in part covered by the fortified house;
- a central space, of quadrangular plan, (about 6 m x 4), difficult to define as regards the southern side;
- in the most eastern part, a space presumably open-air with an area of combustion installed close the monument, in front of a large tank for rain water.

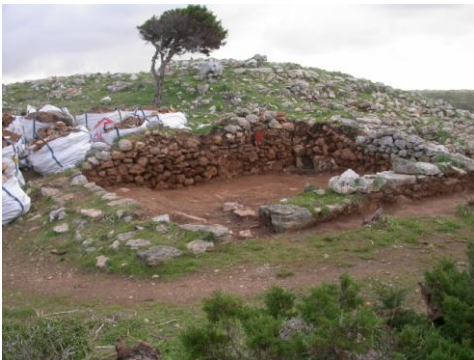
Fig. 5- The fort-house during the excavation

This fortified house (Fig. 5) was built at the SW corner of the cyclopean monument, using stones removed from the ancient structure.

The plan is rectangular, regular, with the door opened near the southwest corner of the south long side; though no longer visible, in the middle of the opposite long side, it had to be a window. Inside the fort, it has brought to light a fireplace located in the northeast corner of the room with still inside layers of ash (Fig. 6).

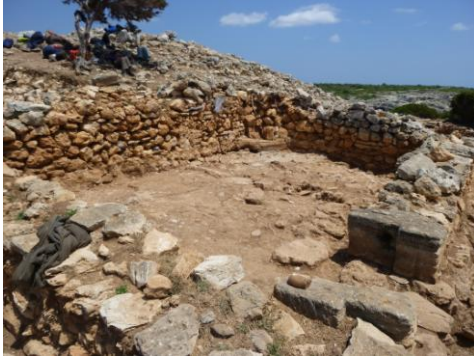
Fig. 7- The inner well-trod soil

The inner floor was characterized by a layer of very rough and damaged well-trod soil (Fig. 7).

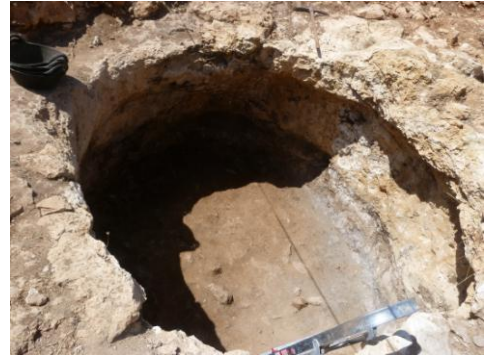
Fig. 8- The cistern for collecting rainwater

Between the two above mentioned living areas (central and eastern spaces), in a depression filled with little stone, has been identified a large cylindrical hollow carved into the limestone, which can be interpreted as a cistern for collecting rainwater for the community (Fig. 8).

The cistern (approximately 3 x 3 m) was found full of filling. The removal of the deposit of stones and soil has clarified the function of the cistern and its time in use until fairly recently, that seem to coincide with the final phases of life of the fort. The bottom of the deposit seems to have been sealed with several layers of mortar.

The presence of some cracks in the rock suggests that this mortar has been taken to seal the cracks so that the tightness of the deposit was not compromised.

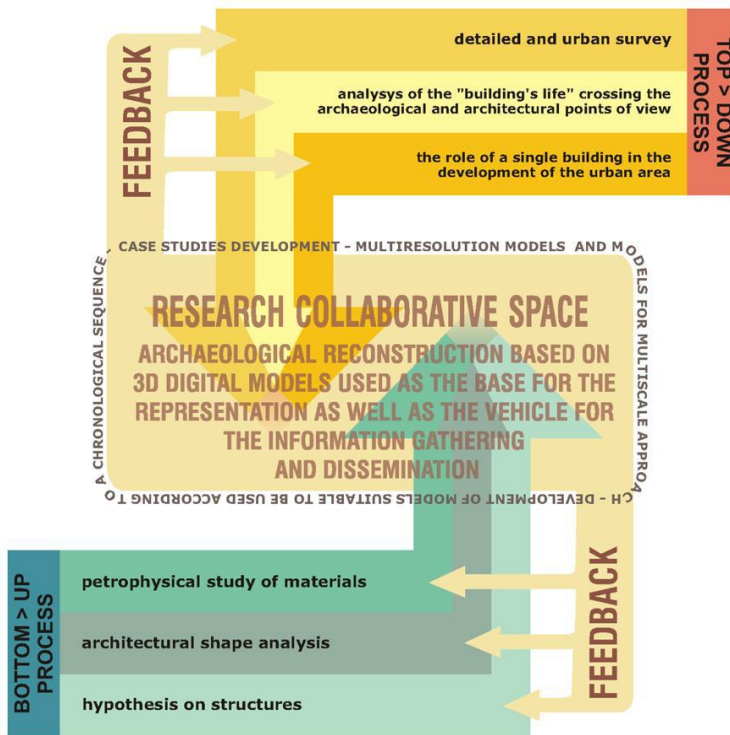
Fig. 9- The general workflow defined (from Columbu & Verdiani, 2011)

The survey investigations done on the masonry of fortifications are set according to the diagram below (Fig. 9, from Columbu & Verdiani 2011), according to following operative phases:

- Study of the existing bibliography and of unpublished archival sources;
- Architectural reading and analysis of the structural aspects (planimetric distribution, building systems, articulation of the wall textures, etc.);
- Macroscopic mapping of characteristics of geomaterials and various forms of alteration (dechoesion, alveolation, exfoliation, etc.) according to Recommendations Nor.Ma.L. 1/88 (1988) and other criteria (Coroneo & Columbu, 2010; Macciotta et al., 2001);
- Sampling stones and mortars from monument and rock outcrops (according to Recommendations Nor.Ma.L. 3/80, 1980) as a function of the representativeness of the various lithotypes and kind of mortars;

- Petrographic analysis by polarized microscopy of lithologies and mortars for define the mineralogic composition and micro-structure and textures;
- Physical analysis of geomaterials (solid, real and bulk densities, porosity, water absorption, hydric dilatation, etc.) according to Columbu et al. 2014, 2015 (in press) and UNI EN 1936, UNI EN 13755;
- Mechanical tests by Point Load Test for define the resistance of materials expressed as punching strength and for define indirectly the hydraulic degree of mortars (also according to Moropoulou et al., 2003);

- Thermo-gravimetric and thermal-differential analysis of mortar binder for define some compositional characteristics;
- Analysis of alteration processes and mechanism of physical and chemical decay of materials present into the monument.
