# BUILDING IN UNCERTAINTY: THE CONSTRUCTION OF THE CHERBOURG BREAKWATER 1780-1853

## ABSTRACT

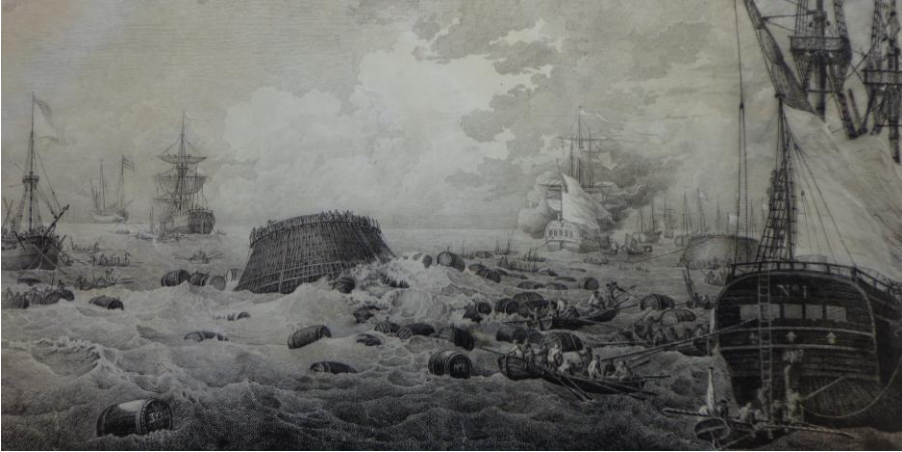
Figure 4 Sinking a cone by releasing the flotation barrels

In 1784 the second cone to be sunk broke up in a NE gale only a few weeks after launching; this cone had already been trialled at Le Havre, dismantled, transported to Cherbourg and rebuilt in 1783 but then left over the winter on the beach when bad weather had prevented its launch. The damage to the cone led to a strengthening of the uprights by doubling them throughout their whole length; this required even more timber per cone and a later evolution of the design was a compromise which still left the upper section of the cone vulnerable.

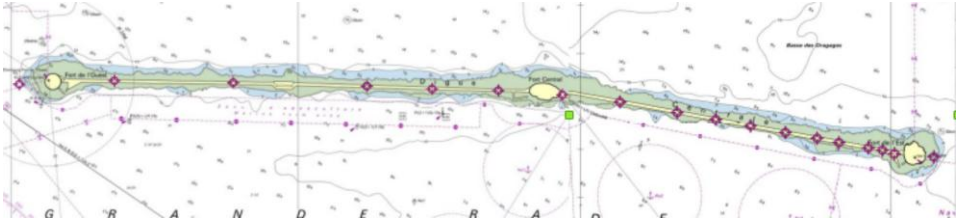
Figure 9 Chart of the completed breakwater, showing GPS positions of cones along its length.

Uneven settlement showed itself in damage laterally and longitudinally. Engineers were aware of the hard spots where the cones were buried (Figure 9), which created unevenness which had to be levelled as the wall rose; the evidence of this can be seen today in the split courses of the wall at various points (Figure 10).

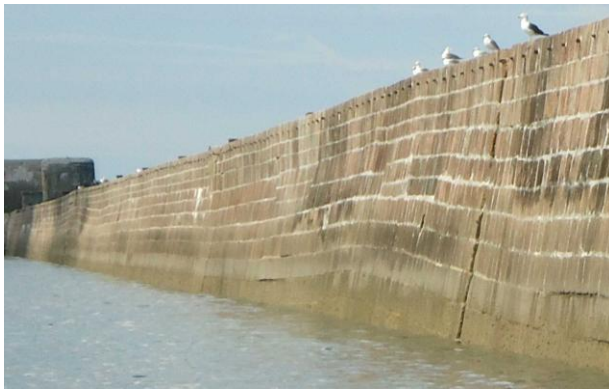
Figure 10 Sites of cones 14 and 15 revealed by the stonework of the wall, western section

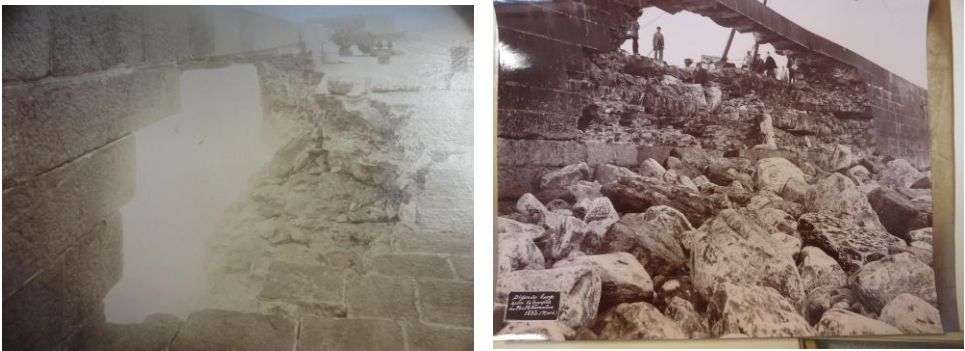
Figure 11 Breach in the parapet of the breakwater, November 1893

sea. A major breach in the upper wall at the western end of the breakwater in November 1893 (Figure 11) made it clear that even more substantial maintenance was required. The addition of the eastern and western breakwaters during the 1890s added to these demands.

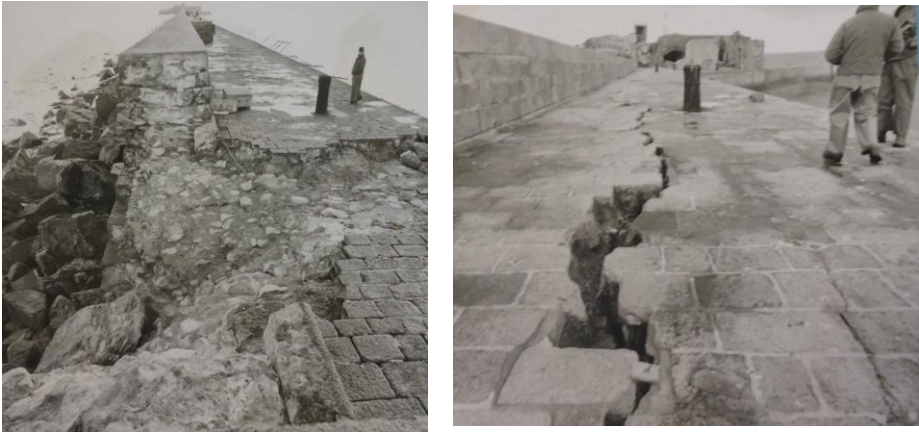
Figure 12 Breach in the parapet and longitudinal fissure, 1978

On 11-13 January 1978, a storm created waves estimated to have been 9m high, which broke to 50 m above the breakwater. The sea caused several breaches in the revetment and severely damaged the parapet, while the paved surface of the top showed a renewal of longitudinal fissures; the damage cost 9 million francs (Figure 12).

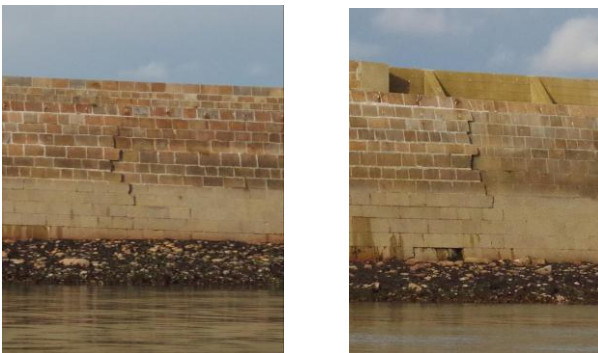
Figure 14 Cracks are beginning to appear in the south face of the wall

According to François Zoonekyndt of the Service historique de la Défense at Cherbourg, the present state of the breakwaters is acknowledged to be of concern, though considered to be of a sensitivity such as to preclude the publication of a detailed report at present. The present condition of the breakwater reveals the progressive internal damage mentioned above, causing cracks to appear on the S face (Figure 14).
