# Old British Breakwaters

## How Have Engineering Developments Influenced Their Survival?

Nigel William Henry ALLSOP

Submitted for the degree of Doctor of Philosophy  
at the University of Edinburgh  
February 2021

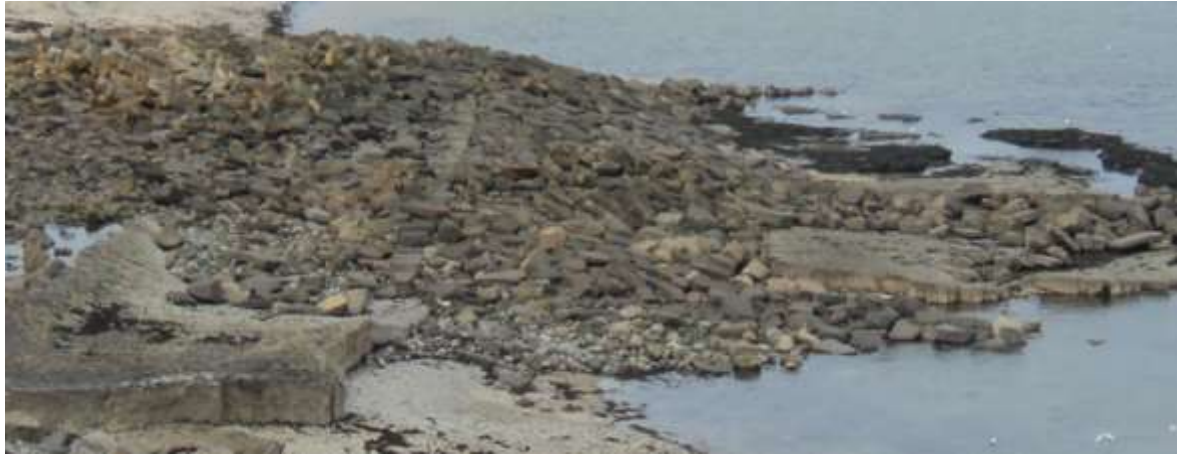
**Figure 2.30** Collapsed breakwater at Skateraw (2014)

The breakwater is reduced in its NW portion to a rickle of debris, in which, however, the line of the outer wall may be traced (Figure 2.30). Chapter 7 of this thesis will report physical model tests of simple blockwork walls which will illustrate the propensity of such walls to fail above the toe blocks. From this it may be judged that the visible blocks are probably 2-3 courses above the original foundation blocks.

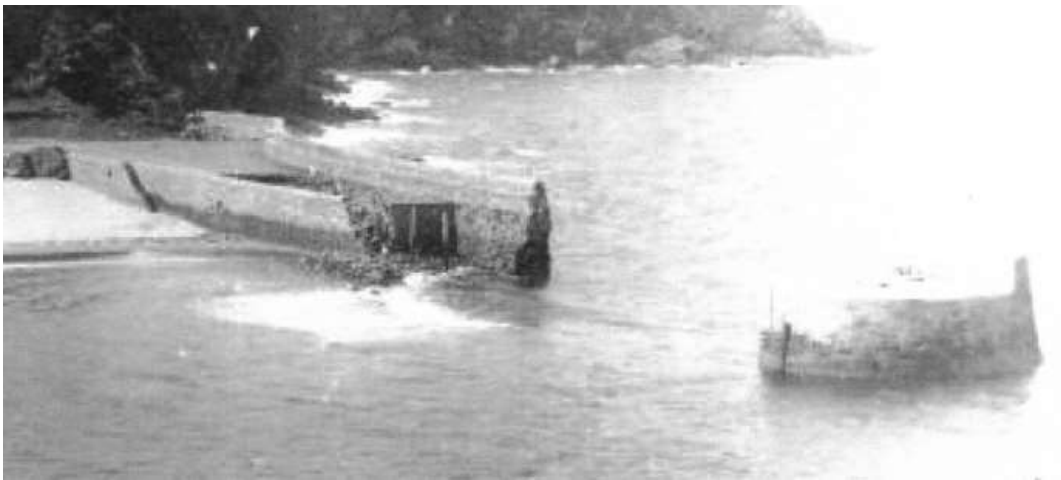
**Figure 2.32 Failure at Greve du Lecq, Jersey, 1884**

Hammond-Spencer had previously reported on an earlier failure of the pierhead in 1879 when he wrote: “It is not necessary to be an engineer in order to see that the quality of the masonry is altogether wretched and worthless, and that if once holes were formed in the face (thus affording a hole for the sea) the collapse of the wall would only be a question of time, longer or shorter according to the severity of the gales.” He also criticised the design of the pier, arguing that the plan layout “caused the force of waves to be concentrated on the section which collapsed”. He appears not to have approved of the outward curve of the pierhead.

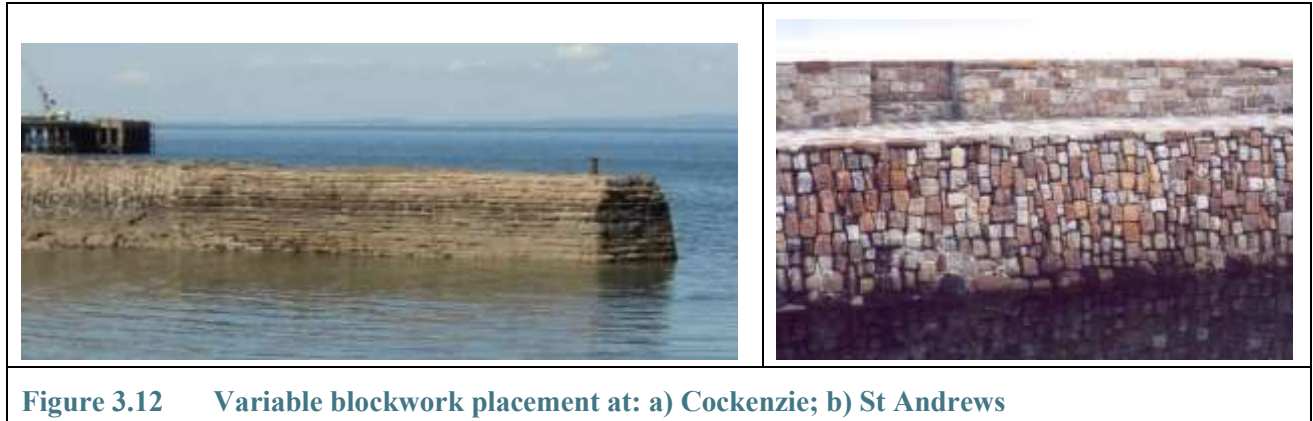
**Figure 3.12** Variable blockwork placement at: a) Cockenzie; b) St Andrews

(examples in Figure 3.12). Apart from the strong recommendation by Stevenson (1874), see below, in favour of slice blockwork, other literature does not seem to suggest any particular reasons for preferring horizontal or vertical courses, perhaps local practice. Slice blockwork is often ascribed to Telford or to Smeaton (see Chapter 12).

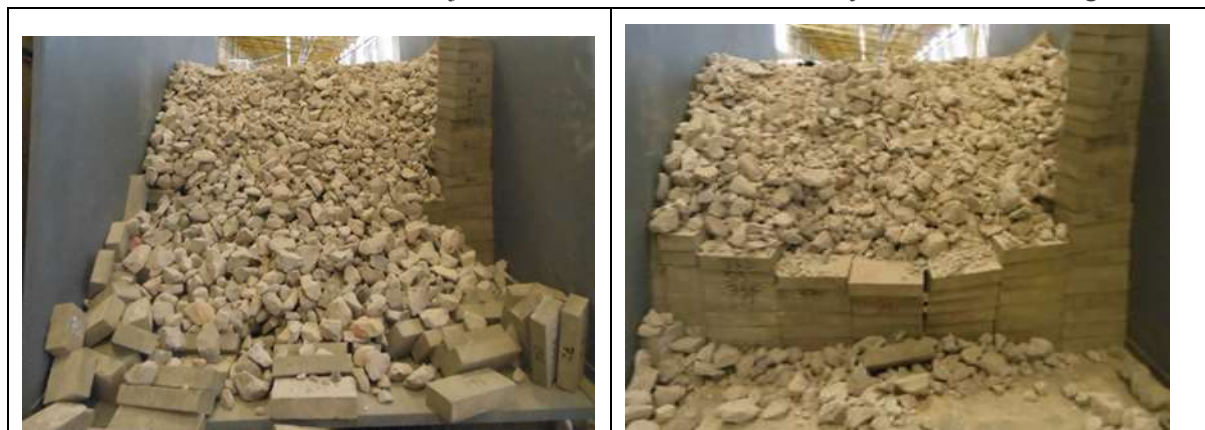
**Figure 7.4** Example dry-build failure

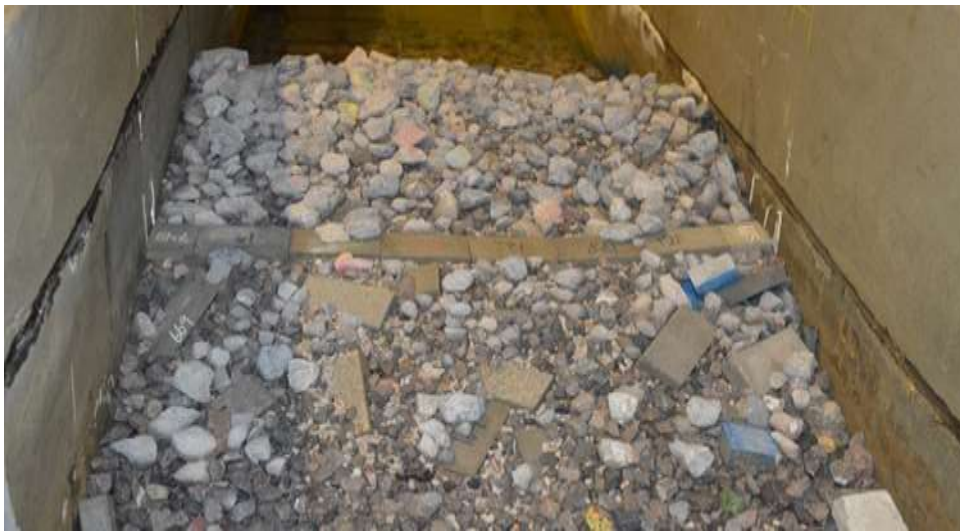
**Figure 7.13** Series 2, post collapse, view from seaward

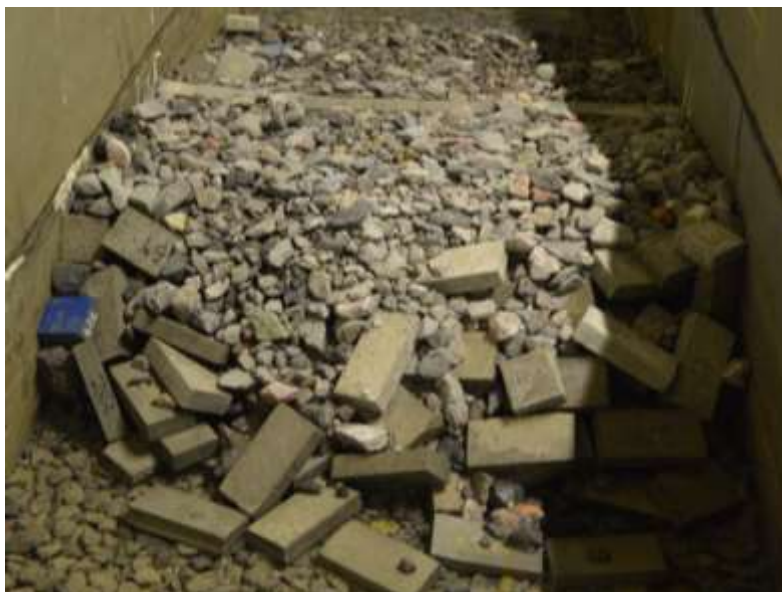
**Figure 7.14** Series 2, post collapse, view from leeward

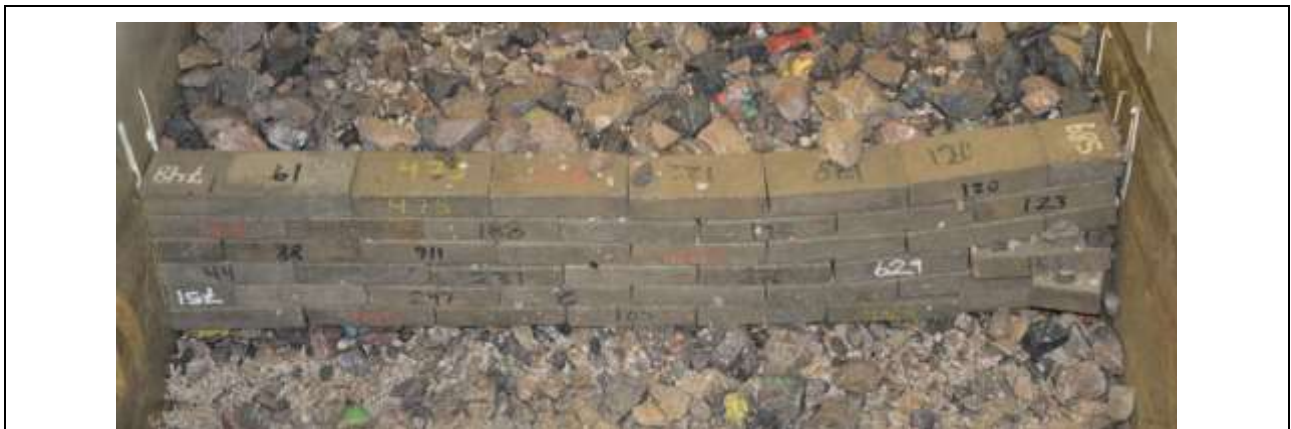
**Figure 7.16** Excavated front wall, note vertical arching where foundation has scoured

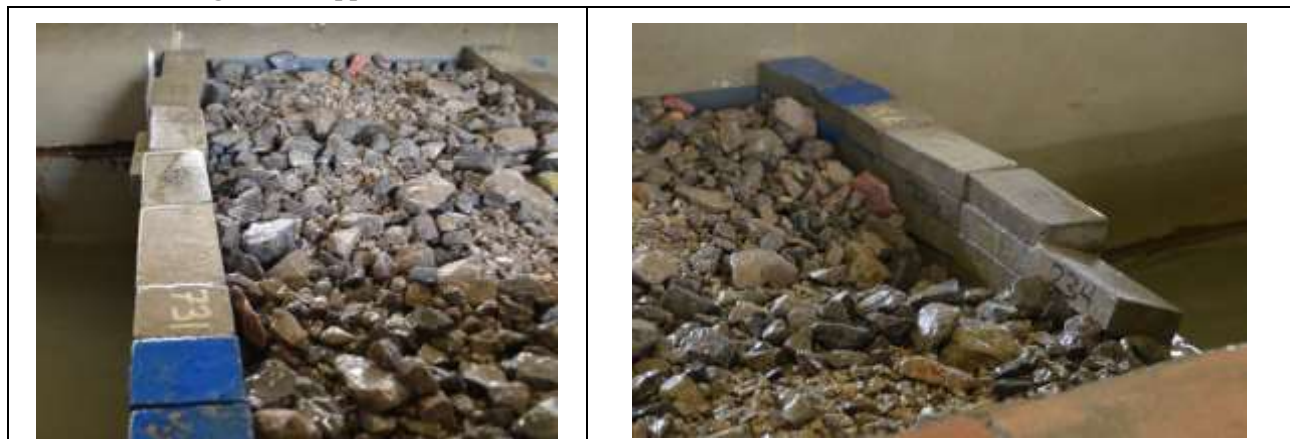
**Figure 7.22** Series 4, start of damage with sink-hole in fill following loss of front face blocks

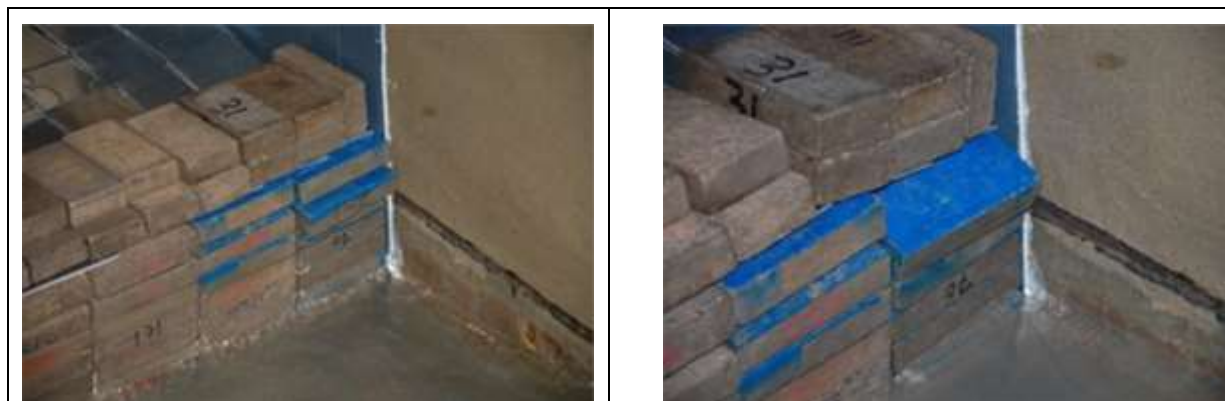
**Figure 7.28** Onset of damage during Tests 138 and 139

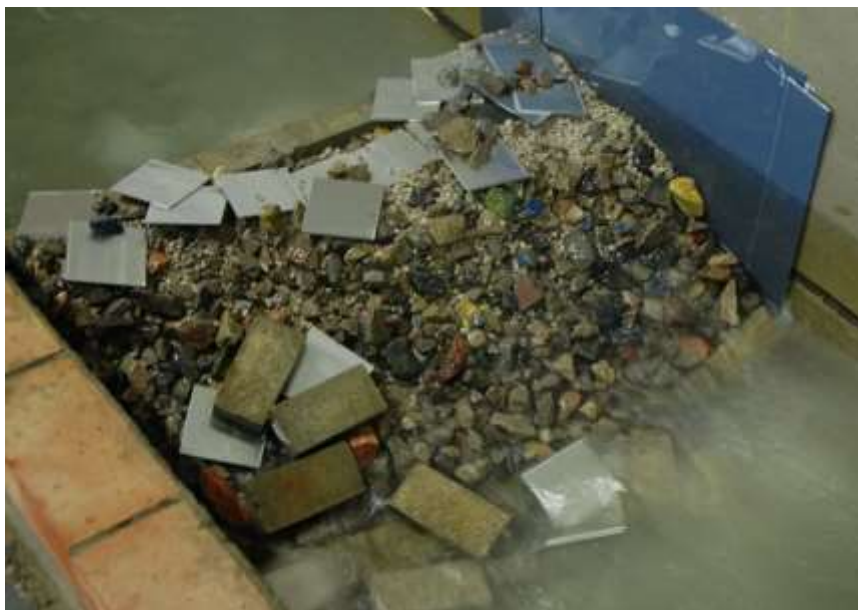
**Figure 7.29** Section 5 after collapse of the seaward wall

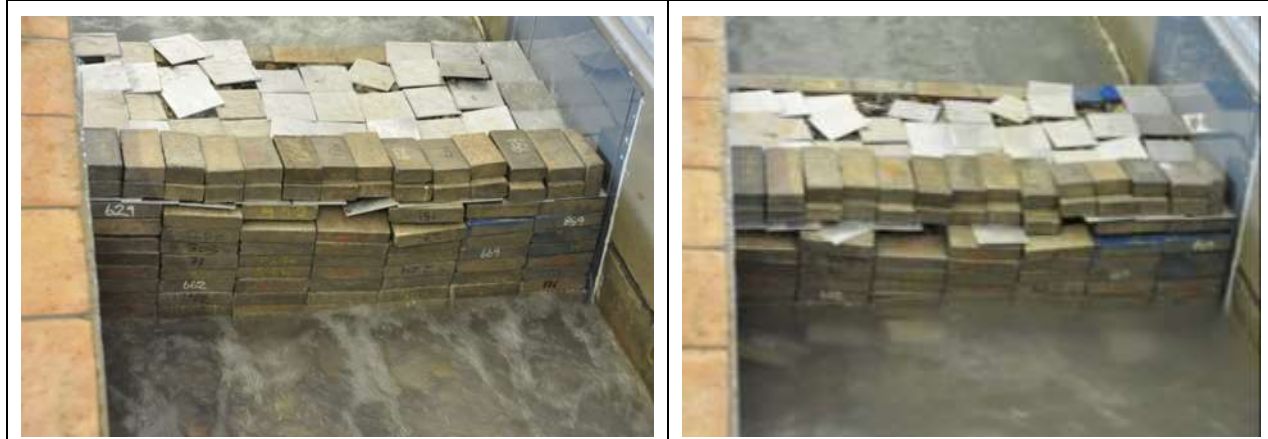
**Figure 7.31** Series 6, block extraction on the front face, later damage progression
