Akrotiri-Dreamer's Bay (*Nissarouin*)

Excavation & Survey, Spring 2019

Interim Report

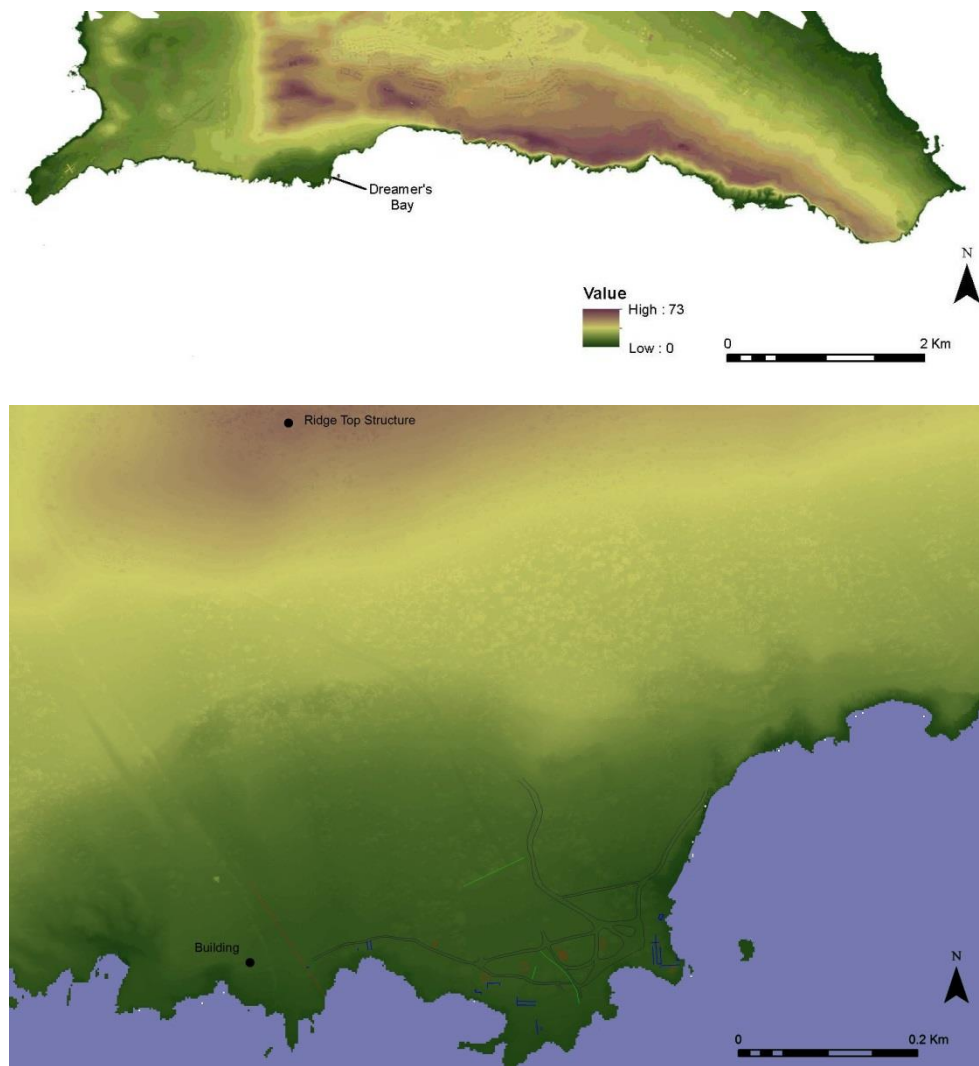
Fig. 2: Digital terrain model of the Dreamers Bay locality, with low ground at left, and the ancient anchorage in the bay itself at right.

The southern coast of the peninsula (Fig. 2) consists of high cliffs or very steep eroding slopes except for one area in the west about 600m long, where a stretch of lower-lying land projects somewhat into the sea. Here, around Dreamer's Bay, the shoreline stands nowhere more than about 5m above sea level, with eroding rocky ledges and inlets, some of which have accumulated tiny sandy beaches. In this area human communications between sea and land are practicable, especially as the bay to the east formed a practicable natural anchorage, its use confirmed by the submerged ancient artificial breakwater, anchors and other archaeological remains known on the sea floor.

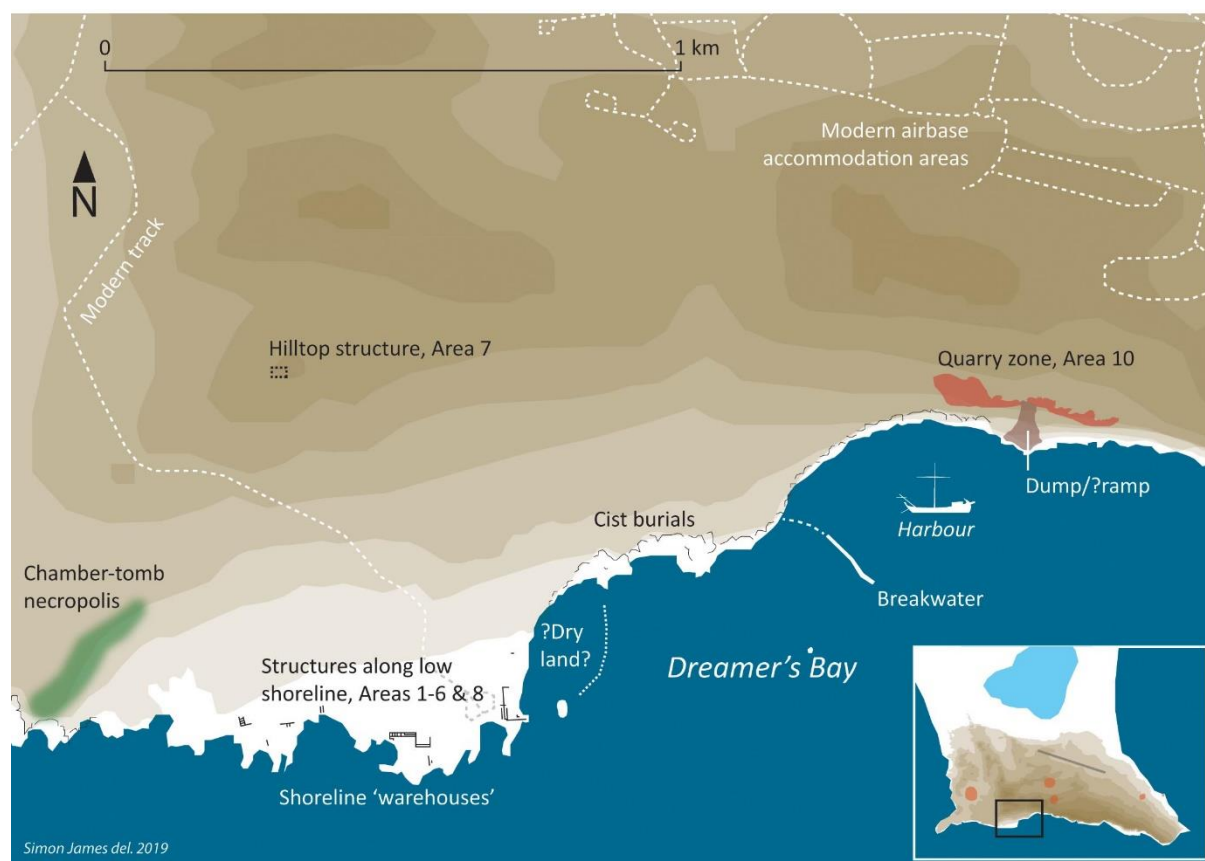
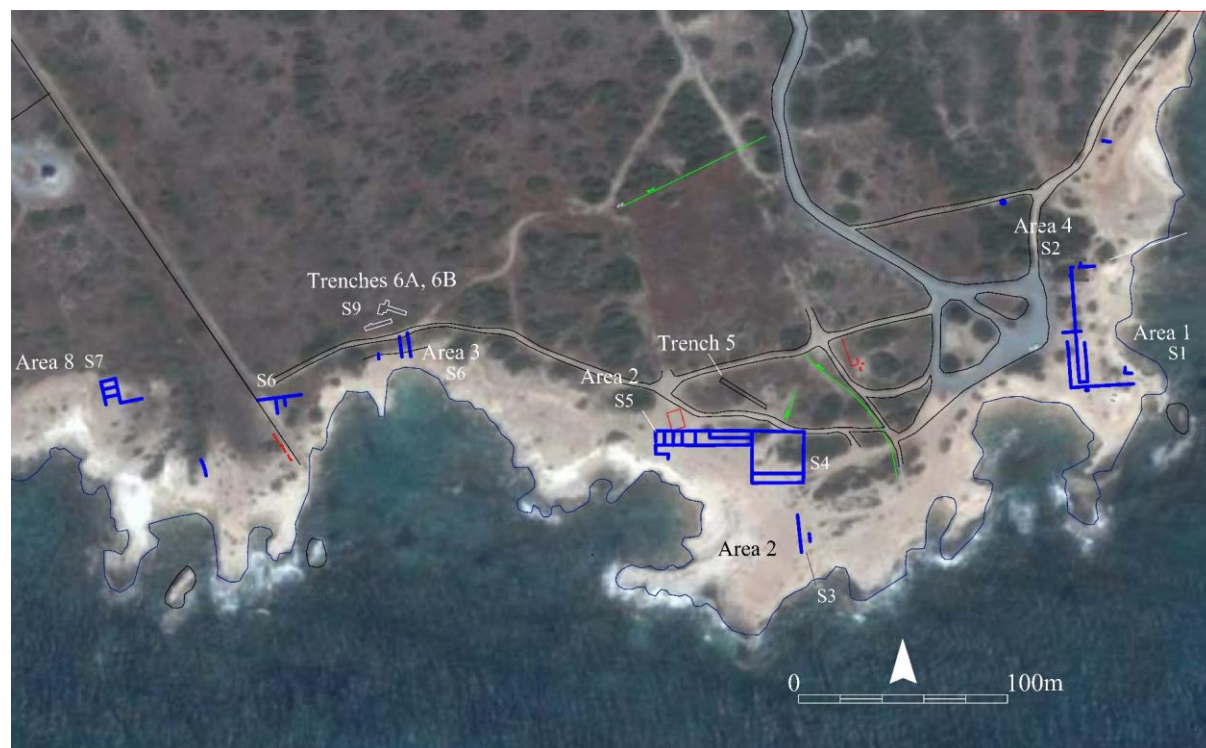
Fig. 3, top: Location of excavated areas at and around Dreamer's Bay. Below: Areas and structures west of Dreamer Bay itself identified 2015-2017, overlain on Google Earth

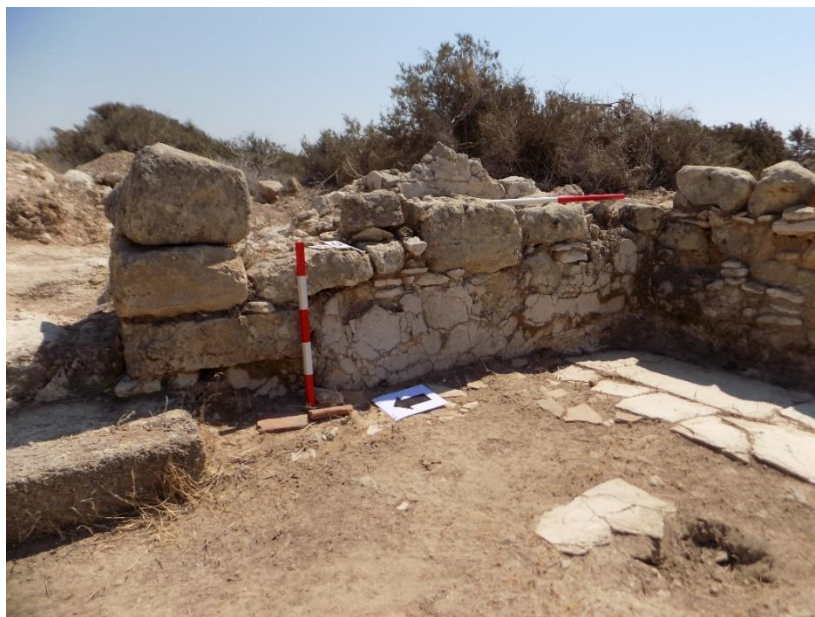
Fig. 5: The south-east corner showing the remains of the wall plaster and the gypsum floor.

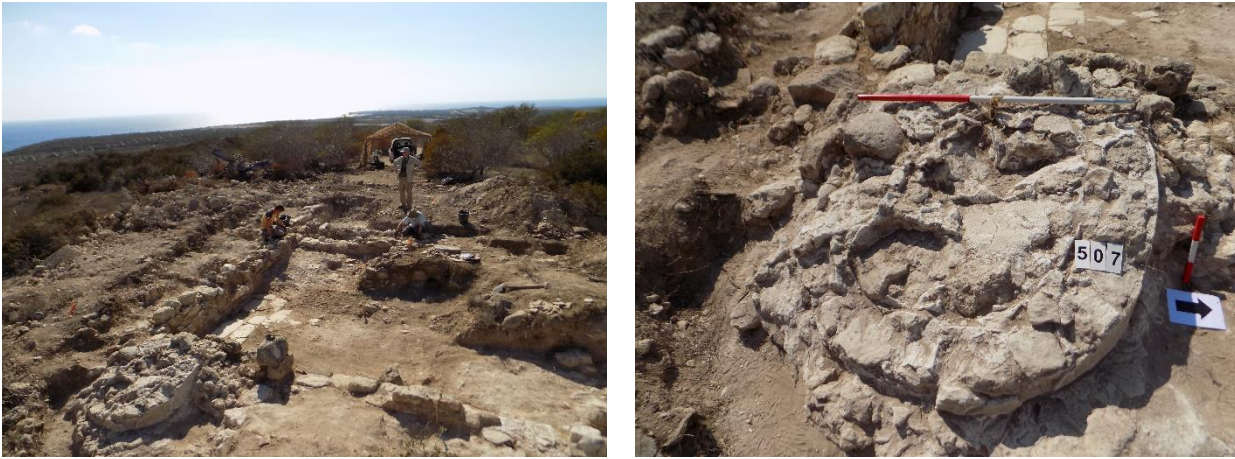
Fig. 6: The semicircular structure on the south-east corner. Looking west.

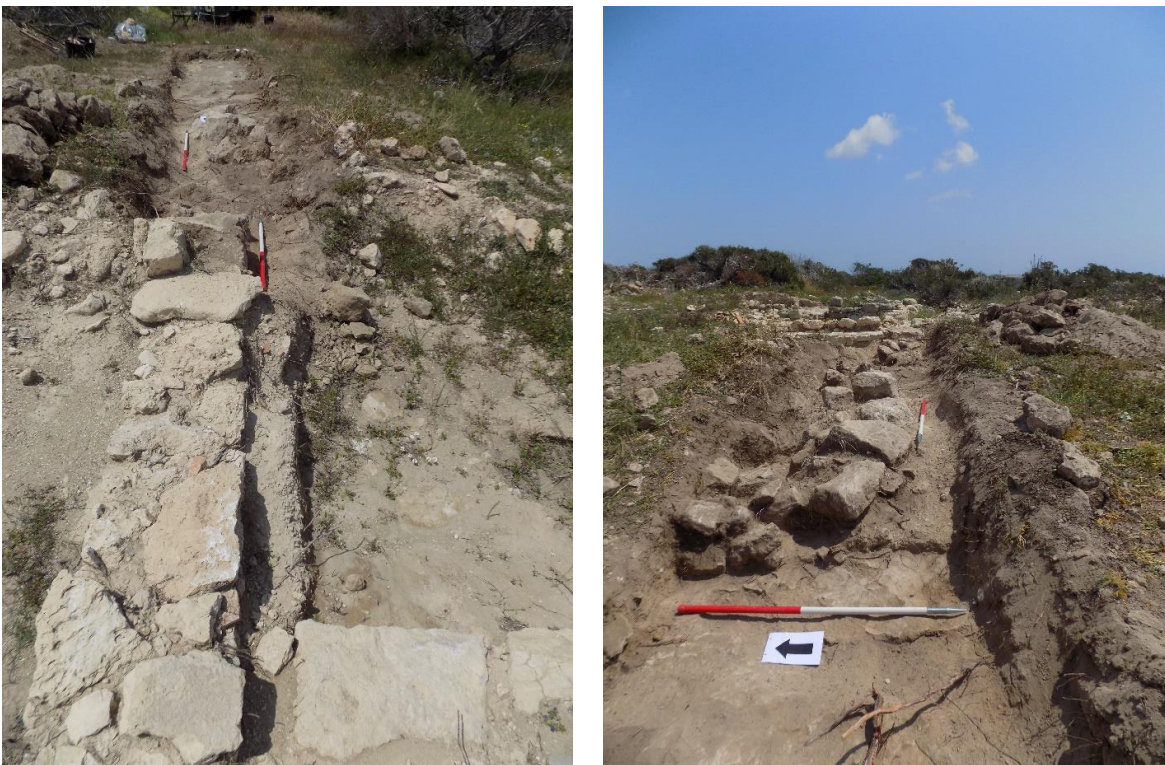
Fig. 7: Area 7: tracing the line of the southern wall to the west.

In 2017 two small trenches were excavated, one to the west and one to the north, to try to determine the extent of the structure(s) (Fig. #7). The western trench traced the line of the southern wall down-slope. Unfortunately, this section was quite badly disturbed by modern activity; however, a junction was identified with a possible corner and wall running north (Fig. 7). Further west bedrock was uncovered suggesting that this wall represents the westernmost limit of the building.

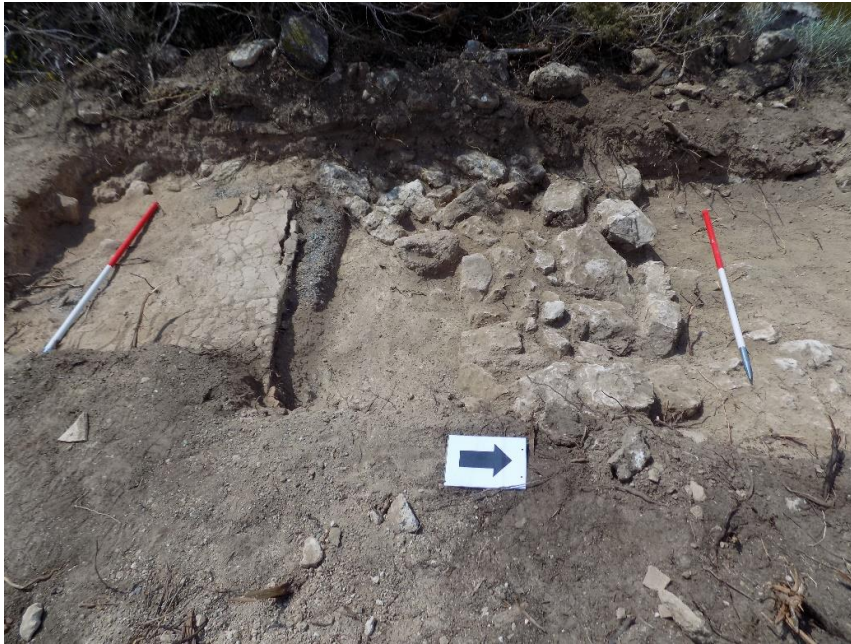
Fig. 8: Area 7 northern trench showing the curved wall and floor looking west.

The northern trench was located to seek the northern extent of the building. Although a wall was revealed, it did not seem to be associated with the main building. Rather it was curving westwards across the trench (Fig. 8). On the south side a plaster floor overlay a layer of pea-grit gravel. The features in this trench seemed more likely to represent a separate building or room structure on the northern side of the main building and its function remains unknown.

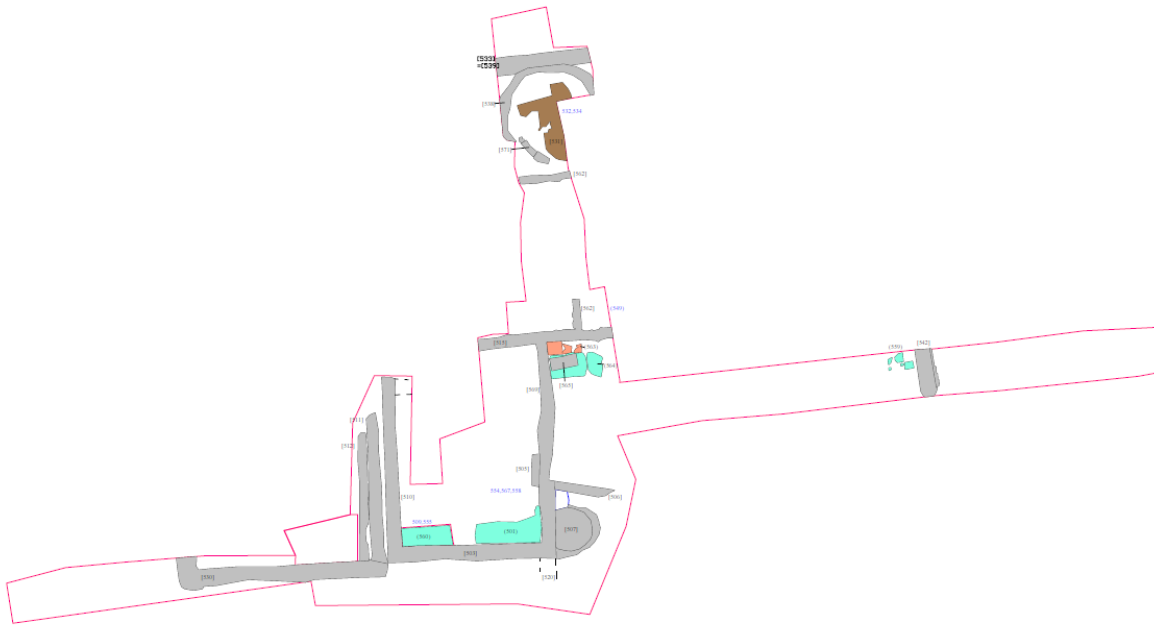
Fig. 9: Area 7 with the main features labelled.

In 2019 work in Area 7 (Fig. 9) focused on three main areas: the northeast corner of hilltop structure Building 1, a long trench extending to the east (7E), and extension of the existing trench to the north (7N). The northeast corner of Building 1 revealed a possible later phase or phases of repair or rebuilding along with evidence of demolition or decay. Area 7E revealed a wall which it seems possible was the wall enclosing a courtyard of the building which had an internal gypsum floor that had been partially robbed or destroyed. There were also decay or demolition layers here. Area 7N revealed a circular structure of uncertain function which may have been joined to Building 1 through walls that have now been lost. There was evidence of decay or destruction which could be associated with an event such as an earthquake or perhaps more gradual decay or deliberate destruction and robbing.

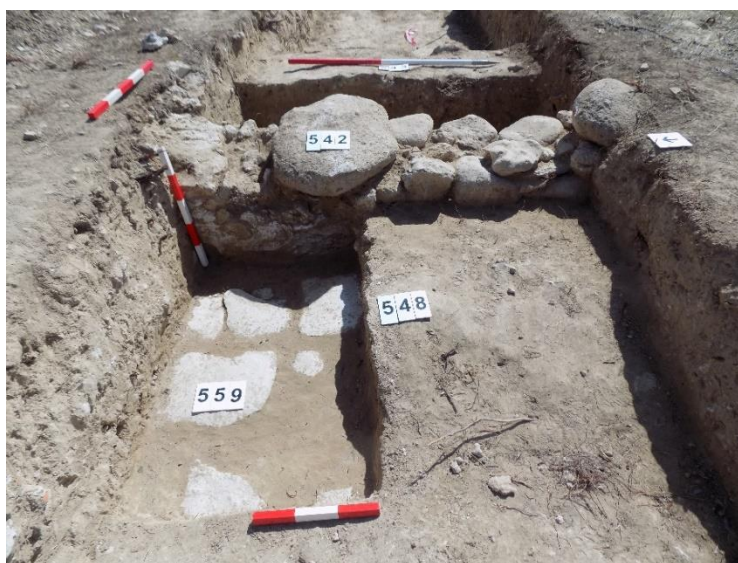
Fig. 10: Wall (542), mixed deposit (548) and gypsum floor tiles (559). (Photo ADB15_0803)

In 7E a long thin area was opened about 21 m long E-W and 2 m wide N-S. At 11.5m along the length of the area was the remains of a N-S wall (542) below the top-soil (Fig. #10). Within the exposed area the wall measured 160 cm long, 55-70 cm wide and 60-65 cm high. The Wall was composed of upper courses of large to medium sized boulders with some pieces of roof tile in places. The foundation layer consisted of more irregular smaller stone. On the Western side of the Wall were traces of wall plaster. The tile within the Wall may indicate that it was constructed at a late date, but it is not possible to confirm this as yet.

To the immediate West of the wall (542), and up against it, was a mixed deposit (548) which appeared to represent a dump or decay layer and contained pieces of pottery and roof tile as well as shells possibly representing food waste. This deposit lay on top of a layer of gypsum floor tiles (559). These tiles came up to the edge of the Wall (542) and they represent a floor laid down in the area (Fig. 10). It seems likely that the gypsum tiles originally covered a large area but they had been robbed or destroyed at some later stage. The probable continuation of the gypsum floor (547) was uncovered around 3 m to the West of (559) (Fig. 11). Across the 7E area above the gypsum floor were deposits of demolition, decay or rubbish material. The material included stones of various sizes and mortar which may have been decayed or destroyed building material. Deposit (540) also included a number of Small Finds including a copper alloy Byzantine coin, a copper alloy buckle plate and a number of possible iron nails. These finds could be indicative of rubbish deposits rather than use of the gypsum floor area.

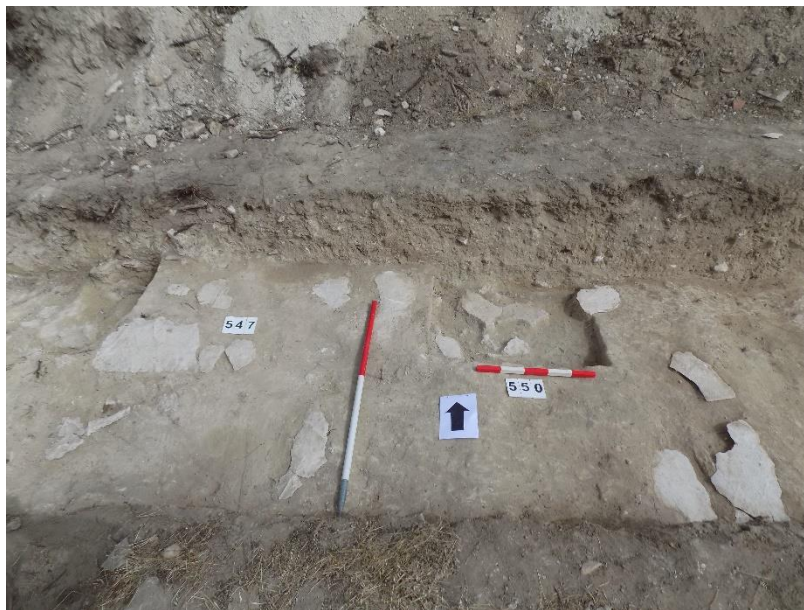
Fig. 11: Gypsum floor (547) and deposit (550). (Photo ADB15_0816)

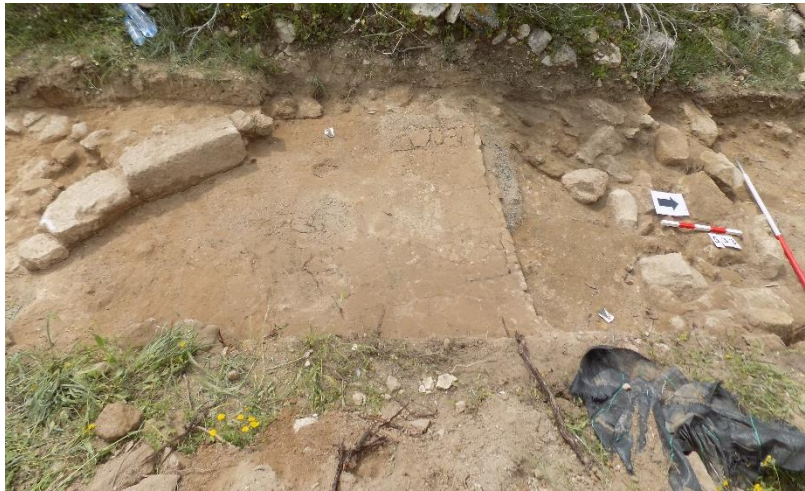
Fig. 12: Wall 533 and the curved wall and the interior tiled floor. (Photo ADB15_0777)

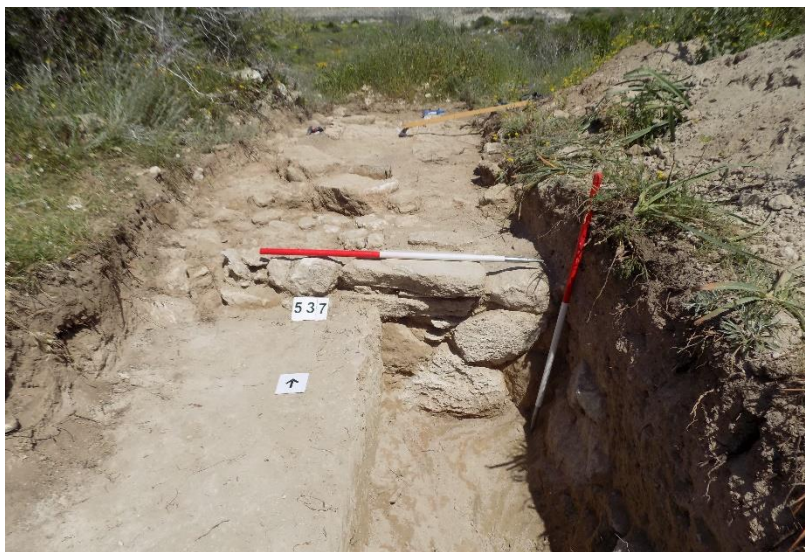
Fig. 13: Wall (537) looking north towards the circular structure (Photo ADB15_0808).

blocks (Fig. 13). In between these two walls was a curved wall possibly representing a circular room or structure. The Wall was composed of a rubble foundation (538) and the inner facing (571) of limestone blocks. Within the circular structure was a floor layer (531) of clay tiles or inscribed clay. It was very friable and cracked and possible tiles of around 60 cm square were identified. The clay floor lay on top of a pea grit make-up layer (532) which in turn lay on top of a loose sand and stone make-up layer (534). Above the clay floor was a rubble infill (535) which may have been a collapse, demolition or decay layer. Cutting into the floor was a feature with a dark fill (551) and possibly beneath the curved wall (538) representing another phase of activity but the fill was not excavated.

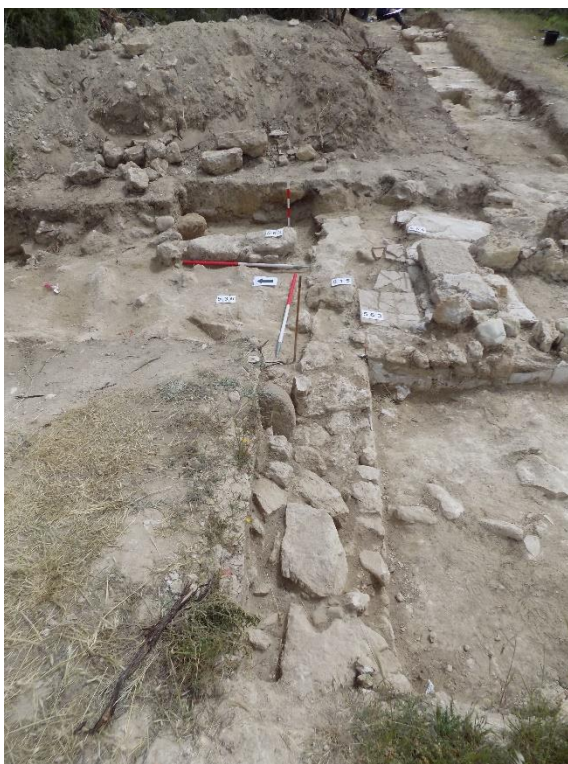
Fig. 14: Wall (515) running east-west and Wall (562) abutting it, running north-south. The rubble layer (536) is also shown as is the edge of Wall (566) and the millstone (568). Also in the photograph is the tile layer (563) and gypsum layer (564). (Photo ADB15_0818).

Work also took place in the northeast corner of Building 1 around the area of the E-W wall (515). A N-S wall (562) was identified abutting against the north side of Wall 515 and running into the rubble layer (536) to the north (Fig. 14). This wall ran for about 230 cm and was around 40 cm wide. The wall was composed of limestone blocks and stones. Its function is unclear, but it may have been a connecting wall with the circular structure to the north with the middle section now lost through robbing or destruction. To the east of the wall was deposit (549) which may represent rubble collapse or decay and contained some large blocks including cut and faced stone with the finer sand deposit.

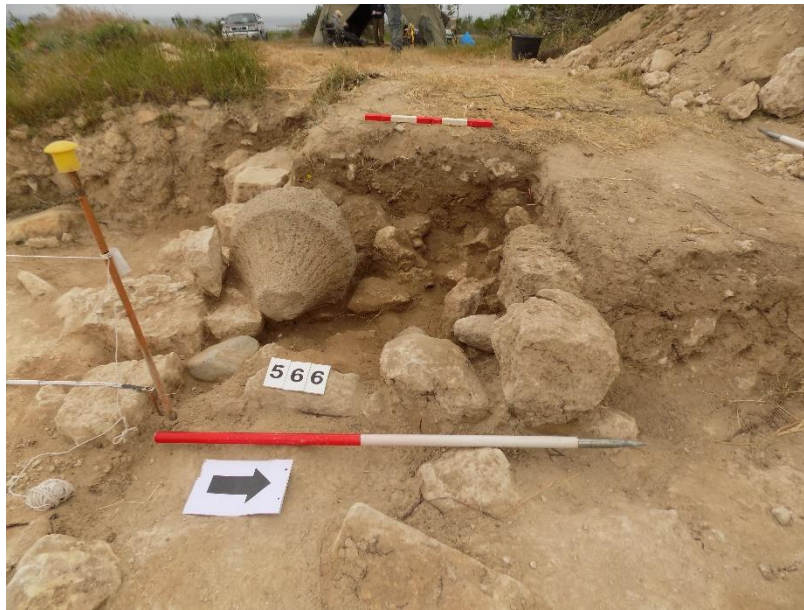
Fig. 15: Millstone (568) and Walls (566) and (515). (Photo ADB15_0839)

Also on the north side of (515) was another possible wall (566) of limestone and mortar running N-S and parallel to wall (562) and 150 cm to its west. The surviving section of wall was also around 230 cm long. In the western corner connecting walls (515) and (566) was a carved basalt millstone (568) which seems to be lying within, or perhaps under, the (536) rubble layer (Fig. 15). It was jammed into the corner of the walls and may represent either structural disturbance or it may have been deliberately placed there as a way of strengthening the walls or formed part of later structural repair of the building where stone was reused from elsewhere. The stone was cone shaped indicating that it was the lower part of the millstone and was 22 cm in length and 13.5 cm in diameter.

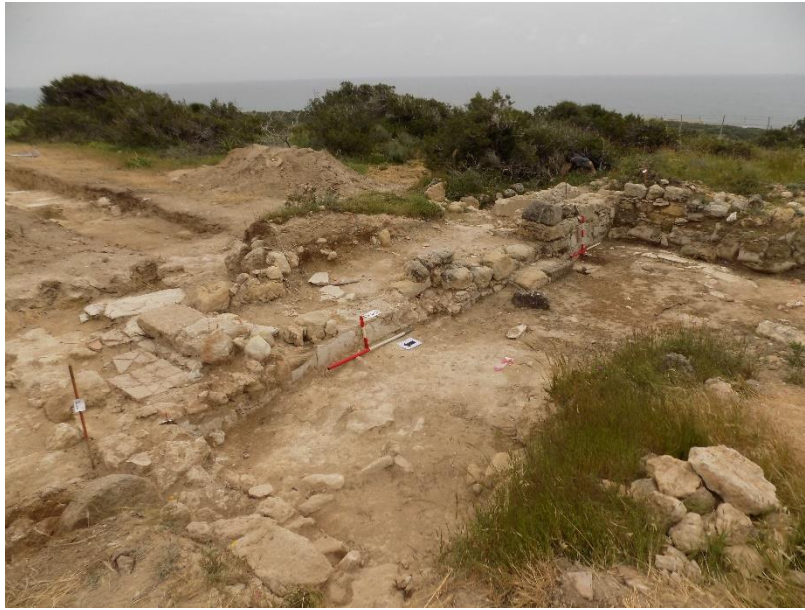
Fig. 16: Wall (504) and (569) and the interior of the room. (Photograph ADB15_0824)

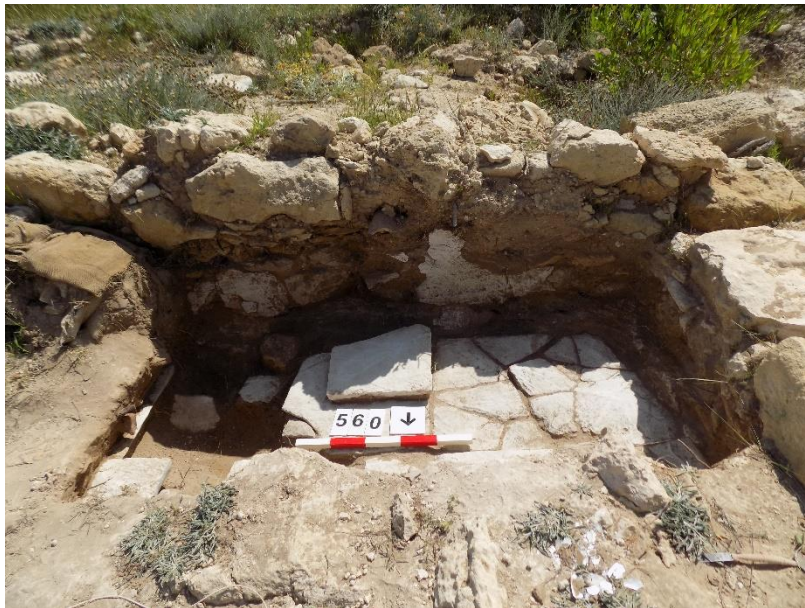
Fig. 17: The gypsum floor surface (560) against the southern Wall (503). (Photo ADB15_0813)

On the south side of Wall 515 and in the eastern corner with Wall 504/569 was what appears to be a later phase of activity represented by the later reuse of material above and/or replacing areas of the gypsum floor of what may have been the courtyard area or possibly a small room. Two blocks of conglomerate (565) around 18 cm thick, 40 cm wide and 45 cm long each were found at the edge of the wall and placed over the gypsum floor. Adjacent to these blocks to the north, against Wall 515, were Roman period roof tiles (563) laid on the floor apparently reused as floor tile. They were cracked, perhaps due to destruction material on top, and one tile had an X pattern on the tile made through finger marks. The surviving gypsum slabs (564) had traces of mortar on top which may suggest that stone blocks or other material had also covered them at some point, but this is uncertain. The material would seem to represent structural alterations or repairs. In the southwest corner of the room of Building 1 was a surviving layer of gypsum tile floor (560) beneath a layer of possible destruction and roof collapse (555) (Fig. 17).

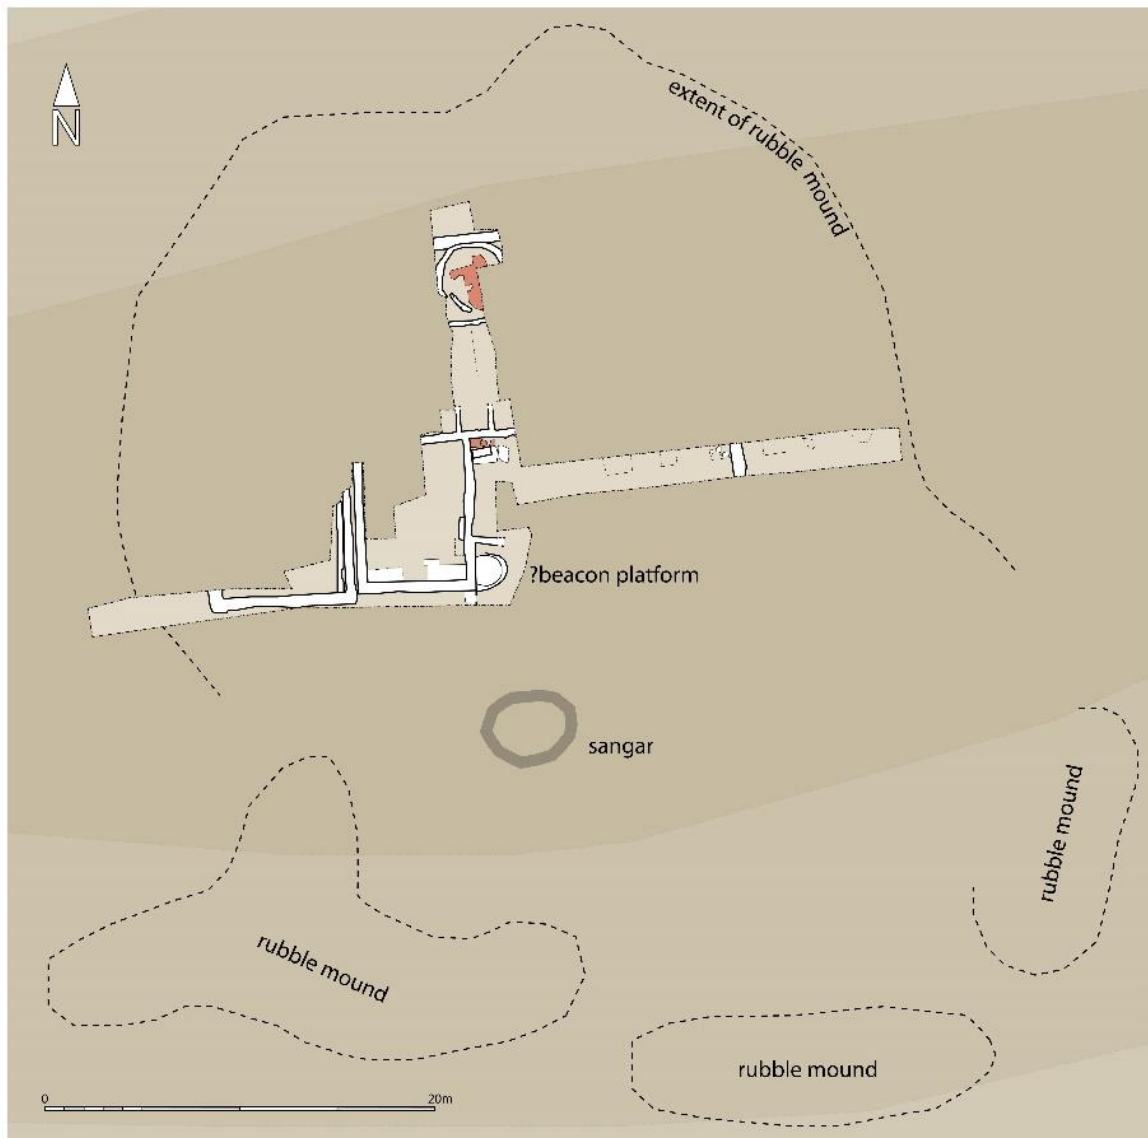
Fig. 18: The apparent extent of the hilltop site, indicated by the extent of rubble mounds. Also plotted is one of the sangars (excavated defensive emplacements), digging of which apparently initially revealed the ancient structures.

Inspection of the hilltop permitted hand-held GPS plotting of the approximate extent of the low rubble mound left by the part-excavated structures (Fig. 18).

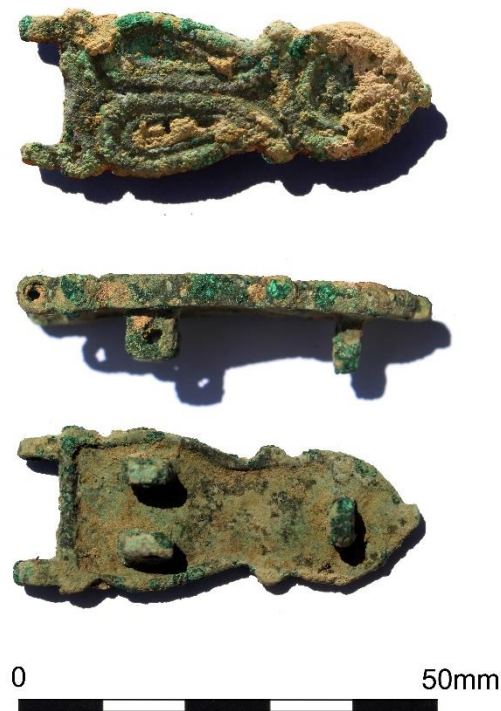
Fig. 19: a copper alloy buckle plate of sixth-century type from Area 7. It was found in a demolition deposit (540).

Initial dating indications from the limited quantities of pottery, roof tile, the very few coins, and a copper alloy belt plate (Fig. 19), are of late occupation, through at least the sixth century. However, structural indications of multiple phases suggest possibly earlier foundation, perhaps contemporary with the shoreline buildings.

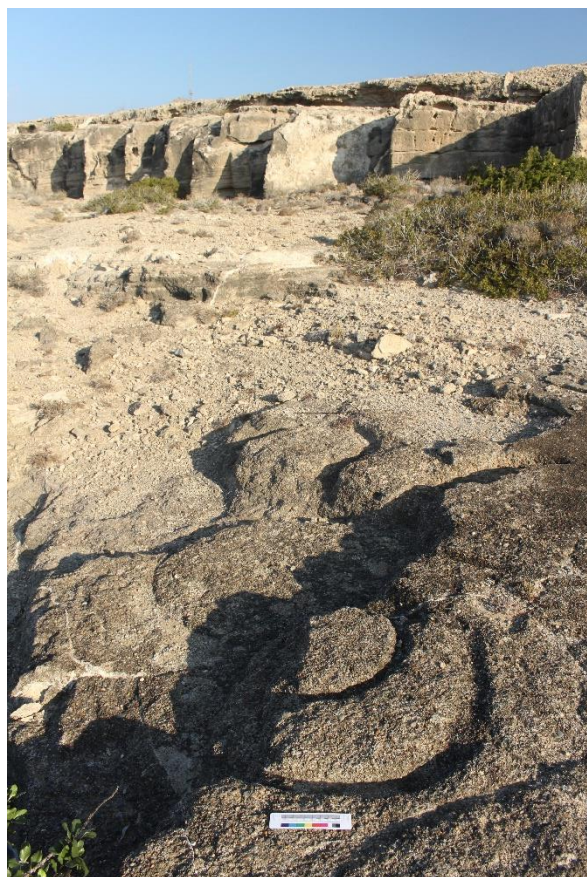
Fig. 21: The quarry by the top of the dump/ramp. Foreground, traces of millstone cutting, with a 'dogtooth' quarry face left by cutting orthogonal blocks in the background.

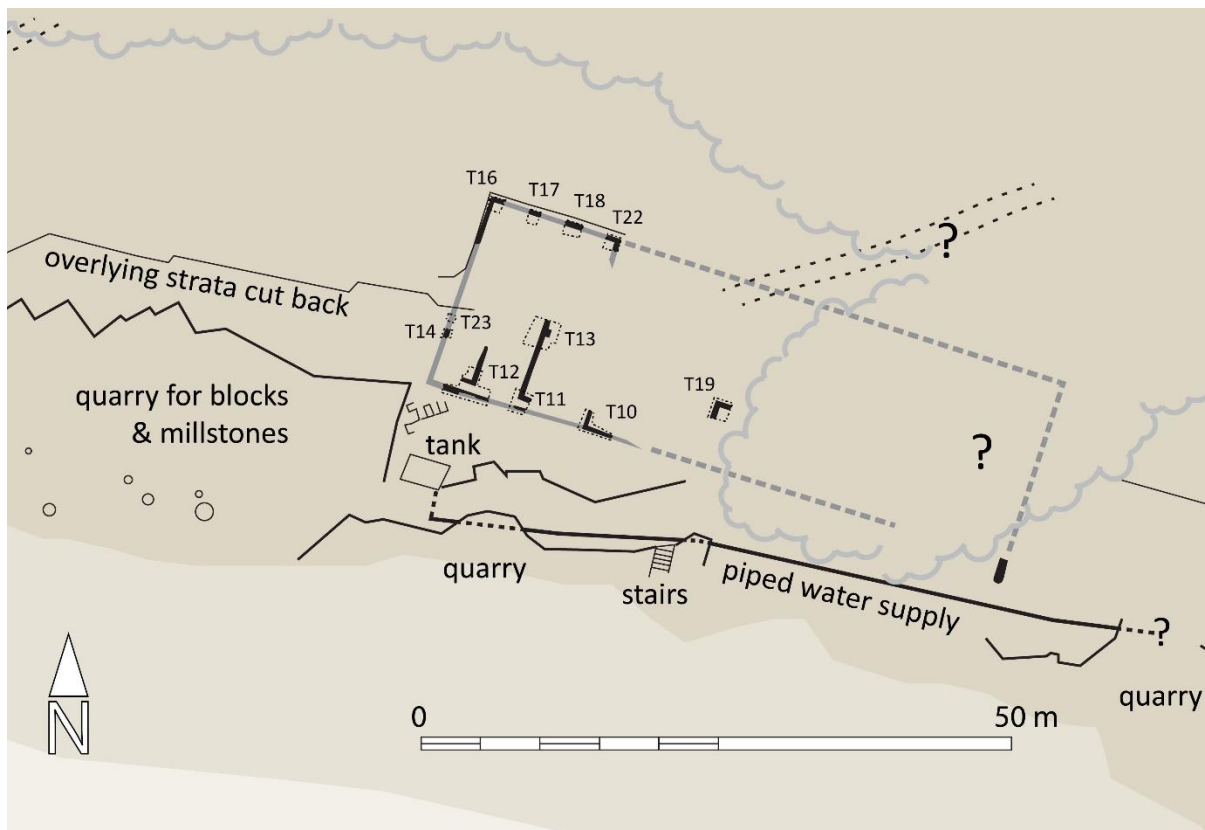
Fig. 22: Plan of the central quarry area with the 12 trenches over the building complex and the rock-cut water supply channel.

Following on from the 2018 survey of the quarry zone, 12 small trenches were opened in 2019 within an area of around 100 m by 75 m set back about 50 m from the cliff edge and associated with the cut ridge edge top. Outside this area, along the cliff edge, a rock cut channel or drain was also excavated (Fig. 22). The trenches revealed what appears to have been one main structure built into the edge of the quarry with a boundary wall separating it from the cliff edge. Other walls may represent additional structures, or they may have formed part of the same complex. Some of the walls had preserved lines of painted wall plaster.

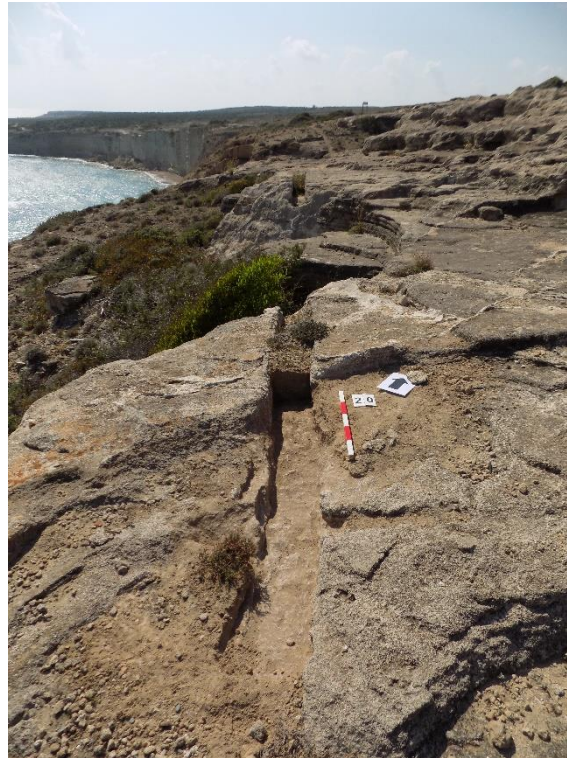
Fig. 23: Photograph ADB15_0896 the rock cut drain and Trench 20.

The rock cut channel or drain (590) was identified running for about 300 m along the cliff edge but in some areas it had been eroded away as the cliff edge eroded. The feature was excavated in two sections (T20 and T21) along its length and was found to be filled with natural silt (573) containing pottery, mortar and clay pipe fragments (Fig. 23). The drain was around 20 cm wide and 16 cm deep and it may have been cut as a hydraulic feature associated with work at the quarry and perhaps associated with a cistern.

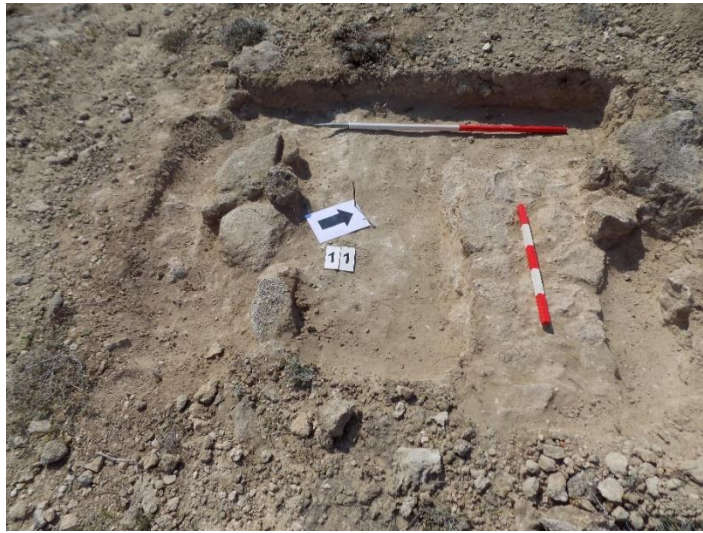
Fig. 24: Photograph ADB15_0859 wall structures (576) and (577) within Trench 11.

also the angle corner of another Wall (577 and 576) composed of large granite blocks and seem to represent the corner of a room or building behind the boundary wall (Fig. 24). This wall was traced 25 m north into Trench 13 (Fig. 25) which also had traces of a wall abutting it running eastwards. Further along the length of the boundary wall Trench 12 (Fig. 26) also contained the corner wall (580) of a room or building and Trenches 14 and 23 contained the remains of the same north-south wall (581). Trench 19 measuring around 0.85 m by 1 m also contained the corner of a building or room with Walls 584 and 585 (Fig. 27). This trench was set to the east of the other trenches and it is not clear how these structural remains relate to the other trenches. They could indicate another structure or perhaps part of the same complex.

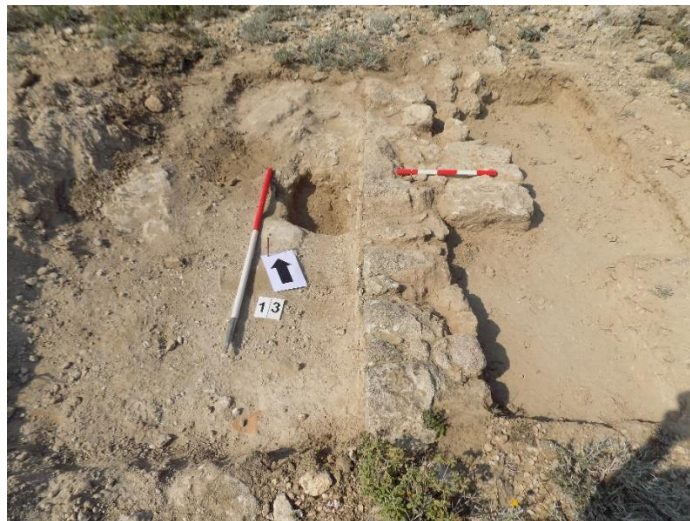
Fig. 25: Photograph ADB15_0865 wall (577) within Trench 13.

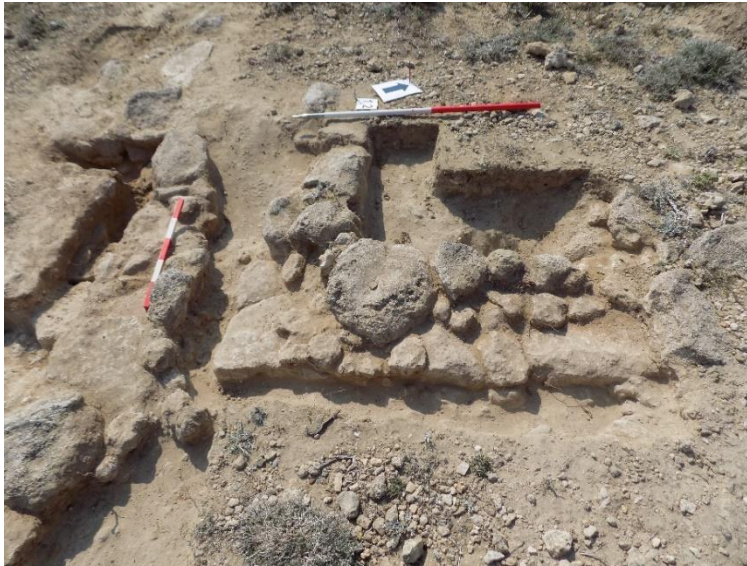
Fig. 26: Photograph ADB15_0862 walls (575) and (580) within Trench 12.

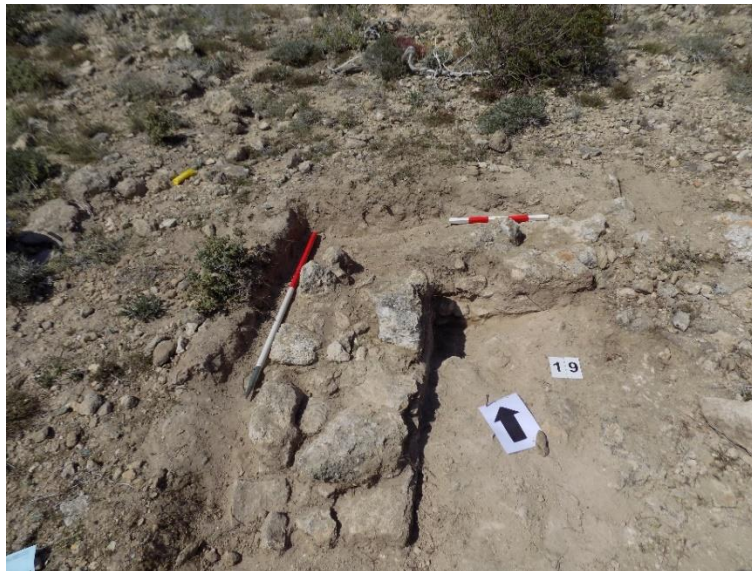
Fig. 27: Photograph ADB15_0890 walls (584) and (585) within Trench 19.

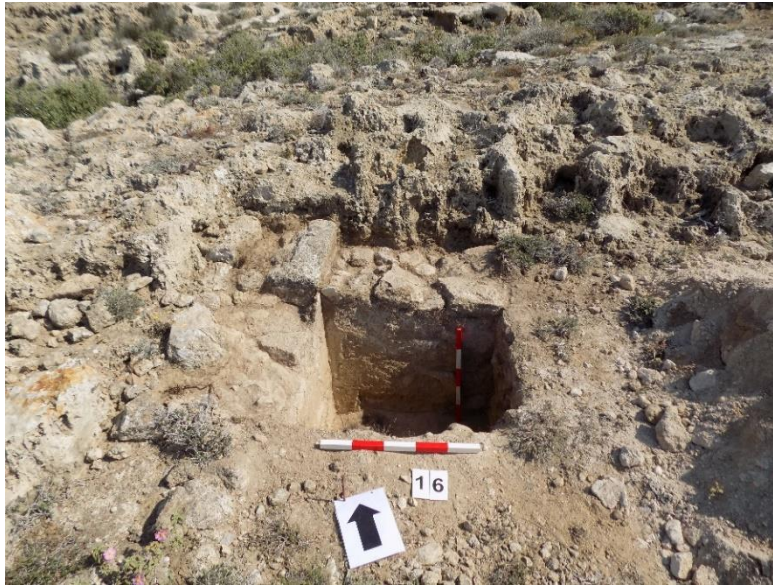
Fig. 28: Photograph ADB15_0871 walls (852) and (853) within Trench 16.

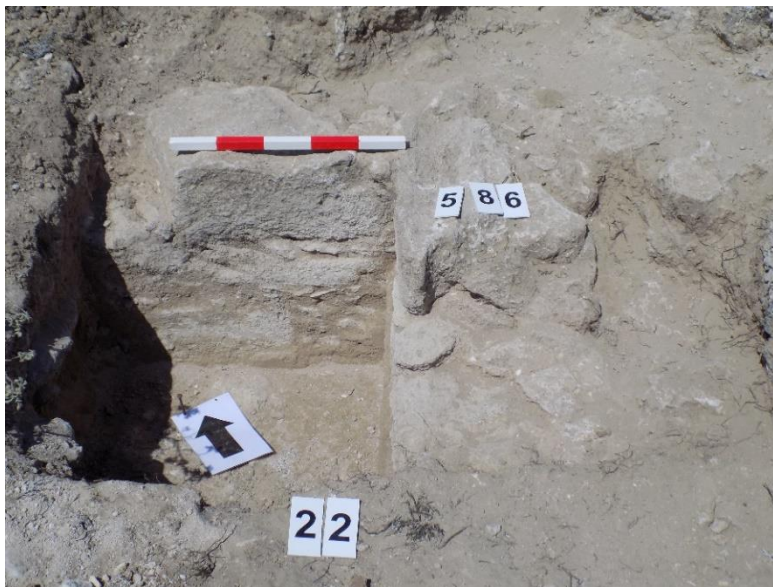
Fig. 29: Photograph ADB15_0888 walls (583) and (586) of Trench 22.

The back wall of the building(s) complex was built into the ledge of the quarry and was traced in Trenches 16, 17, 18 and 22 (583). It appears to have been all one single wall within these trenches. It was constructed of large granite blocks in linear formation. Within Trench 16 the wall survived to a maximum height of around 140 cm (Fig. 28). A north-south Wall (582) provided a corner to (583) within Trench 16 and against the edge of the quarry. The wall was plastered and so it was difficult to identify stone courses in the wall, but it would appear to have been constructed mainly of conglomerate. The plaster had a black painted border 8mm wide. Trench 22 also contained a N-S Wall (586) abutting Wall (583) and was constructed of large granite blocks. This wall was also plastered with traces of black and red stripes (Fig. 29).

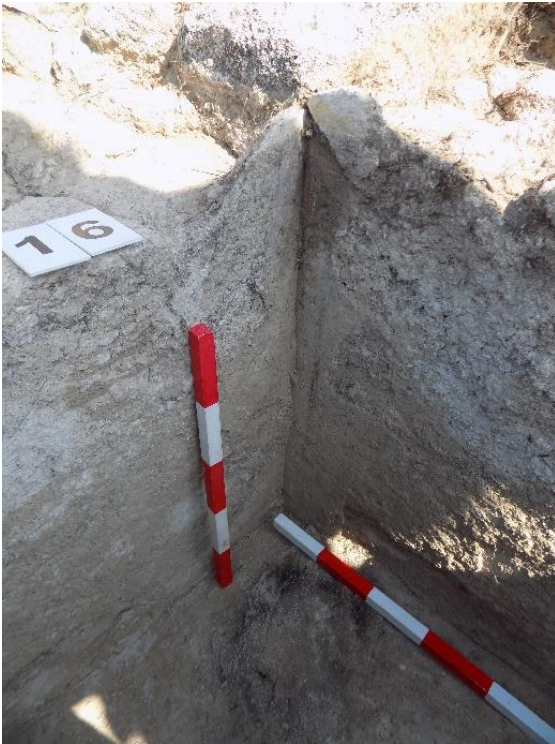
Fig. 30: Photograph ADB15_0874 showing the burnt area in the floor of Trench 16 and the black lines of the wall plaster on the wall.

Trench 16 was excavated to a greater depth than the other trenches in order to understand more of the stratigraphy of the building. A small sondage around 80x80cm was dug within the corner of the trench against the corner of the two walls. Here a layer of fine sandy silt (574), perhaps blown up against the walls, was found above a possible beaten floor surface (588). A burnt area of burnt posthole (589) was identified cutting into the floor surface but this feature was not excavated (Fig. 30). There was no evidence of sooting or burning on the wall plaster here. The sondage would suggest that traces of activity do survive within the building.
