## FAILURE MECHANISM OF KAMAISHI BREAKWATERS DUE TO THE GREAT EAST JAPAN EARTHQUAKE TSUNAMI

Keywords: Kamaishi breakwater; tsunami overflow; stability of breakwaters

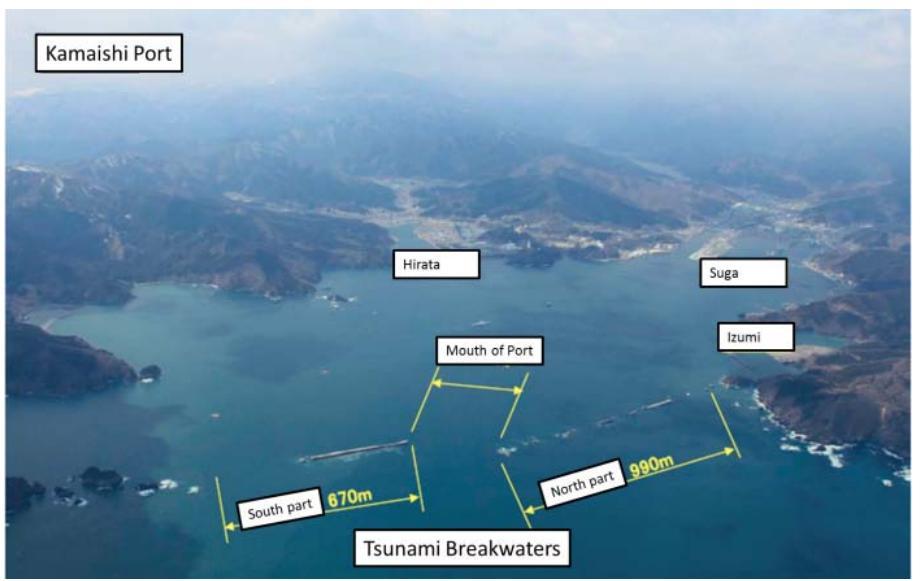
Photo 1. The Kamaishi Bay mouth breakwaters (taken by Tohoku Regional Bureau)

The Kamaishi Bay mouth breakwaters include the North Breakwater (length 990m), South Breakwater (length 670m), and the Bay mouth section (length 330m) as shown in Photo 1. The maximum depth at the breakwaters is 63m.

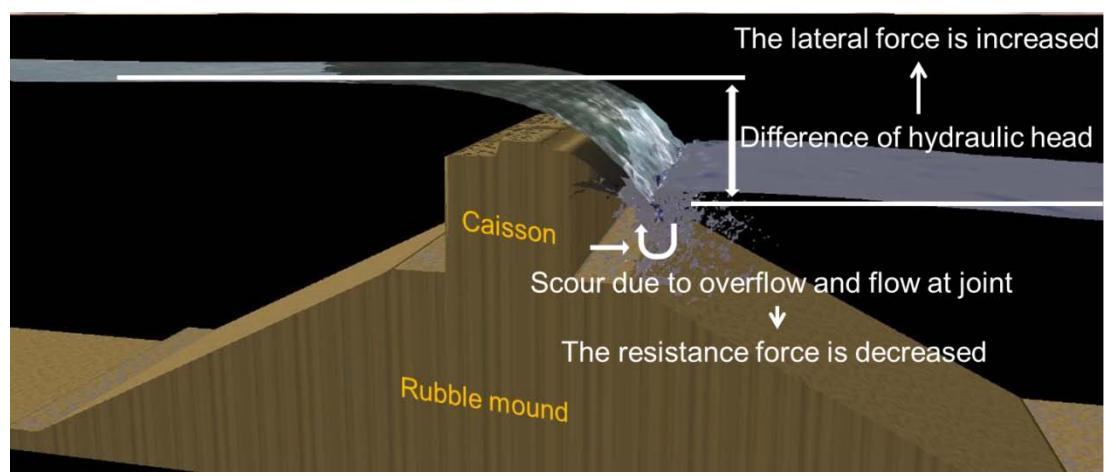
Figure 6. Major failure causal factors under tsunami overflow

- [1] Dynamic water pressure as wave force
- [2] Water level difference between the outside and inside of the harbor
- [3] Scouring of the foundation mound caused by overflowing and joint flow velocity
- [4] Decline of bearing capacity caused by increase of pore water pressure

Assuming that during overflow, [1] is small, hydraulic model tests were done to study [2] and [3] in particular (see Fig. 6).

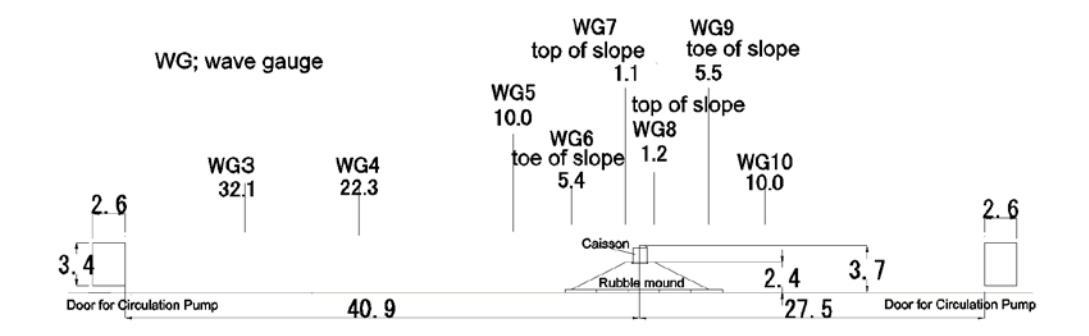
Figure 7. Experimental cross section (rectangular case, unit m)

Fig. 7. is a full section diagram of the experiment. The model scale was 1/20 for the deep part at Kamaishi. A wave meter was attached as shown in the figure. The model was installed inside an approximately 70m section in the circulation device. The foundation mound was installed so that the heights of the crests of the caissons were aligned at 3.7m. The numbers in the diagram show distances from the reference line. The shapes of the caissons were trapezoidal used in the deep part and rectangular (Fig. 8.). The height of the trapezoidal caisson was 1.65m and that of the rectangular caisson was 1.4m. Wave meters (PG) were attached to the front, back, and top surfaces, while pore water pressure meters (UG) were attached to the bottom surface. The caissons were both 1.5m wide. The channel width was 3.5m, so the 1.5m wide caissons were installed in the center, and 0.9m wide dummy caissons were installed at both ends. The trapezoidal and rectangular 1.5m wide caissons

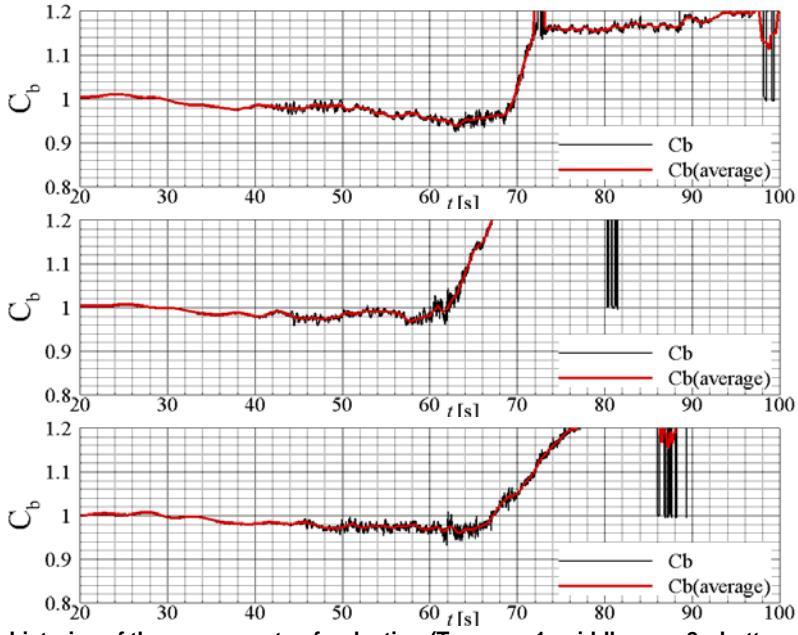
Figure 9. Time histories of the average rate of reduction (Top case 1, middle case 2, bottom case 3, red line is represented as the line, which is smoothed with moving average method)

And this experiment also confirmed that the front surface wave pressure is almost unchanged from the hydrostatic pressure, failing to reach a few percentage points. On the other hand, the water level at WG10 was used to study the back surface wave pressure as a percentage of the hydrostatic pressure. If the pressures at each point on the back surface are integrated by a typical surface area and the average rate of reduction is represented by Cb, the third time series in each case are as shown in Fig. 9.

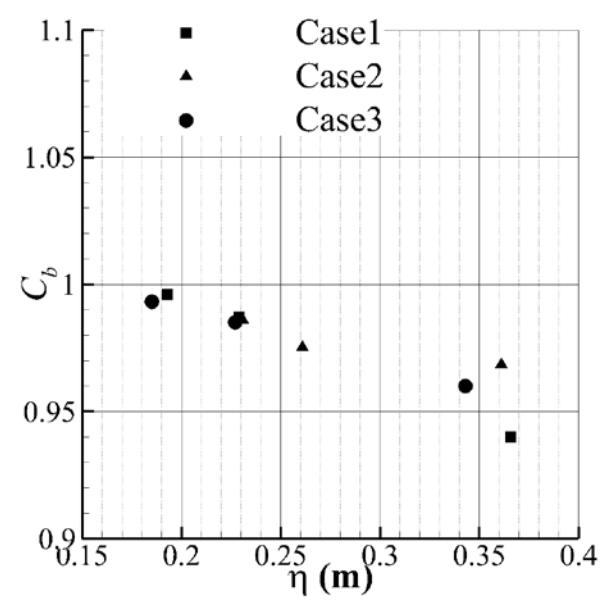
Figure 10. Relationship between the average rate of reduction and overflow height

Fig. 10. plots the smallest value obtained after moving averaging at 0.5s of the rates of reduction for all experiments in all cases. The axis of abscissas represents the height of the water surface above the caisson crowns. As it clearly shows, the overflow quantity increases at the same time as it falls to a maximum of about 6% of the hydrostatic pressure on the rear surface.

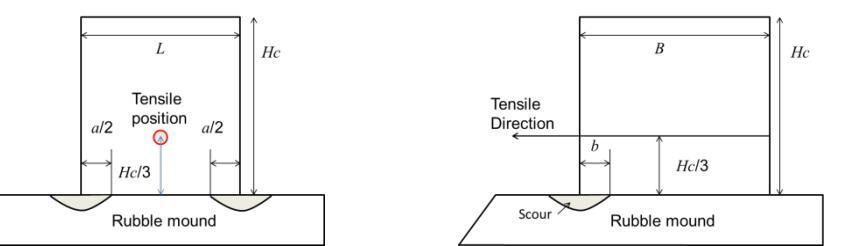
Figure 11. Image of Joint flow scour (left) and overflow scour (right)

Tensile testing was done in the atmosphere in order to confirm the friction coefficient. A foundation mound was built in the atmosphere and at a location about 1/3 below the height of the caisson, it was pulled with a winch. It was done to both the rectangular and the trapezoidal caissons, and in order to see its relationship with scouring, it was compared with a case where joint scouring and overflow scouring were excavated in advance. Each case is shown in Table 3. The percentages in the table are, in the case of joint scouring, percentages of the caisson width equal to the width of the joint, and the percentages of the width combining both ends (see left side of Fig. 11.) The percentages of the overflow scouring width are ratios to the caisson length (direction pulled), and excavation is done across the entire bottom (see right side of Fig. 11.). Photo 7. shows an example of the initial state when it was done forming scouring.

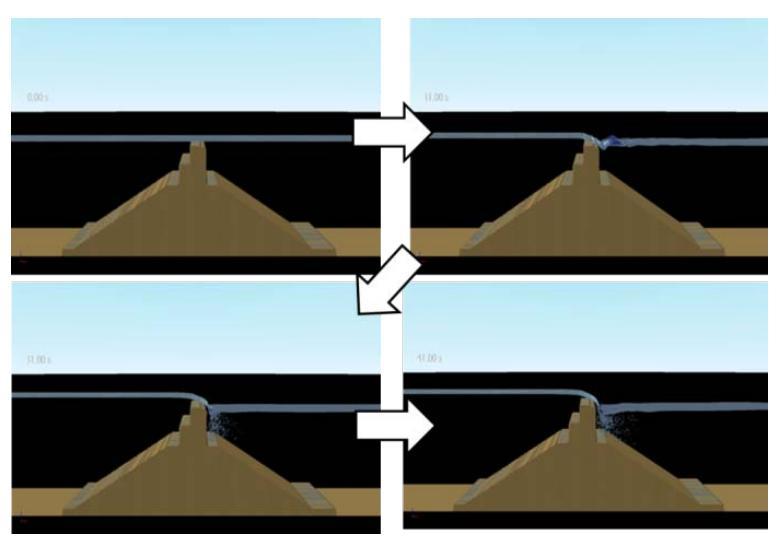
Figure 13. State of calculation

Fig. 13. shows one example using a rectangular caisson, where the water level gradually changed from the initial water level (discharge/inflow 0.1 m/s). This shows that it is possible calculate the same situation as that in Photo 1.

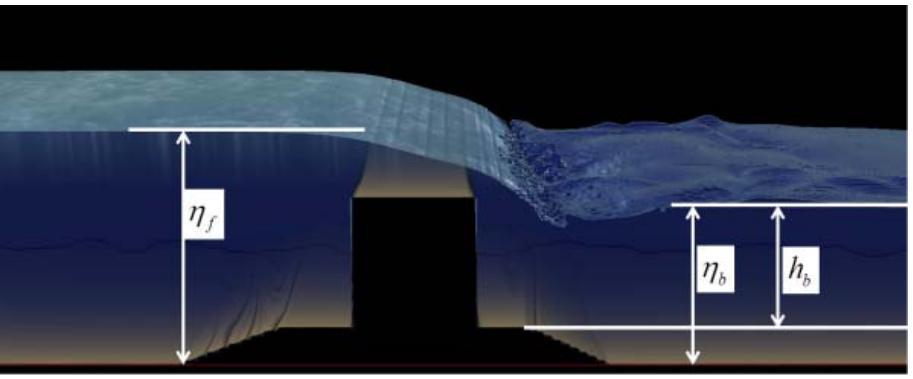
Figure 15. Definition of water level

In Fig. 15. the water level of the front surface of the caisson is  $\eta_{f}$ , the water level at the back surface is  $\eta_b$ , the distance from the foundation mound to the back surface water level is  $h_b$ , and the ratio of the water level difference and at the front surface and back surface  $(\eta_f - \eta_b)$  and  $h_b$  is considered to be the water level difference/back surface water level ratio.

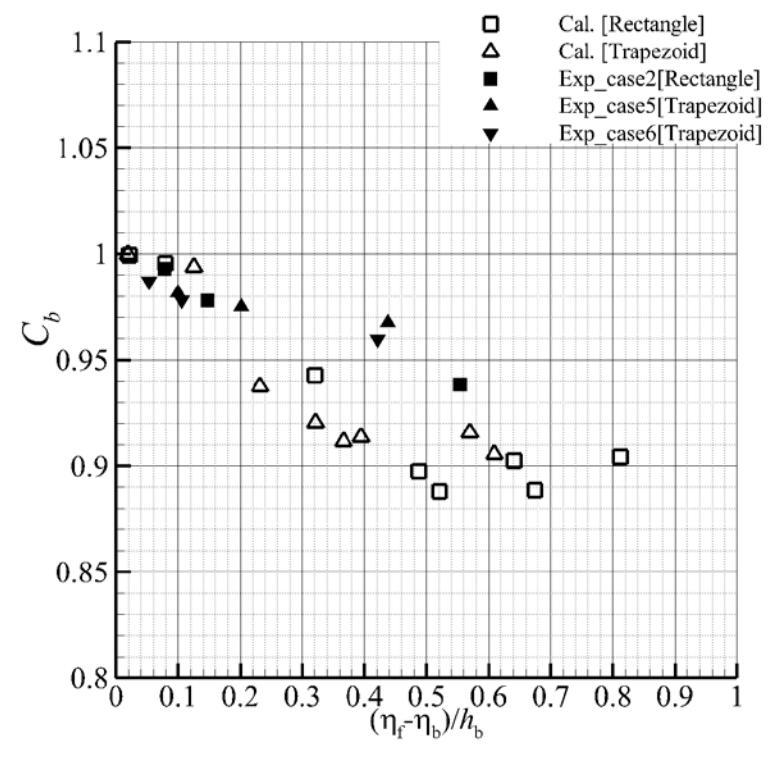
Figure 16. Relation between the rate of reduction and water level difference

Fig. 16. plots the relationship between the water level difference/back surface water level ratio and reduction rate  $(C_b)$  at the time when the reduction rate was lowest, based on time history data of the reduction rate and water level difference/back surface water level ratio in each case. Black shows the experimental results and white shows the calculation results.

Although overall they conform, if the water level difference/back surface water level ratio increases, the numerical calculation obtains  $C_b$  smaller than that obtained by the experiments. This means that because the disturbance of the pressure fluctuation behind the caisson is larger in the calculation results, it is presumed that the overflow water mass splashed down nearer the back surface than in the experiment, and that its impact is one cause.
