TECHNICAL REPORT CERC-88 10

# ST. PAUL HARBOR BREAKWATER STABILITY STUDY ST. PAUL, ALASKA

## Hydraulic Model Investigation

September 1988  
Final Report

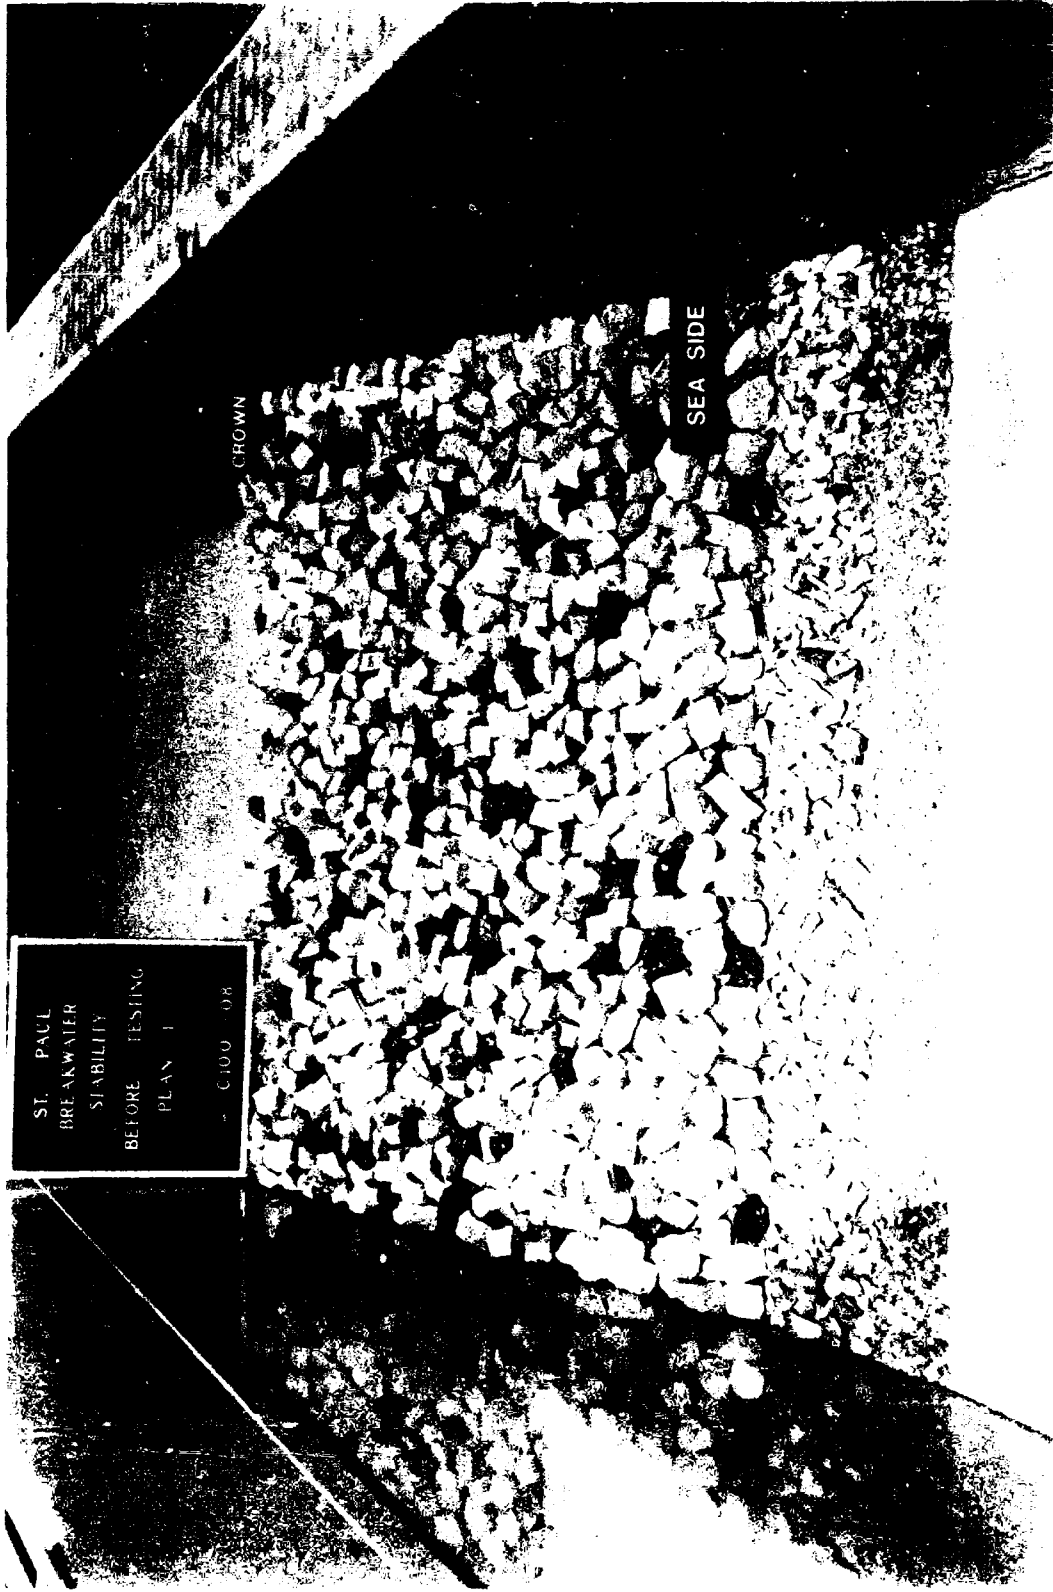
Photo 2. Plan 1. before Test 3, sea-side view; St. Paul Harbor breakwater stability study

36. Five tests as outlined in Table 4 were conducted with Plan 1. A stability test (Test 1) was followed by a survivability test (Test 2); the structure was torn down and rebuilt and the tests repeated (Tests 3 and 4); and the structure was then tested for toe stability (Test 5). Wave runup, rundown, and overtopping results of the tests are given in Table 4. Plan 1 is shown before Test 3 in Photos 1 and 2, after Test 4 in Photos 3 and 4, and after Test 5 in Photos 5 and 6.

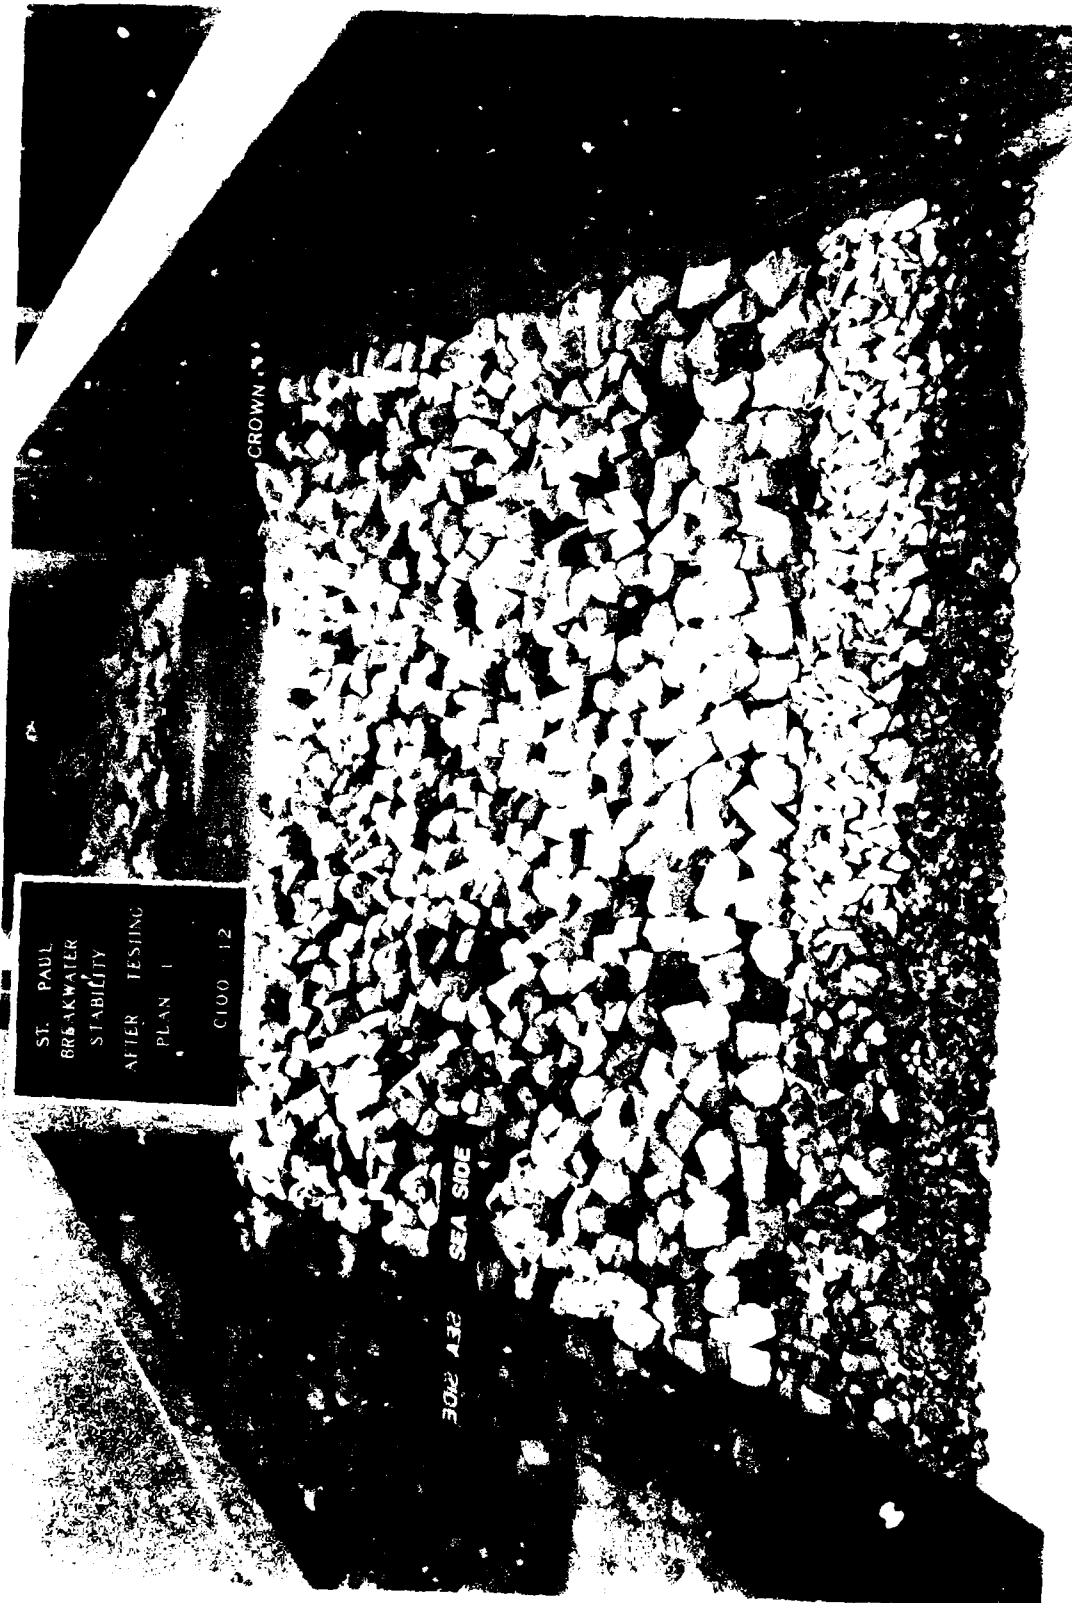
Photo 1. Plan 1, after Test 4, sea-side view; St. Paul Harbor breakwater stability study

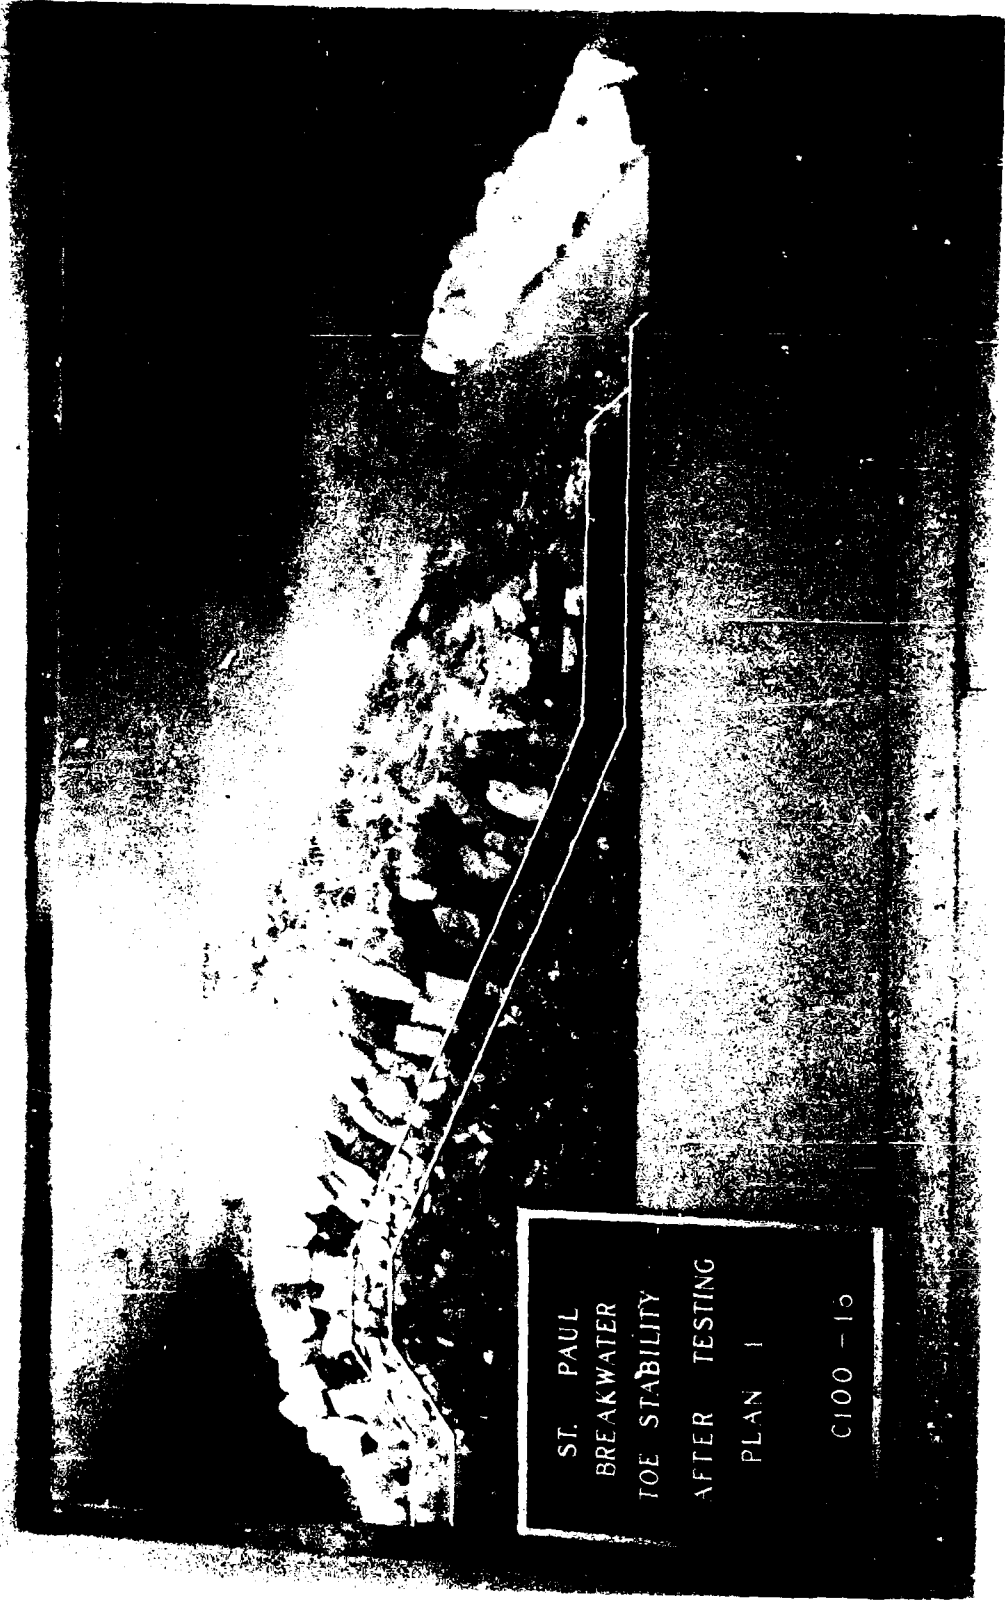
Photo 5. Plan 1, after Test 5, side view; St. Paul Harbor breakwater stability study

40. The toe stability test (Test 5) demonstrated adequate stability of the toe. No stones were displaced and very little movement was observed.

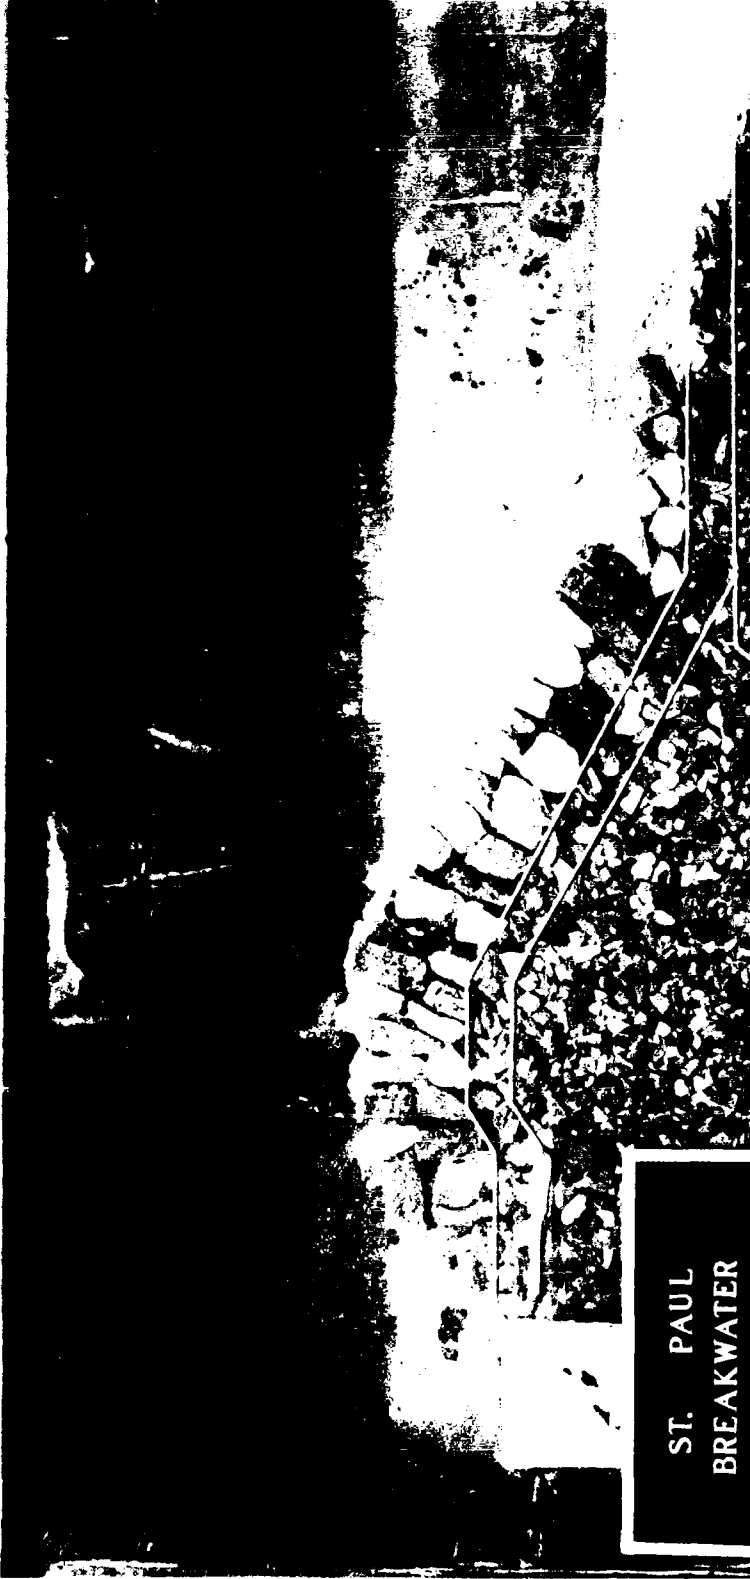
Photo 9. Plan 2, after Test 9, side view; St. Paul Harbor breakwater stability study

42. Table 5 summarizes the test conditions and wave runup, rundown, and overtopping results of the six tests conducted on Plan 2. A stability test (Test 6) was followed by a survivability test (Test 7), the structure was disassembled and rebuilt and the tests repeated (Tests 8 and 9), then the structure was tested for toe stability (Tests 10 and 11). Plan 2 is shown before Test 8 in Photos 7 and 8, after Test 9 in Photos 9 and 10, and after Test 11 in Photos 11 and 12.

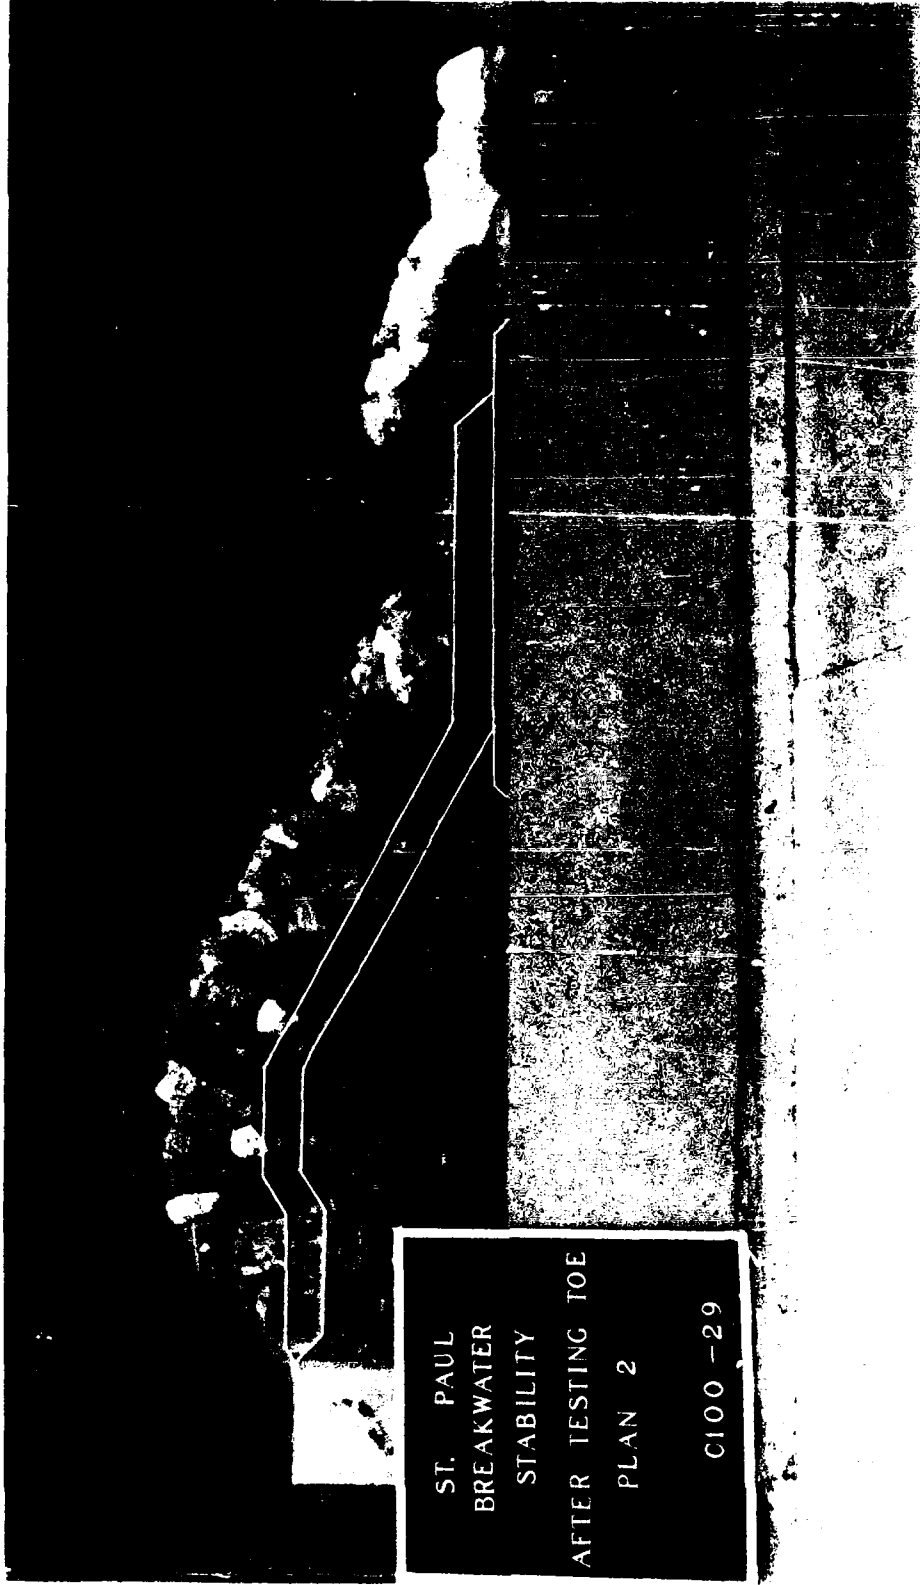
Photo 11. Plan 2, after Test 11, side view; St. Paul Harbor breakwater stability study

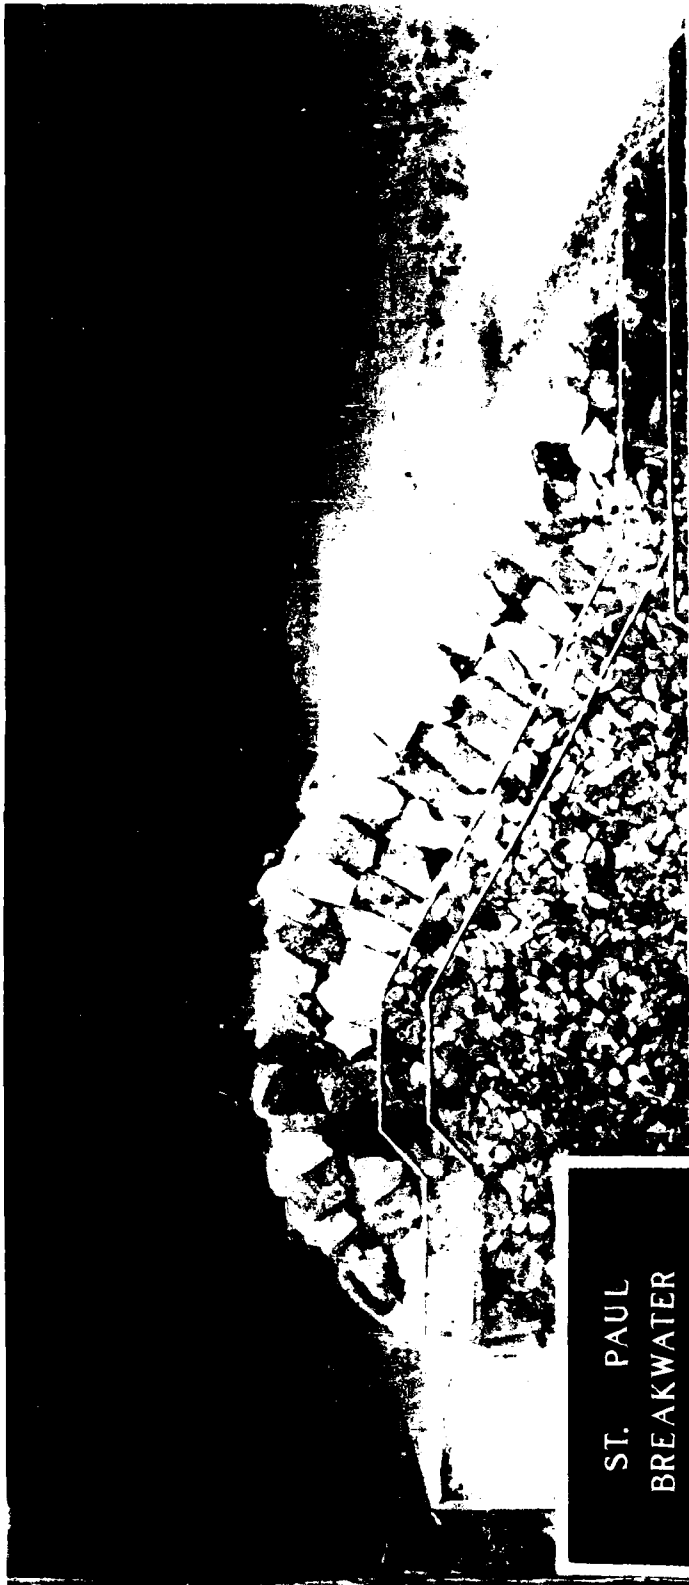
Photo 13. Plan 3, before Test 15, side view; St. Paul Harbor breakwater stability study

48. Table 6 summarizes the test conditions and wave runup, rundown, and overtopping results of the seven tests conducted on Plan 3. A stability test (Test 12) was followed by a survivability test (Test 13) and a high-water toe stability test (Test 14). The structure was then disassembled, rebuilt, and tested with a stability test (Test 15), survivability test (Test 16), low-water toe stability test (Test 17), and high-water toe stability test (Test 18). Plan 3 is shown before Test 15 in Photos 13 and 14, after Test 16 in Photos 15 and 16, and after Test 18 in Photos 17 and 18.

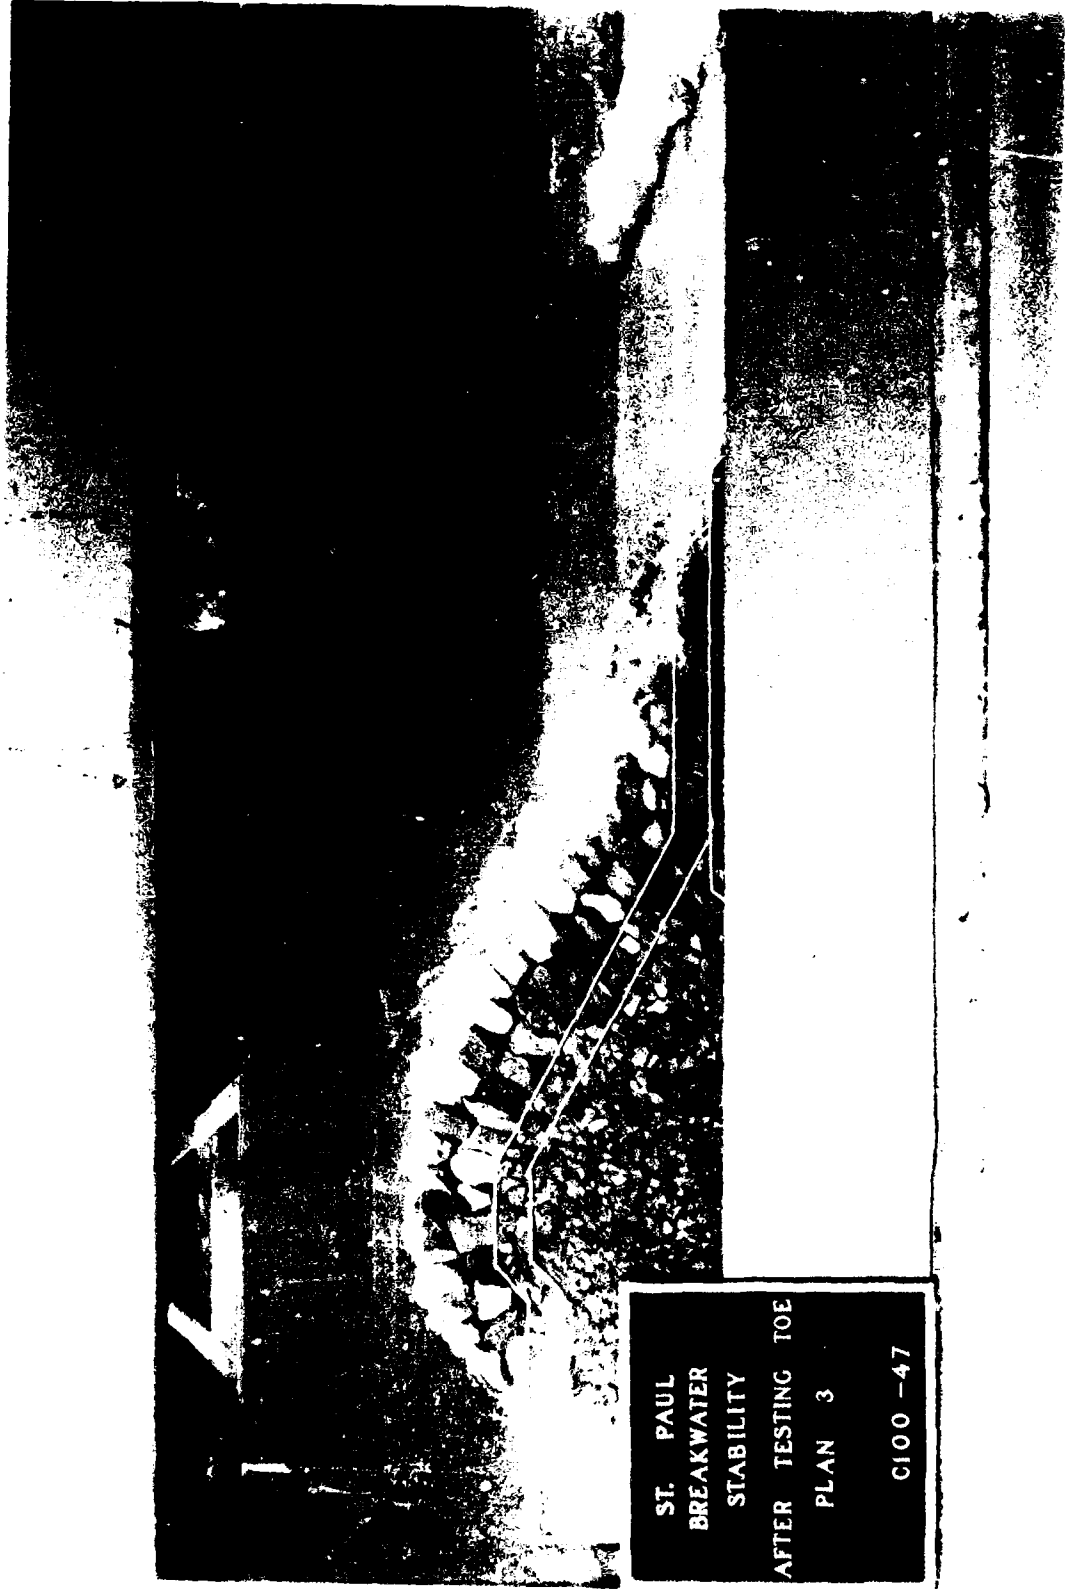
Photo 17. Plan 3, after Test 18, side view; St. Paul Harbor breakwater stability study

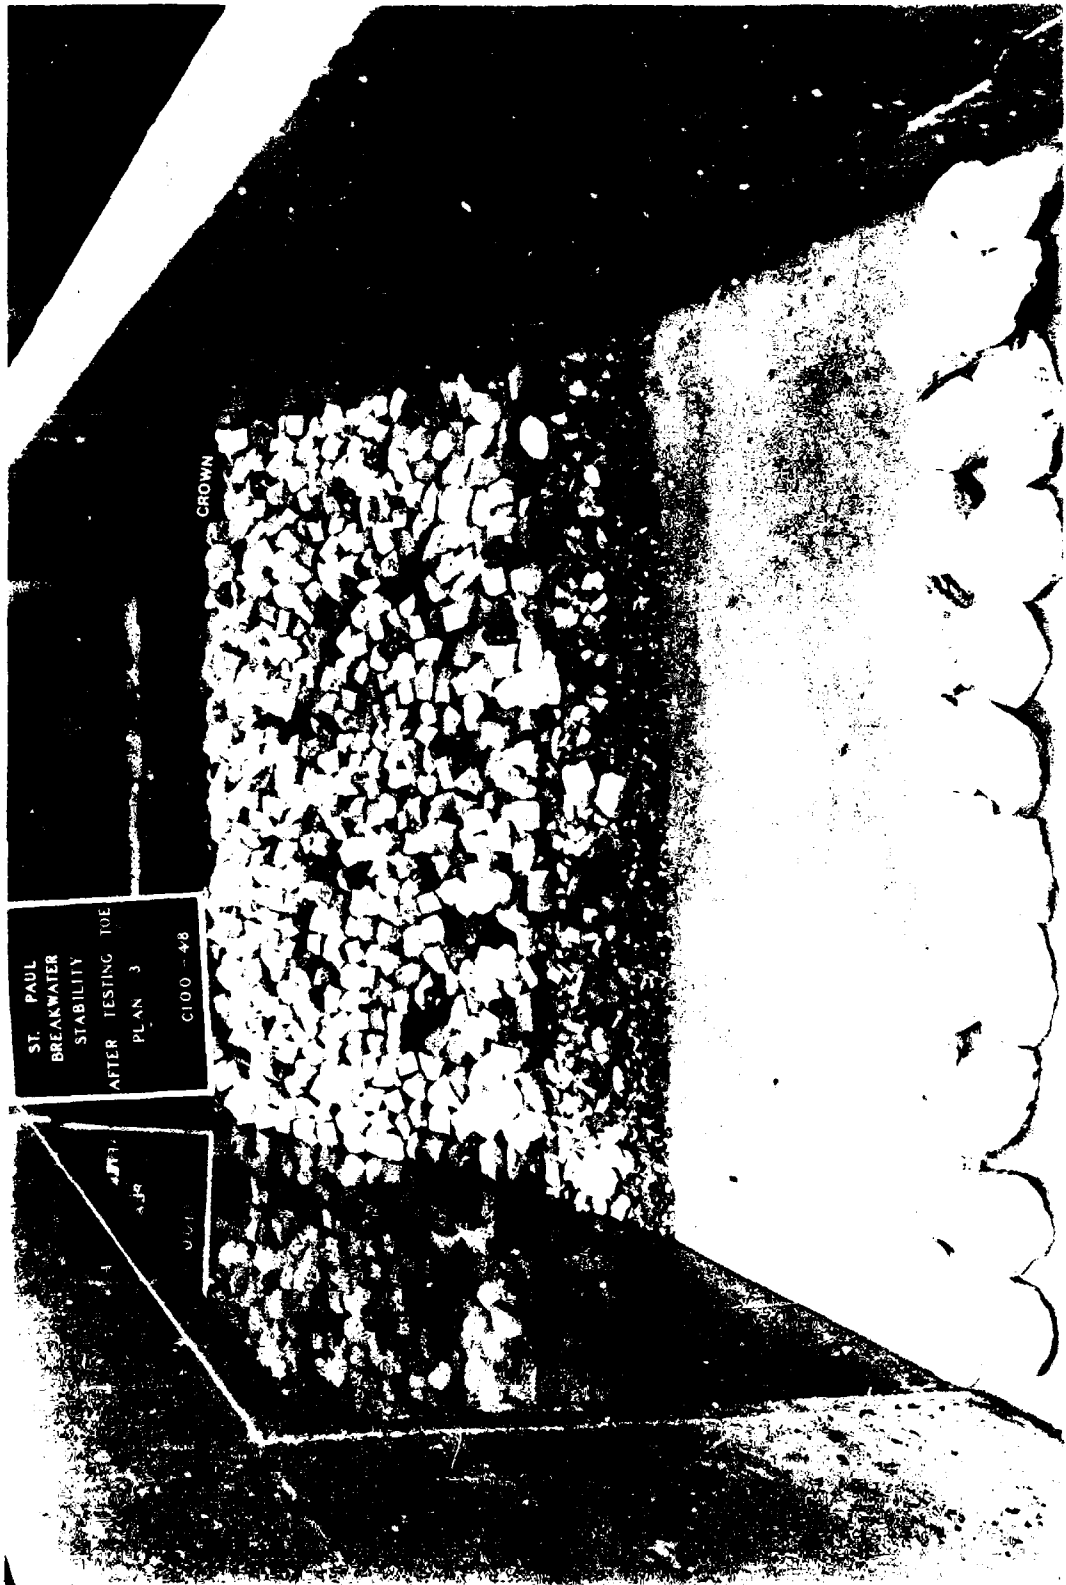
Photo 18. Plan 3, after test 18, sea-side view; St. Paul Harbor breakwater stability study
