### Introduction

### Conceptual formulation and technical information

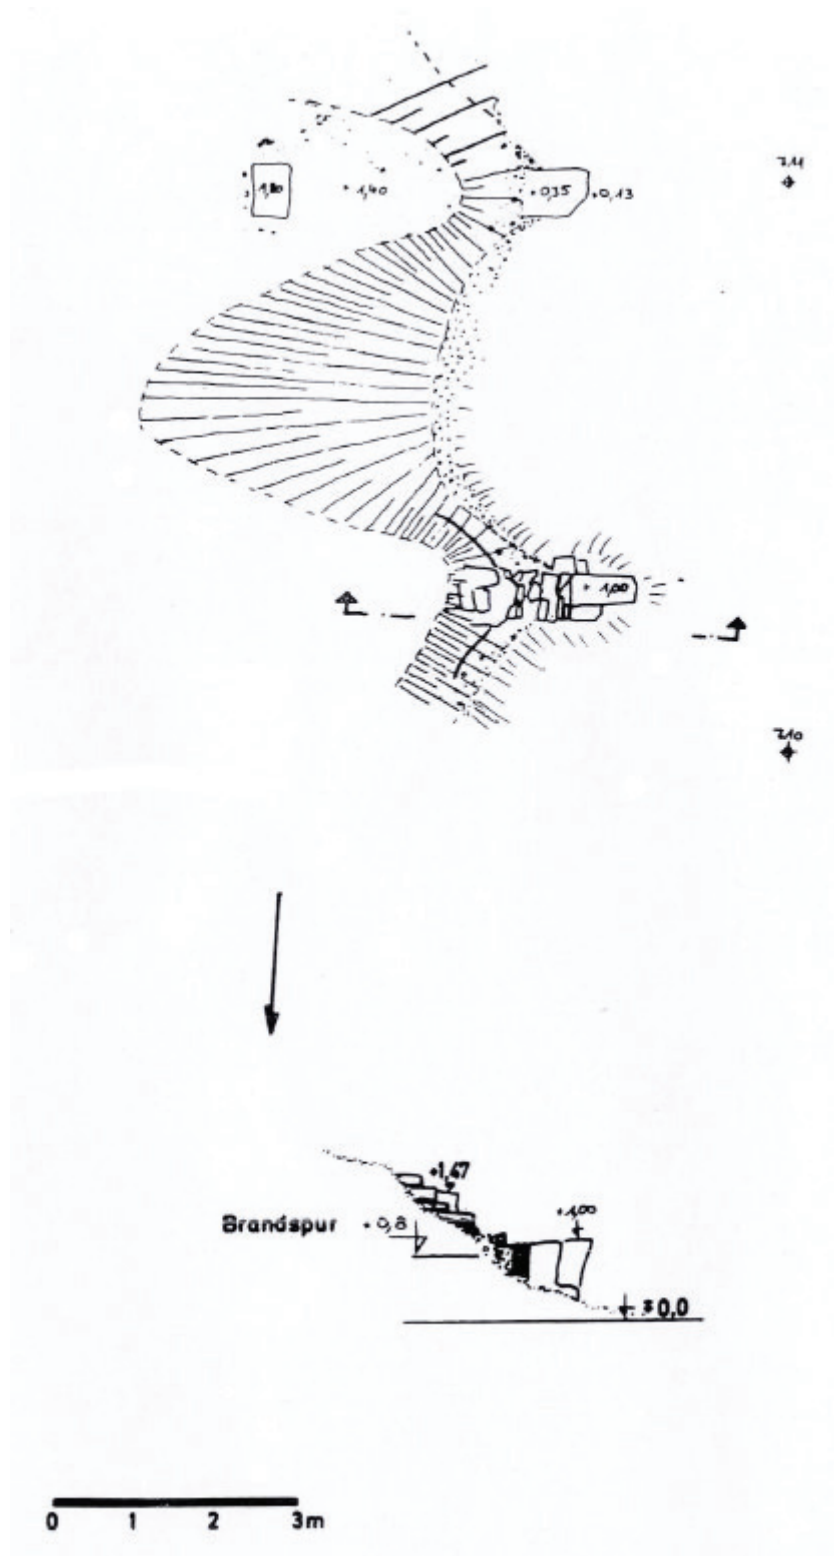
Fig. 14. Point "N" in Fig. 8 (Pl. 21 b and 22)

**Brandspur** = trace(s) of burning
