## **Kyrenia Ship**

## Kyrenia II

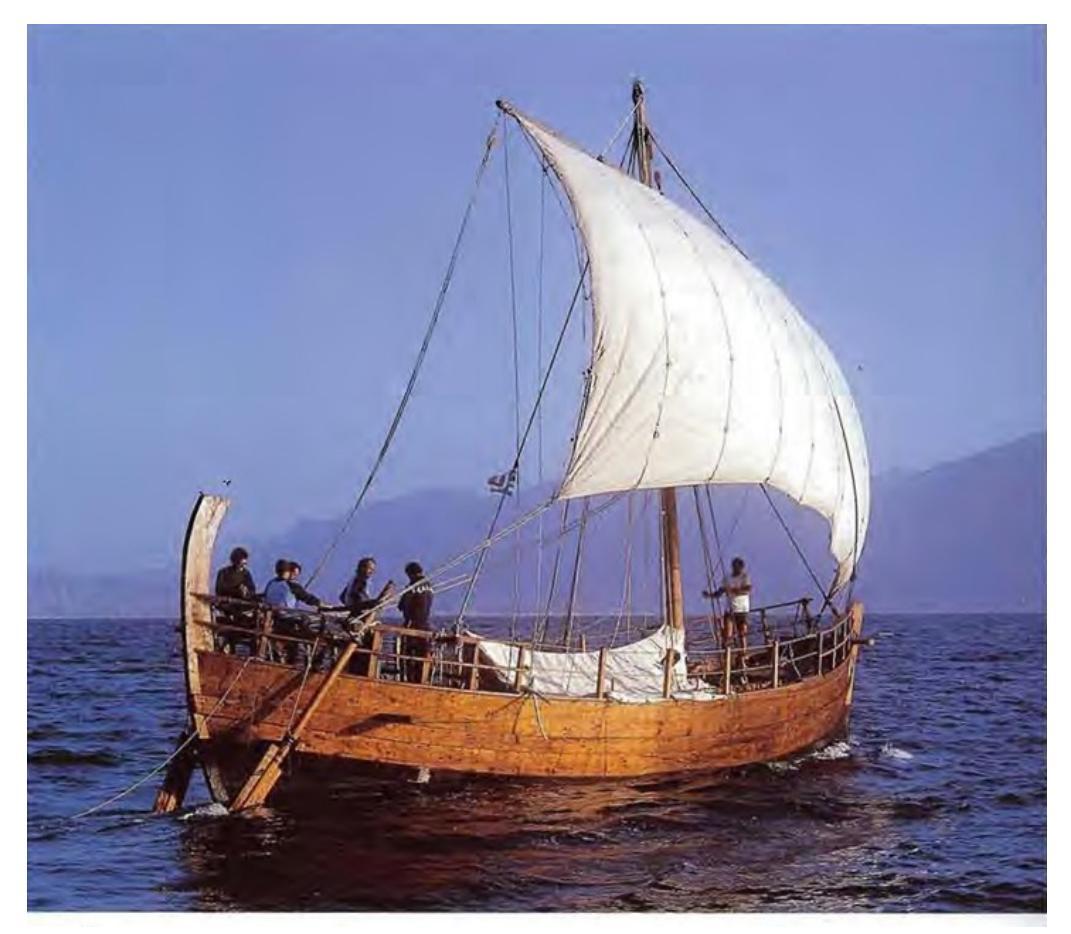
Kryrenia reconstruction sailing in the Aegean sea

The wooden hull, built mostly of Samos Aleppo pine, measured 14.3 m long by 4.4 m beam. The hull was built in the <u>"shell first" manner (../../../initatives/amfilissos/)</u>, quite the opposite of today's method.

The Kyrenia II sailed very well under different directions of wind and conditions of the sea. The average speed varied from 2 to 6 knots. She proved her seaworthiness, with a remarkable ability to sail into the wind.
