The ROMACONS Project: a Contribution to the Historical and Engineering Analysis of Hydraulic Concrete in Roman Maritime Structures

Since all long-distance trade in the Roman world travelled by water, Roman harbour design and construction have special importance. Harbour excavation must be supplemented by analysis of the components of the hydraulic concrete, structural analysis of the cementing materials, and consideration of the design of the wooden formwork. The authors have begun collecting large cores from concrete blocks at Roman harbours and other maritime structures, analysing the materials used, the method of placement, and the structural characteristics of the resulting concrete. These data have provided new information on the engineering properties of Roman concrete, the process of funding and execution, and the trade in the volcanic ash which was the crucial component of hydraulic concrete.

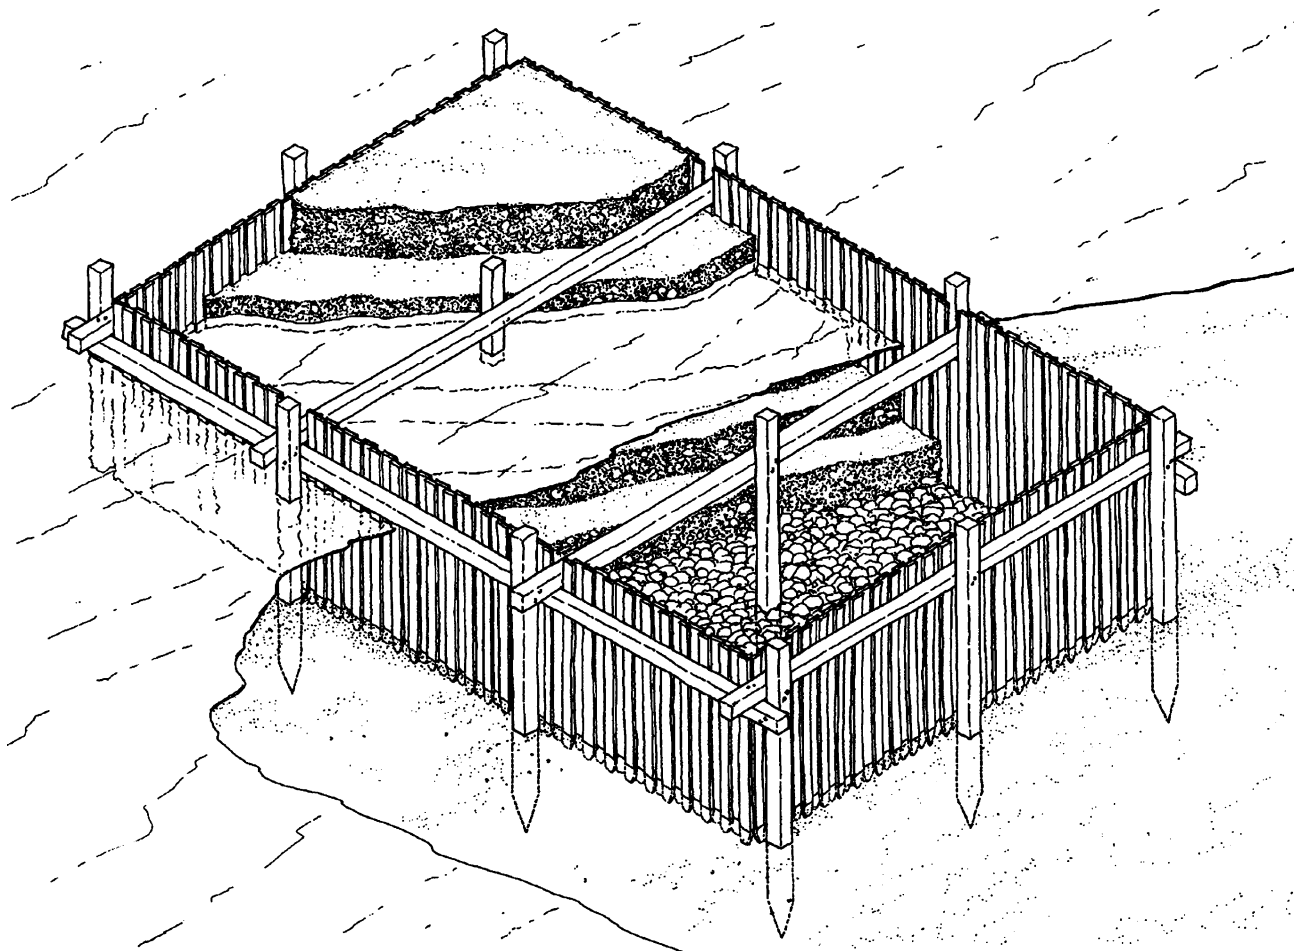
Figure 1. Vitruvius' formwork for hydraulic concrete. Reconstruction. (C. Brandon)

Powdery sand [*pulvis*, i.e. pozzolana] is to be brought from that region which runs from Cumae to the promontory of Minerva and mixed in the mortar used in these structures. Next, in the designated spot, formwork enclosed by stout posts and tie beams is to be let down into the water and fixed firmly in position. Then the area within it at the bottom, below the water, is to be levelled and cleared out, [working] from a platform of small crossbeams. The building is to be carried on there

with a mixture of aggregate and mortar, as described above, until the space left for the structure within the form has been filled ... But in locations where the powdery material does not occur naturally ... Let double-walled formwork [*arcae duplices*, i.e. cofferdams] be set up ... held together by close set planks and tie beams, and between the anchoring supports have clay packed down in baskets made of swamp reeds. When it has been well tamped down in this manner, and is as compact as possible, then have the area bounded by the cofferdam emptied and dried out by means of water-screw installations and water-wheels with compartmented rims and bodies. The foundations are to be dug there, within the cofferdam ... and then filled in with a concrete of aggregate, lime, and beach sand (Vitruvius, 5.12.2–3, 5–6).

The mortar should be mixed ‘in the proportions of two parts pozzolana to one of lime’. He also provides our only detailed description of the wooden formwork into which Roman concrete was poured (Schläger, 1971; Oleson, 1985; Oleson, 1988; Brandon, 1996; Brandon, 1999) (Fig. 1).

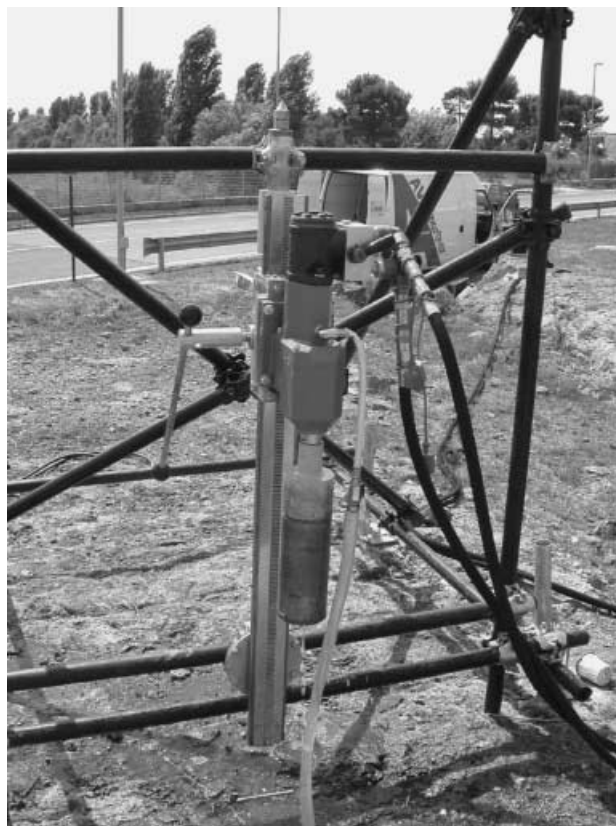
Figure 7. Coring motor and rack, detail.

The core-drilling rig used in 2002 and 2003 (supplied by Cordiam S.r.l. of Como) comprises a hydraulically-powered drill (model M60-0) mounted on a manually-operated rack and pinion track (Fig. 7). The rack can be mounted onto either a frame built of standard scaffolding tubes or a purpose-built aluminium frame such as that developed for the Project (Fig. 8). A hand-held hydraulically-driven drill (model MAG15) is used to cut small holes in the surface of the concrete for the expanding anchor bolts used to secure the support frame to the ancient structure. The main core drill rotates 10-cm diameter barrels with a diamond-tipped bit. Unlike that used on conventional concrete diamond core-drilling systems, the bit has larger diamonds that form a bracelet around the side as well as on its cutting face. This arrangement is intended to deal with the variety of hard and soft aggregates and mortars that make up Roman concrete. A core-catcher, consisting of a wide, split sleeve with roughened ridges on its interior, is fitted inside the lowest extension barrel, immediately above the drill bit. The sleeve holds the concrete core in position so that it can be lifted out together with the barrels once coring is completed. As the drill bit descends through the concrete, extension barrels of 0.5 m and 1 m lengths (depending on the circumstances) are added in sequence, up to a combined length of 6 m. The hydraulic drill (model LP11P) is powered by a petrol-driven pump connected to it with twin 25 m long, oil-filled, high-pressure hoses with quick-release fittings. A continuous flow of

water is required throughout the drilling process to keep the cutting face of the diamond bit clear of concrete paste and to lubricate the outside of the coring barrels, even when working under water. Quick-release fittings on the drill body channel the pressurised stream of water down the inside of the coring barrels, between the barrel wall and the core, over the diamond bit, and up the outside of the rotating barrel.

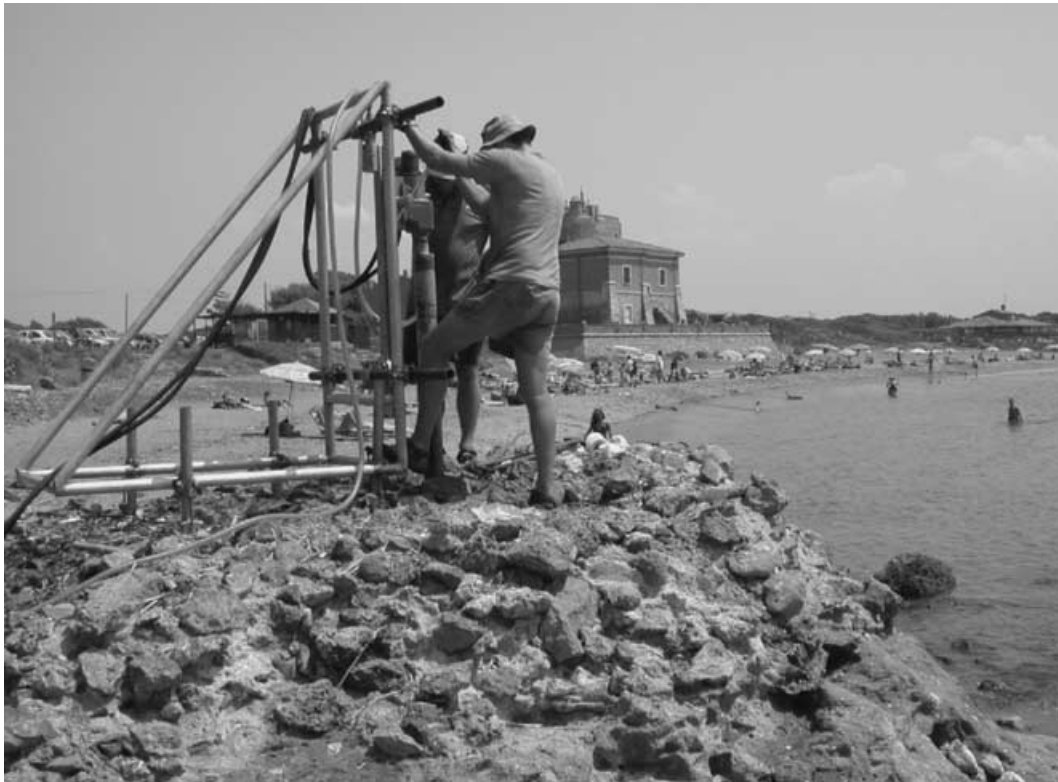
Figure 8. Coring device and frame in use at Cosa, Pier 1.

At each site where samples are to be taken, the scaffold or frame is positioned to ensure that the rack and pinion is located vertically above the point to be cored. Loose concrete, aggregate or marine growth is carefully removed from around the scaffold or frame in order to provide stable positions for the adjustable feet. These are secured to the concrete with conventional expansion bolts and to the scaffold or frame with scaffold clips. The rack and pinion unit is mounted vertically onto the frame and the drill fitted to it. The hydraulic and water hoses are connected to the drill and the diamond drill bit with a 0.25 m long core-catcher barrel is connected to the drill for the first cut. This initial cut with a short barrel ensures that there is no deflection at the point

where the bit first cuts into the concrete. After removing the initial surface plug, a 0.5 m long barrel is added and the drilling commenced in earnest. The drill is cranked down the rack and pinion with a hand-operated lever, maintaining constant, even pressure. One operator turns the lever while another adjusts the drill speed and monitors the water flow. As the bit cuts into the concrete it is possible to sense the nature of the material being cored by the resistance to the lever and by the colour of the flushing water, which carries away small particles of spoil.

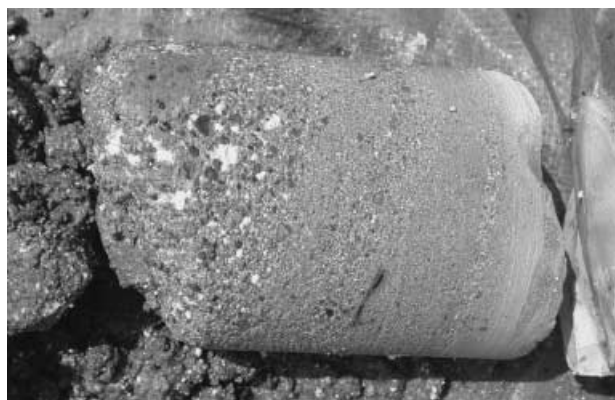
Figure 13. Core POR.2002.02, c.-1.60 to -2.0 m.

-1.98 to -2.32	A stratum of loose, limey mortar washed away during coring.		
-2.32 to -3.14	As above.	As above.	Original lagoon (?) floor reached at - 3.14 m, extremely fine grey brown sand with numerous black specks.

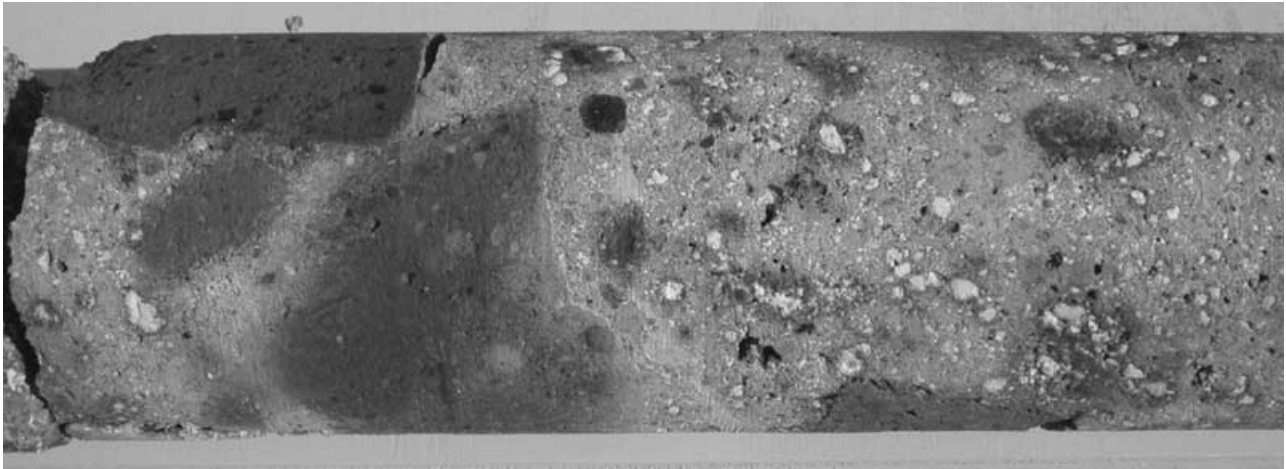
Figure 15. Core SLI.2003.01, area around -0.78 m.

SLI.2003.01. Taken from centre of *pila* just off the north-west corner of the piscina at Santa Liberata (32T0688713. UTM 4700418). Core tube was drilled to depth of 2.28 m below the upper surface, c.0.10 m into the original sand bottom, yielding a core L 1.50 m. This was a hard, well-mixed concrete, which possibly preserves traces of a day joint at -0.78 m.

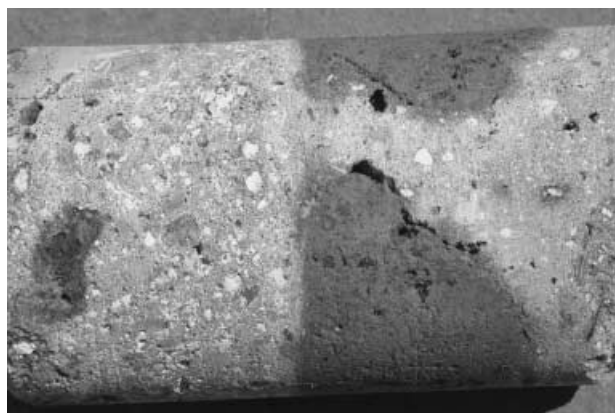
Figure 16. Core PCO.2003.01, c.-0.40 to -0.60 m.

Depth (m)	Mortar	Aggregate
0.0 to -0.5 (Fig. 16)	Very hard, fine-grained, light greenish grey to dark greenish grey (Gley 1 7/N to 7/10Y), well-mixed, but containing many small white nodules of lime (D up to c.0.01 m; most <D 0.005 m), small tuff fragments, occasional small voids (D c.0.003 to 0.02 m), and occasional small fragments of ceramic. In contrast to the other PCO samples, the mortar in this pier apparently did not include beach sand along with the pozzolana.	Irregular, light grey (Gley 1 8/N to 7/N) chunks of limestone (D ≤ 0.10 m).
-0.50 to -1.30	As above, but possibly slightly more fine-grained.	The same yellow brown (10YR 5/6 to 4/4) tuff seen in SLI.2003.01 and the other Cosa samples, containing large black grains and yellow fibrous pumice inclusions. This is Volsinian tuff, from a source 60 km northeast of Cosa (Gazda, 1987: 76 n. 5). The proportion of aggregate seems quite low, perhaps only 10 percent. There is no obvious seam at the point where the limestone and the tuff aggregate concretes meet, but the lower mortar is slightly more yellow brown than elsewhere in the sample, perhaps as a result of laitance.

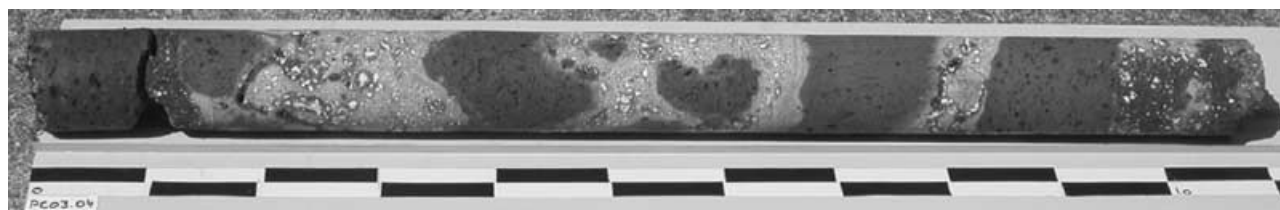
Figure 17. Core PCO.2003.04, view (0.0 at left).

Depth (m)	Mortar	Aggregate
0.0 to -0.15	Very hard, light grey (1 Gley 7/N) to grey (1 Gley 6/N), with many lime inclusions, poorly mixed and varying from D 0.001 to 0.015 m, and several voids and inclusions, particularly at -0.45 m. The mortar takes on a greenish tinge in proximity to the aggregate.	Volsinian tuff as above, but coloured greenish grey (Gley 1 4/1 10GY) by reaction to the pozzolana in the presence of infiltrated water.
-0.15 to -1.10 (Fig. 17)	As above.	Volsinian tuff, preserving its typical yellow brown (10YR 6/6) colour, and containing fibrous brownish yellow (10YR 6/6) pumice inclusions and black specks.
-0.40	Several irregular voids up to D 0.02 m.	
-0.60 to -0.70	A layer in which the particles have been water-sorted by size, forming a thin stratum of fine particles, perhaps a day joint.
