THE KITTEN SHIPWRECK:
ARCHAEOLOGY AND
RECONSTRUCTION OF A
BLACK SEA
MERCHANTMAN

A Dissertation

August 2009

Major Subject: Anthropology

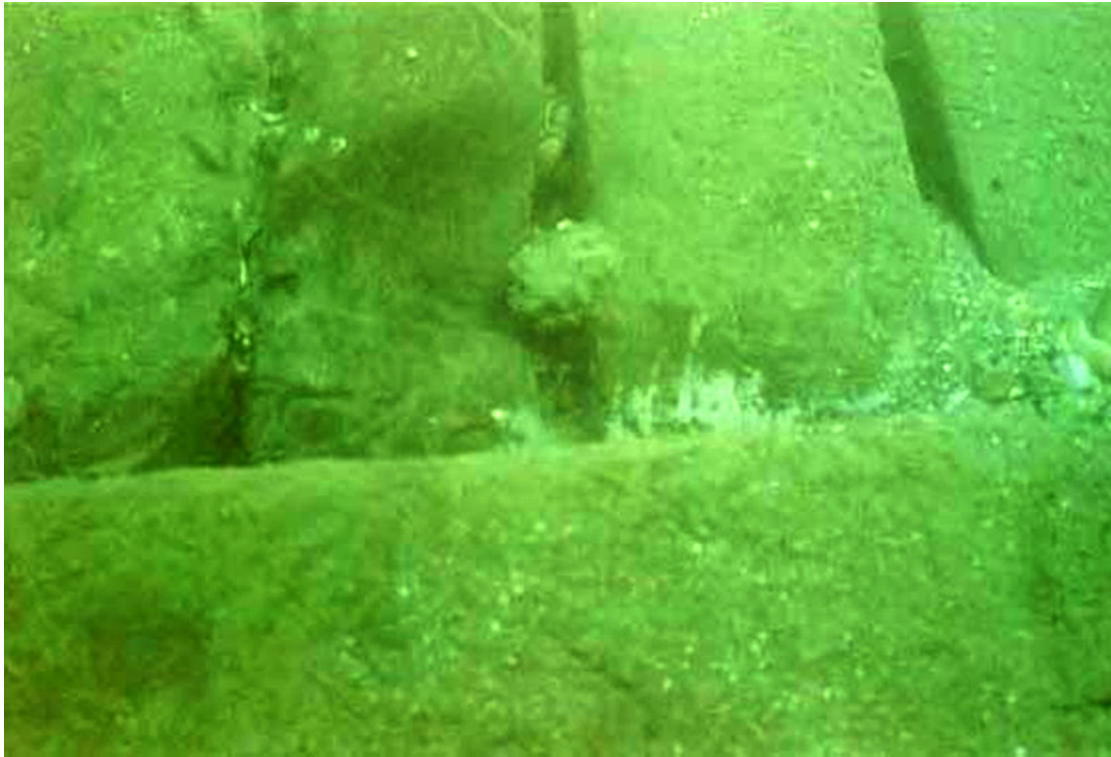
Fig. 19. Notch in adjacent timber for fastener of a toptimber. Photo: K. N. Batchvarov.

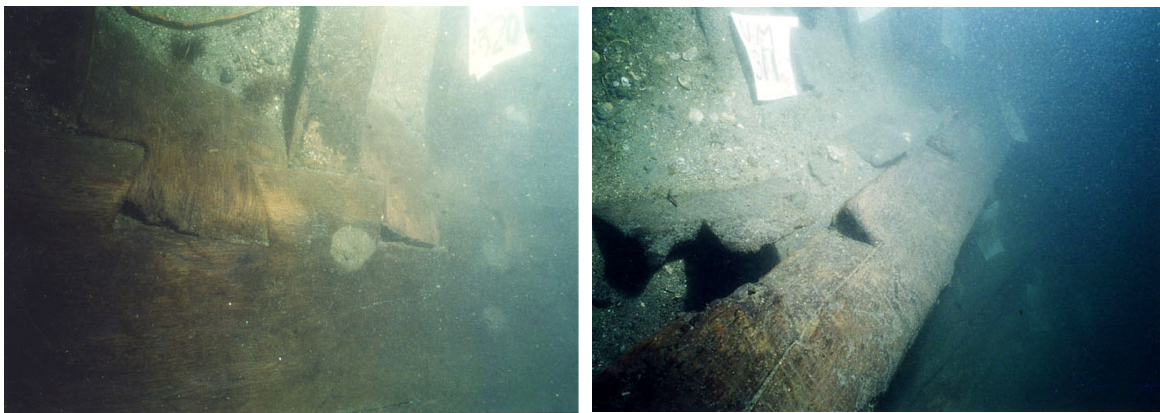
Fig. 23. Crenelated timbers with filling pieces between the futtocks. Photo: L. Klissurov.

The bilge stringer is partially covered by two thinner, but still massive strakes (c. 5-10 cm thick and c. 20 cm wide each) of footwaling extending from about the middle of the stringer outboard. Forward, the outer strake butts into a timber with nearly square section, which forms the continuation of the strake towards the bow of the vessel. Originally, it probably reached the stem or a breasthook. The timber was fastened to each frame, although most frames have now fallen off and the timber itself is in very poor condition. Nevertheless, dovetail mortises were clearly observable on its upper and outer surfaces, and some still contained the dovetails of filling pieces that covered the room between the futtocks. Aft, the outer of the two footwaling strakes is crenelated and notched around the futtocks, with dovetail-jointed filling pieces between the frames (fig. 23).

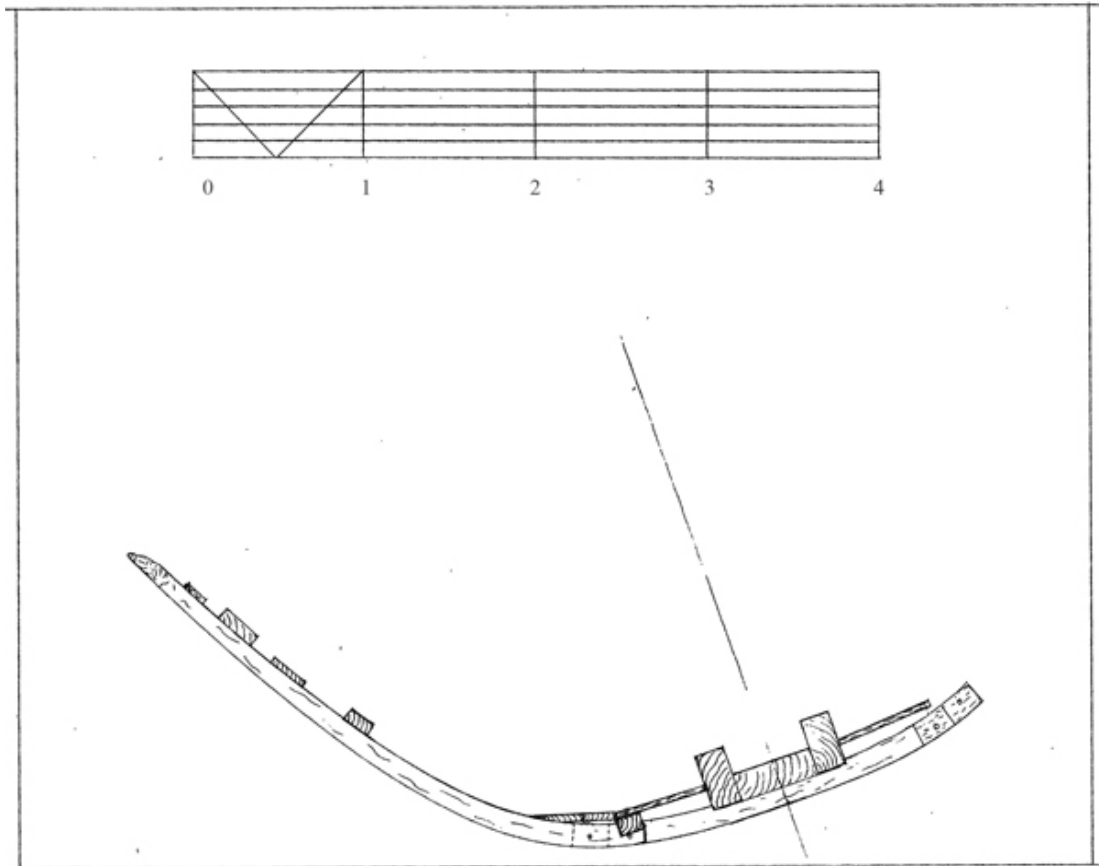
Fig. 31. Frame E as recorded. Drawing: K. N. Batchvarov.

concentration in the bow and stern areas where the shape of the hull changed more rapidly. The recorded sections include from the bow toward the stern S, P, M, E (fig. 31), the midship frame, 3, 7, 13, 18, 22 and 28 (fig. 28, 32).

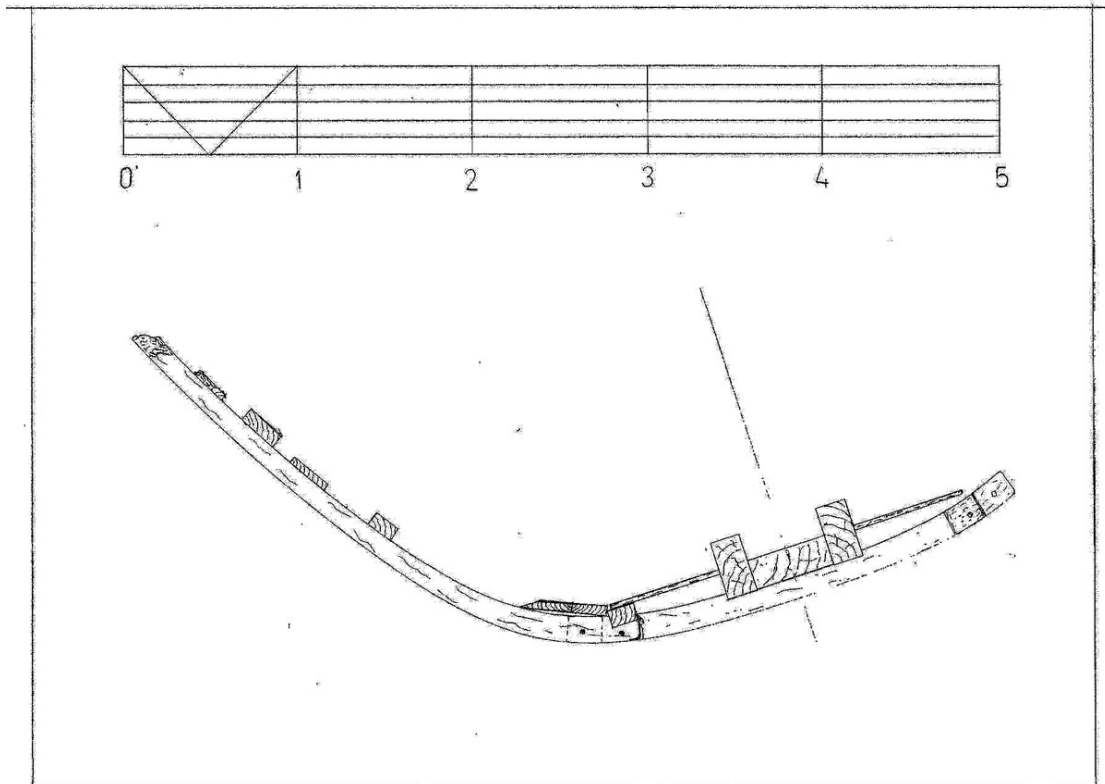
Fig. 33. Midship frame as recorded. Scale in meters. Drawing: K. N. Batchvarov.

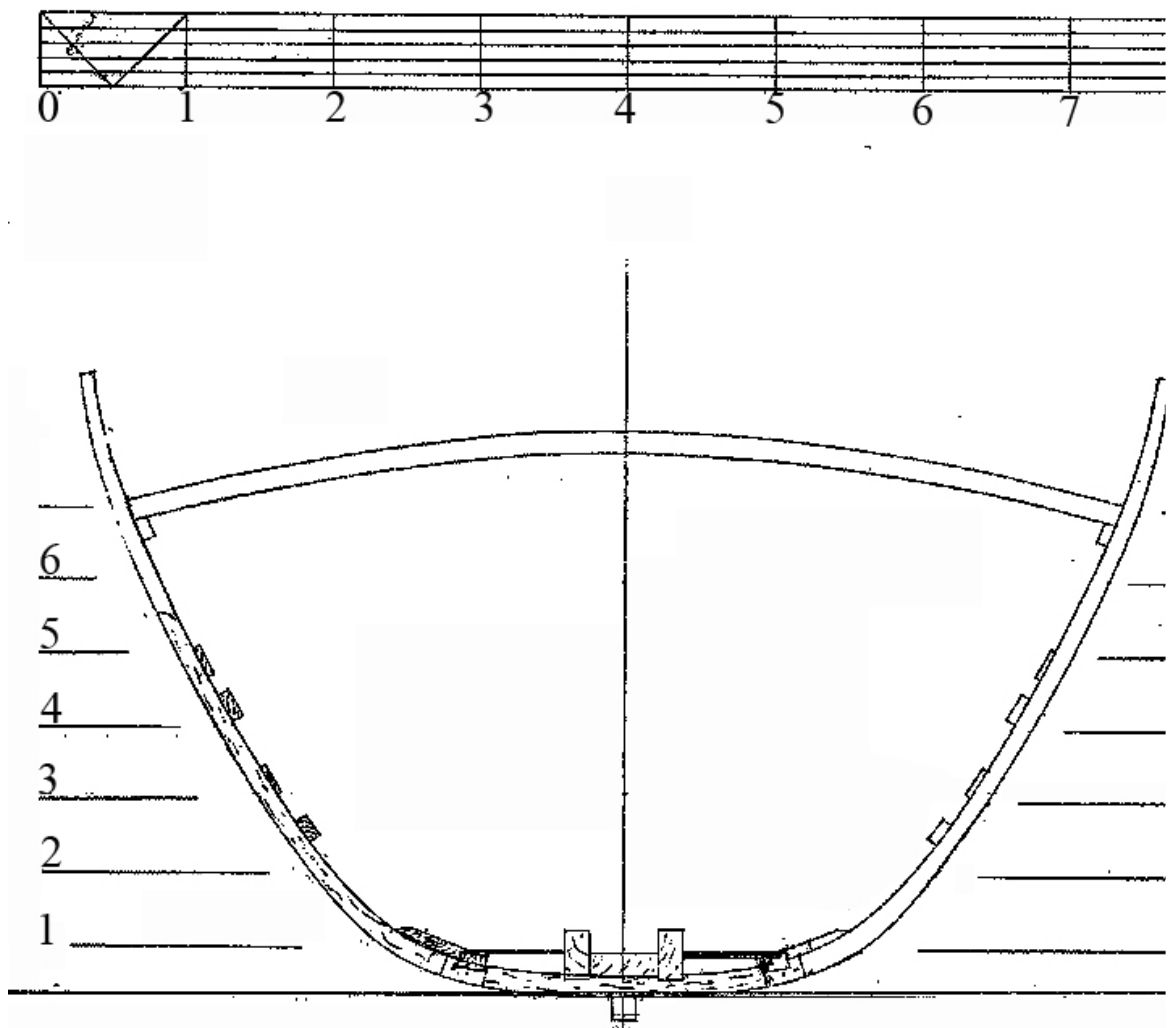
Fig. 34. Reconstructed midship frame. Drawing: K. N. Batchvarov.

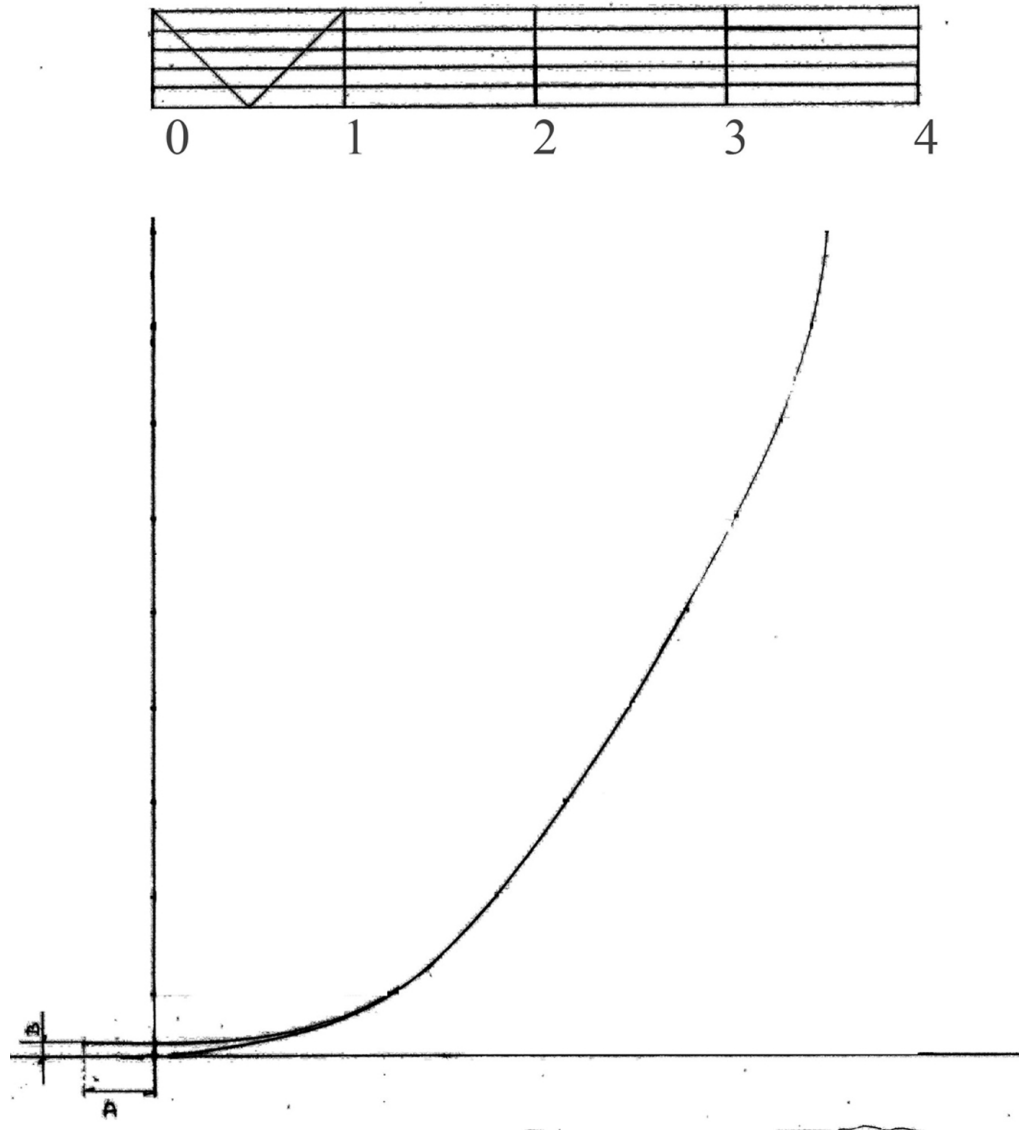
Fig. 37. Narrowing and rising at Frame E. Drawing: K. N. Batchvarov.

Forward, this was frame E (fig. 37). Aft, frames 3 and 7 were recorded, but 3 was so close in shape to the midship frame that the distinction would hardly be noticeable at the scale at which I worked and for this reason frame 7 (fig. 38) alone was used. Knowing the maximum narrowing or rising at the tailframes, I had to attempt to find a geometrical aid - mezzaluna, mezzarola or triangle - which would produce increments into which frames E and 7 would fit.

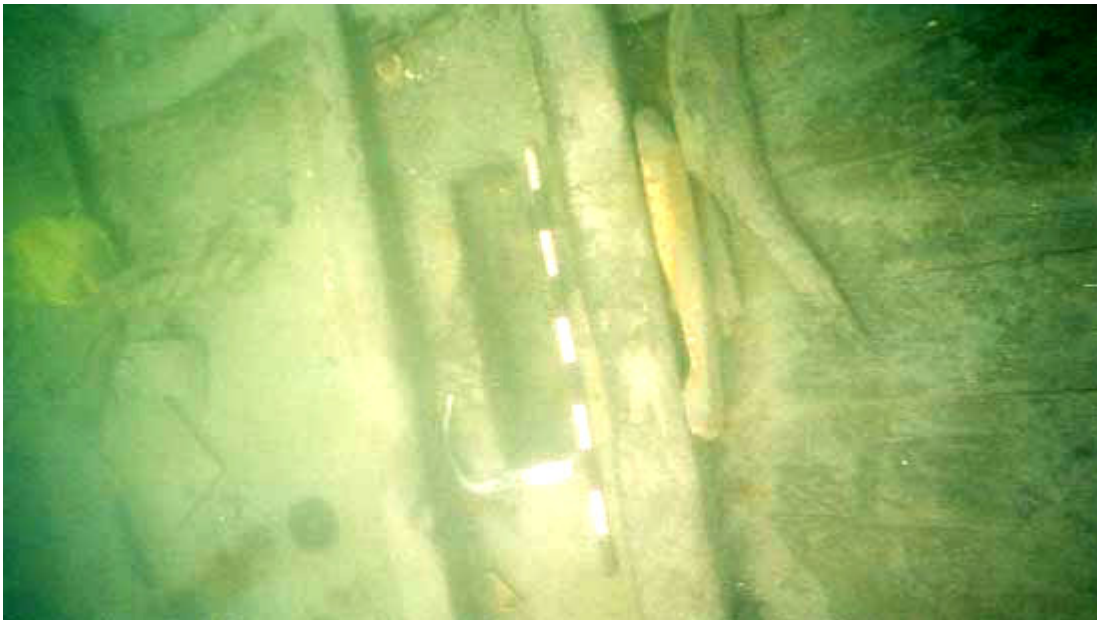
Fig. 43. The mast step, supported by the sister-keelsons. Photo: K. N. Batchvarov.

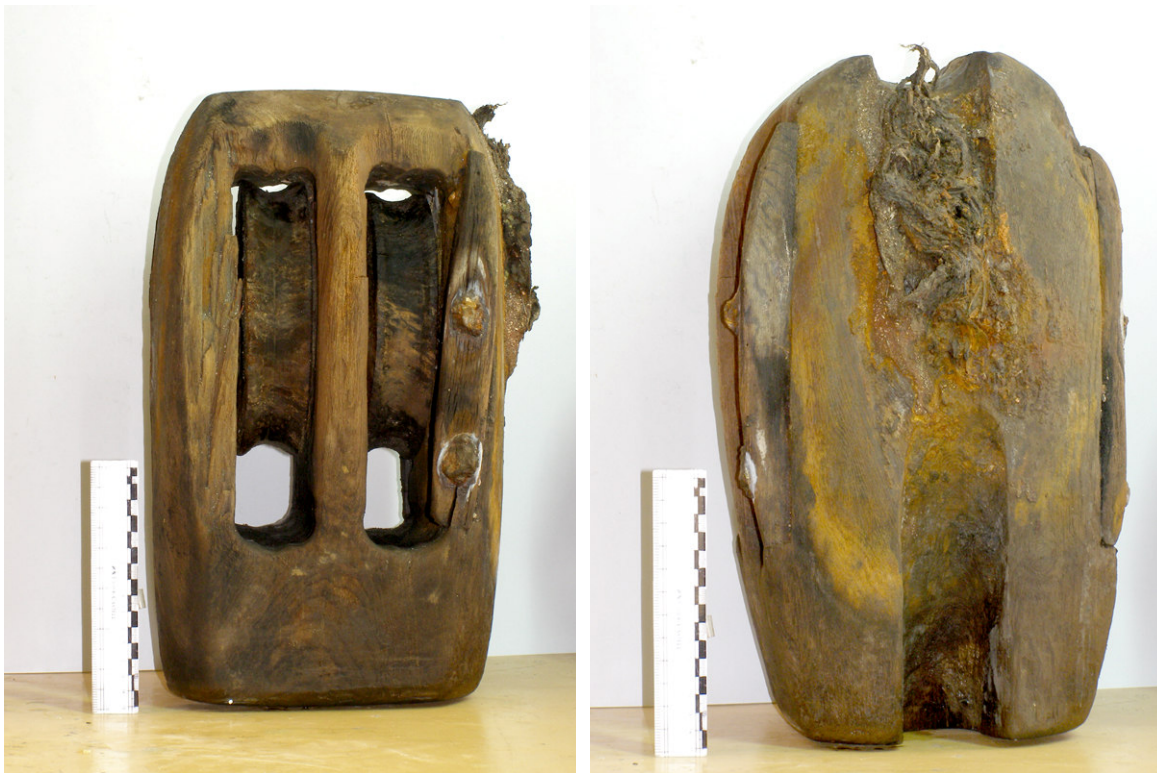
Fig. 45. Double block. Repairs to the shell are visible. Photo: K. N. Batchvarov.

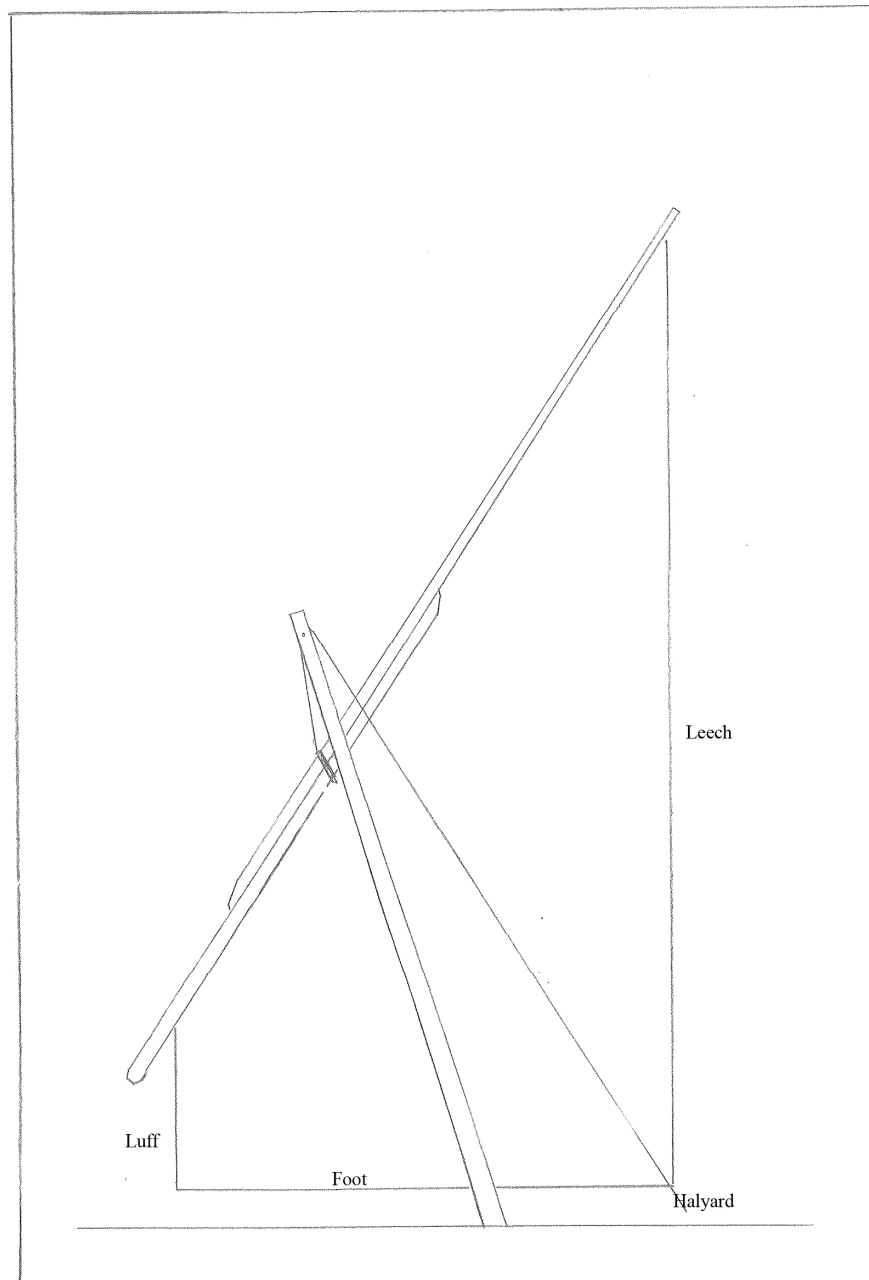
Fig. 59. Settee rig as carried by Alexandrian *feluccas*. The halyard leads aft and the yard swings forward of the mast in tacking. Drawing: K. N. Batchvarov.

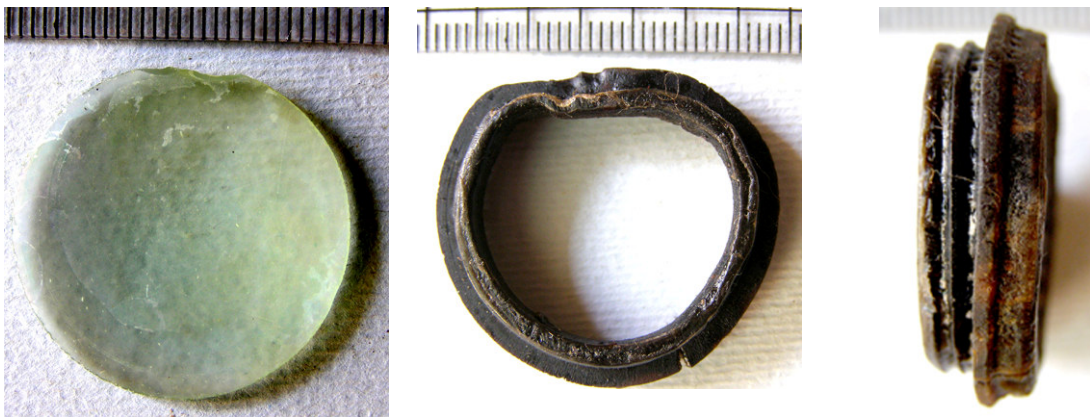
Fig.101. KT118 Possibly an ocular from the same navigational instrument as KT117.
Photo: K. N. Batchvarov.
