## Eight Byzantine Shipwrecks from the Theodosian Harbour Excavations at Yenikapı in Istanbul, Turkey: an introduction

Cemal Pulak, Rebecca Ingram and Michael Jones

Excavations at Yenikapı in Istanbul, Turkey, related to the Marmaray Project, have unearthed remains of Constantinople's Theodosian Harbour, including 37 Byzantine shipwrecks of 5th- to 11th-century date. Eight of these shipwrecks, six round ships and two of the first long ships, or galleys, to be excavated from the Byzantine period, were studied by archaeologists from the Institute of Nautical Archaeology. These well-preserved shipwrecks are an important new source of information on the maritime commerce of Constantinople and the gradual shift from shell-based to skeleton-based shipbuilding in the Mediterranean during the second half of the first millennium AD.

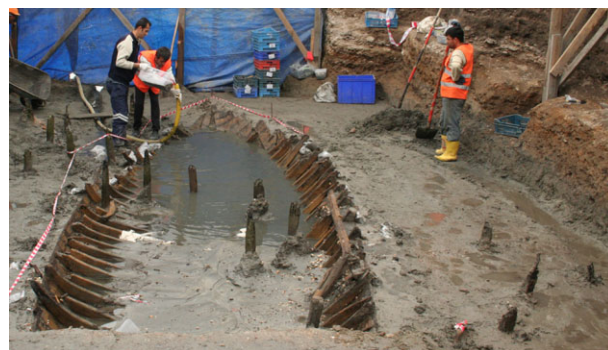
Figure 2. Wooden dock piles were found throughout the site, often piercing the hulls of wrecked ships, as seen in this excavation photo of 9th-century shipwreck YK 14; April 2007. (Photo M. Jones/INA)

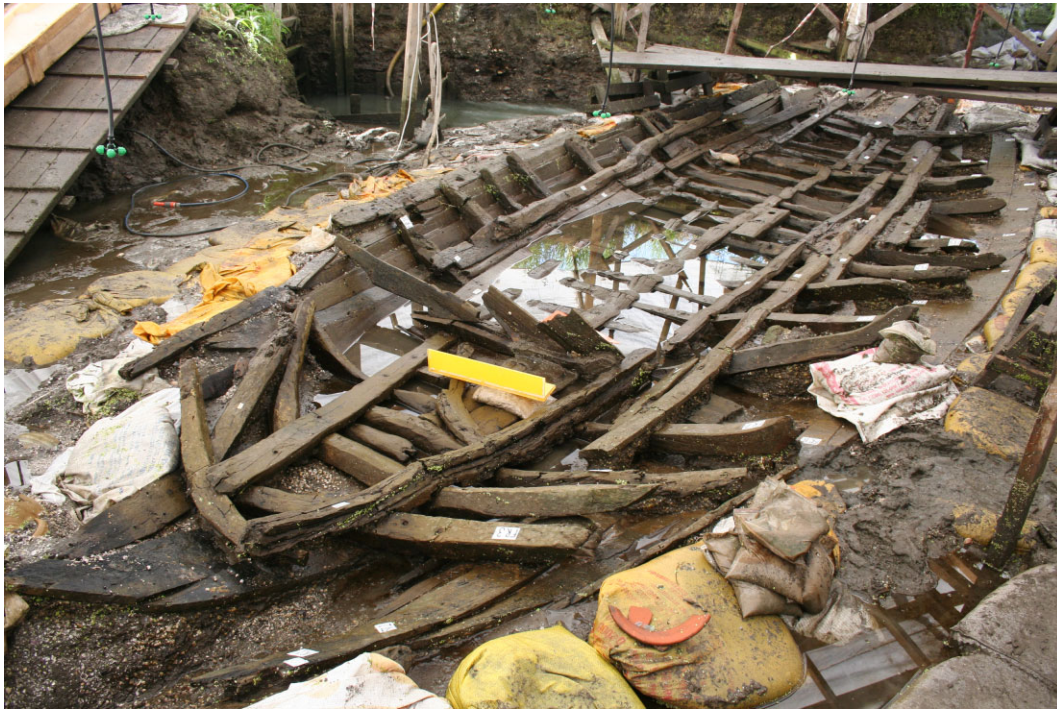
Figure 7. Shipwreck YK 11 *in situ*, with upper level of disarticulated timbers removed; July 2008. (Photo O. Köyağasıoğlu/INA)

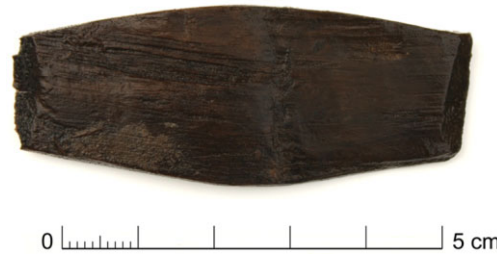
Figure 8. Intact tenon recovered from port-side planking of ship YK 11. (Photo R. Ingram/INA)

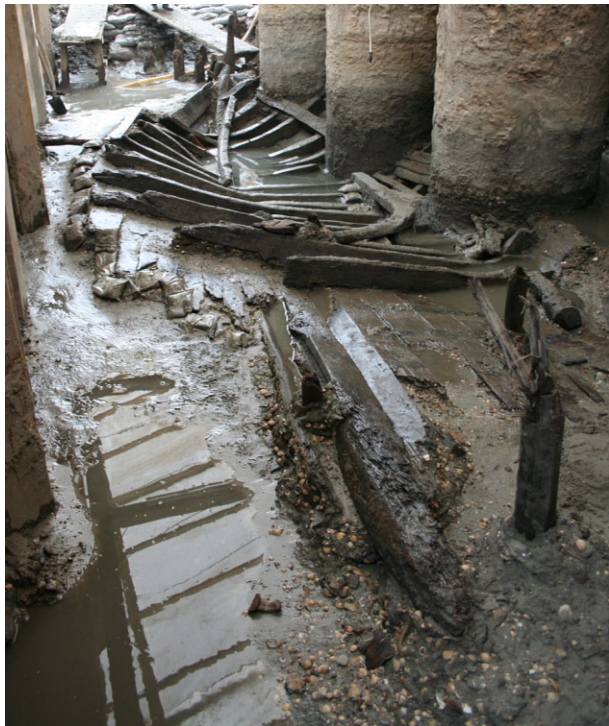
Figure 11. Shipwreck YK 23 *in situ*, showing coffer dam, at left, and concrete pillars through the better-preserved side of the ship, at right; December 2007. (Photo I. İvgin/INA)

While the ship was very well preserved, the boring machine inflicted significant damage to the better-preserved side of the vessel. As part of the construction site's retaining wall, the 1.5 m-diameter holes were filled with concrete, resulting in four concrete pillars

that pierced the shipwreck (Fig. 11). Ship timbers along the periphery of these columns were broken and splintered. At some point after the ship sank, but while the harbour was still in use, at least 14 wooden piles were driven into the harbour floor in the area around the ship, with two of the piles driven through the hull itself. The hull was found in a layer of fine gray sand with shell and artefact inclusions; the ship may have sunk in a storm, with its cargo dispersed in the harbour or salvaged soon afterwards.

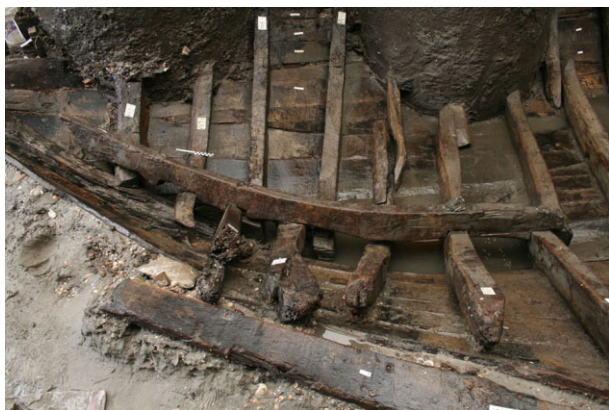
Figure 12. *In situ* central longitudinal timber on YK 23, either a stemson or sternson; January 2008. (Photo R. Ingram/INA)

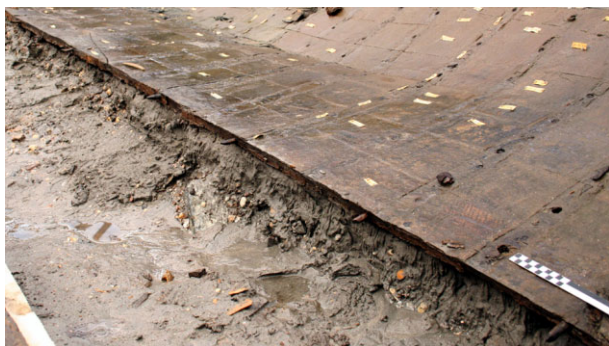
Figure 14. Edge fasteners along exposed plank edge of YK 14; September 2007. (Photo M. Jones/INA)

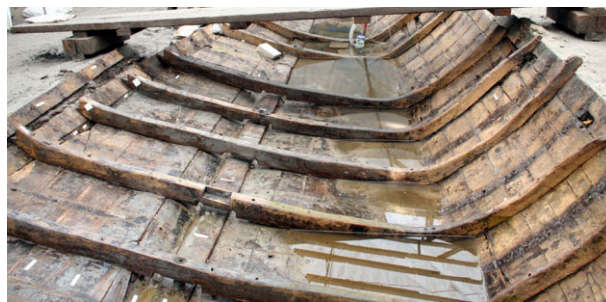
Figure 16. L-shaped floor timbers in YK 14's hull amidships, photographed during the dismantling of the hull; May 2007. (Photo M. Jones/INA)

Evidence for approximately 50 frame stations was preserved on YK 14, including 45 surviving floor timbers and, where frames were not extant, fastening holes for frames in the planking. Floor timbers were closely and regularly spaced, with an average room and space of 230 mm. In contrast to some of the other round ships found on the site, YK 14's frames were comparatively light, with average maximum cross-sectional dimensions of 58 mm sided and 95 mm moulded; beyond the turn of the bilge, the cross-sectional dimensions of the floor timbers decreased, often significantly. While earlier ships were constructed with a framing pattern of floor timbers alternating with paired half-frames, YK 14 was built with flat, L-shaped floor timbers whose long arms alternated in orientation and extended past the turn of the bilge to the strake above the first wale. The short arms of the floor timbers were scarfed into, although not fastened to, futtocks at the turn of the bilge area (Fig. 16). Frames were typically fastened to the ship's planking with 1–2 treenails per strake, supplemented with iron nails in some locations, most often at the turn of the bilge. Rounded limber-holes were cut into the outer faces of the floor timbers at either side of the keel. Only 20 of the ship's approximately 50 floor timbers—based on both surviving floor timbers and the locations of frame fasteners in the keel and hull planking—were nailed to the keel, at every second or third frame.

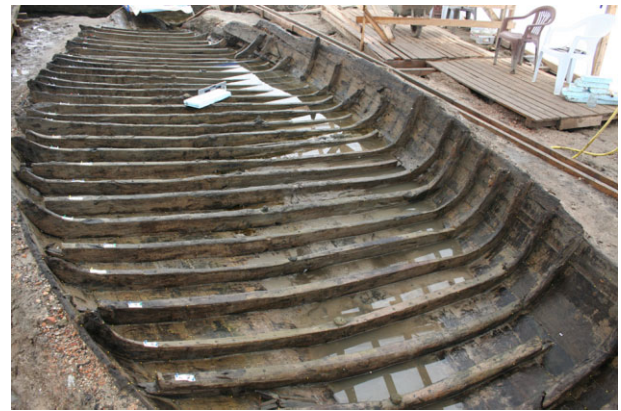
Figure 18. *In situ* framing of ship YK 5; April 2006. (Photo S. Matthews/INA)

YK 5's keel is roughly rectangular in section. The moulded dimensions of the keel timbers are on average 89 mm, while the sided dimensions are on average 121 mm. The keel and stem tapered along the length of the vessel, with smaller cross-sectional dimensions at the better-preserved forward end of the shipwreck; unusually, for most of the ship's length the sided dimensions of the main keel timber are larger than the moulded dimensions, a feature absent from the other Yenikapı shipwrecks under study by INA. The lack of a rabbet in the keel also allowed for a flatter-bottomed hull, giving the ship a cross section similar to the nearly contemporaneous Serçe Limanı ship (Bass *et al.*, 2004: 157) (Fig. 18). The keel and endpost timbers were

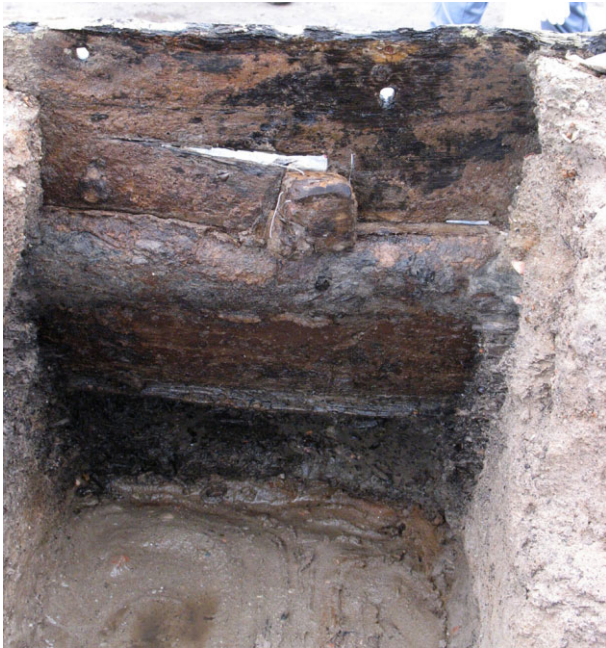
Figure 19. *In situ* through-beam of YK 5, as viewed from ship exterior; note the slight displacement of the plank abutting the through-beam; September 2006. (Photo S. Matthews/INA)

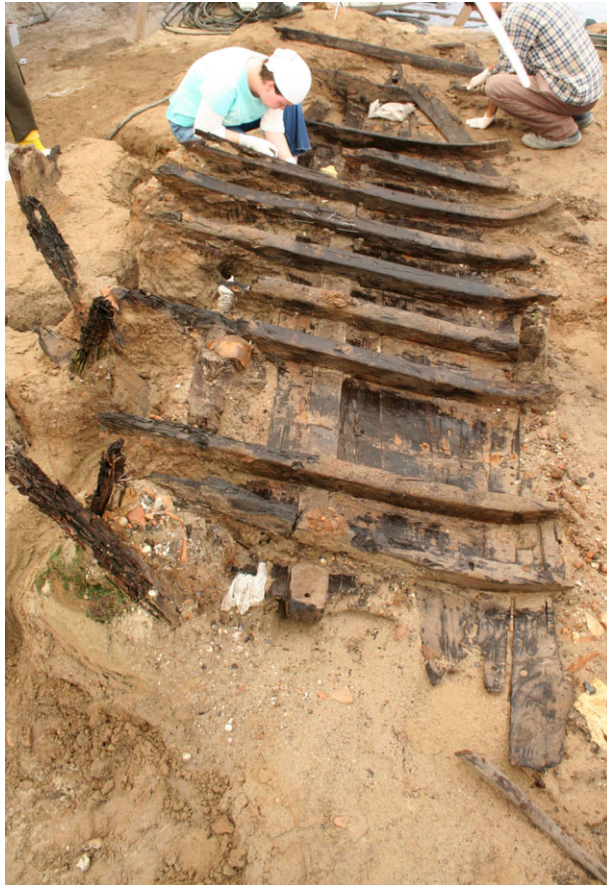
Figure 21. Shipwreck YK 24 during excavation; July 2007. (Photo M. Jones/INA)

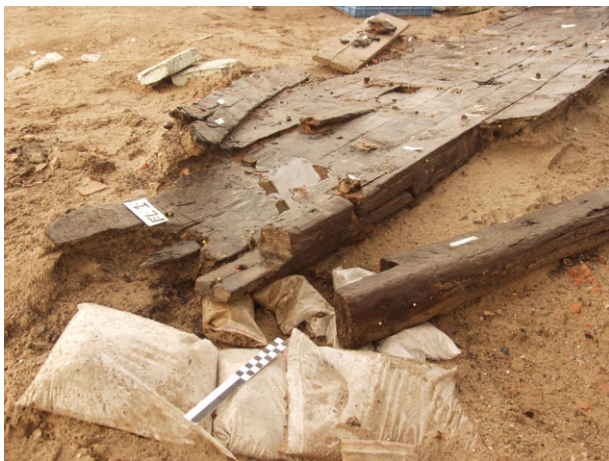
Figure 22. *In situ* repair timber on the keel of YK 24 (YK 24 Keel 1); July 2007. (Photo M. Jones/INA)

Evidence for extensive repairs, including at least one major overhaul, is apparent in the surviving section of YK 24's hull. These repairs included the addition of several graving pieces, apparently inserted into rotten or leaky sections of the hull along plank seams. A large number of iron nails used in the hull, many of which were driven in or near treenails, was likely added to reinforce treenails that had loosened after years of service. Two unusually shaped keel blocks (Keel 1 and Keel 4) were installed at either end of the keel, between the keel (Keel 2 and Keel 3) and endposts; unlike the central keel timber (Keel 2), these blocks, as well as a curved keel timber from one end of the hull (Keel 3) (Fig. 22), were not edge-fastened to the garboards with coaks. It is likely that all three of these keel timbers

were added during the same repair episode; the short keel blocks likely replaced more complex keyed hook scarfs used to join the original keel and endpost timbers.

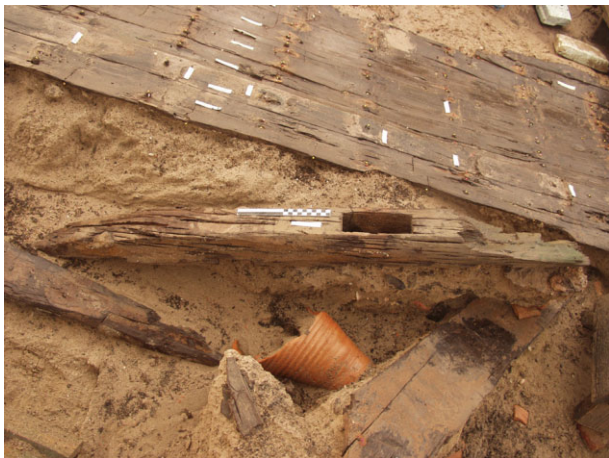
Figure 23. Mast-step of ship YK 24 *in situ*; July 2007. (Photo M. Jones/INA)

Another of YK 24's significant hull elements is the vessel's disarticulated mast-step, found next to the shipwreck; this is the only example found on the eight vessels studied by INA at Yenikapı. This timber is preserved to a length of 1.27 m, with a maximum cross section of 120 x 95 mm; its original length was probably only slightly longer (Fig. 23). One end of the mast-step is damaged, but the preserved end shows that it was originally nailed at either end to floor timbers; the mast-step's under face is also notched to fit over the vessel's floor timbers. The mast-step has a single mortise for the mast's heel, approximately 150 x 65 mm in size and cut through the timber from its inner face. Due to the poor preservation of the mast-step and the ends of the hull, the mast-step's original location on the ship has not been confirmed at this stage of research.

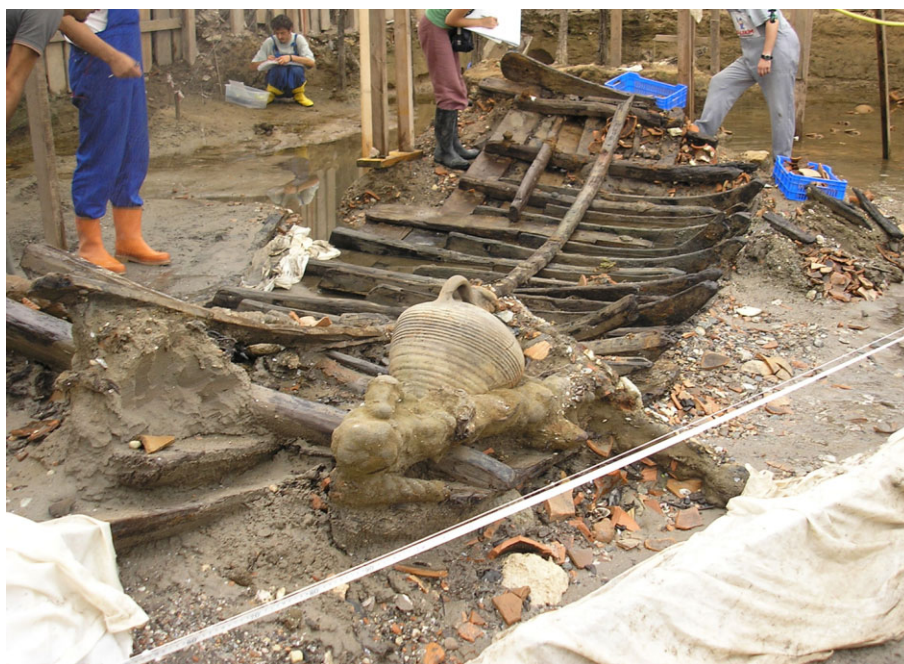
Figure 25. Shipwreck YK 1 *in situ*, with a Ganos-style amphora visible next to a concreted iron anchor at the ship's bow; August 2005. (Photo M. Jones/INA)

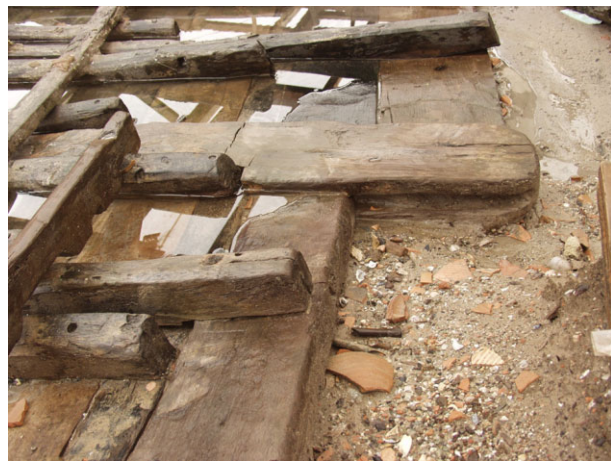
Figure 26. Slotted timber on YK 1 that accommodated removable strakes of planking; August 2005. (Photo M. Jones/INA)

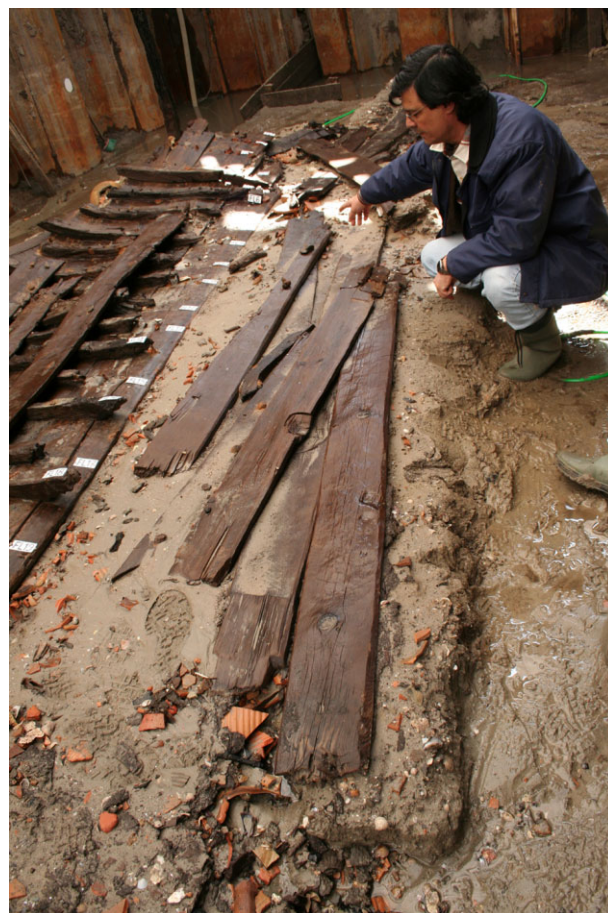
Figure 29. At least nine disarticulated deck beams, which would have also functioned as rowers' benches, were found near one end of galley YK 2; April 2006. (Photo S. Matthews/INA)

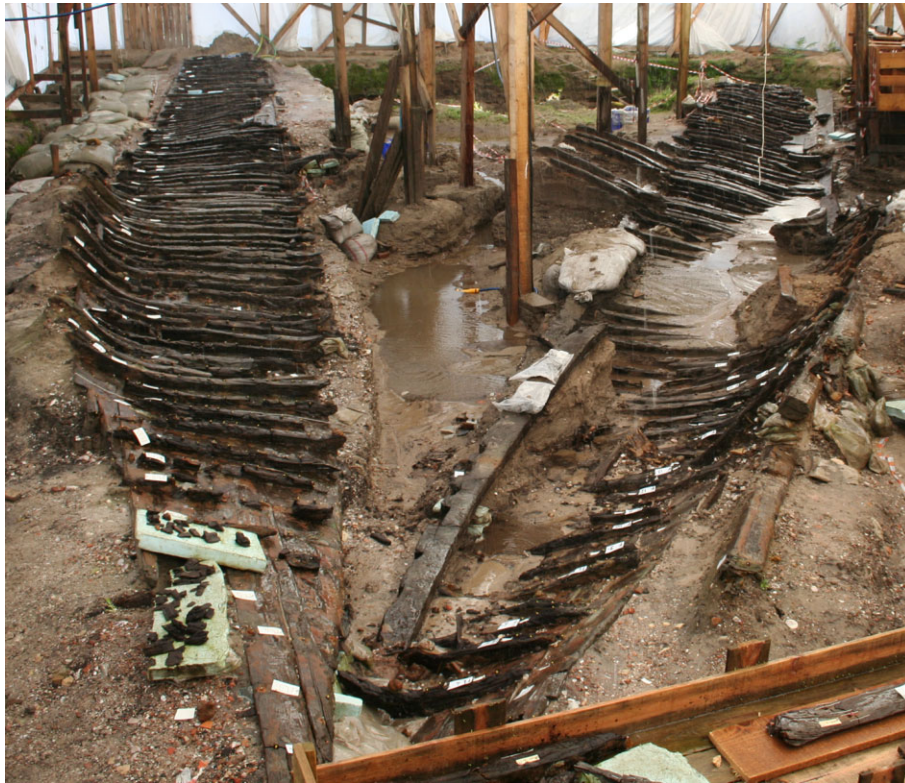
Figure 31. Longitudinally split galley YK 4 shortly after excavation, with the ship's bow in the foreground; October 2006. (Photo M. Jones/INA)

had split along its keel so that the port and starboard sides extended from the ship's bow at an angle (Fig. 31). Because the port side of YK 4 lay directly under the well-preserved end of vessel YK 5, it is likely that both ships sank during the same violent storm in the late 10th or early 11th century. Surprisingly, preliminary radiocarbon analysis of two treenails from the YK 4 frames indicates an initial construction date between the 8th and 10th century (Table 3). Although there were extensive repairs to this vessel, a lifespan of more than a century seems unlikely; additional radiocarbon and dendrochronological analyses should

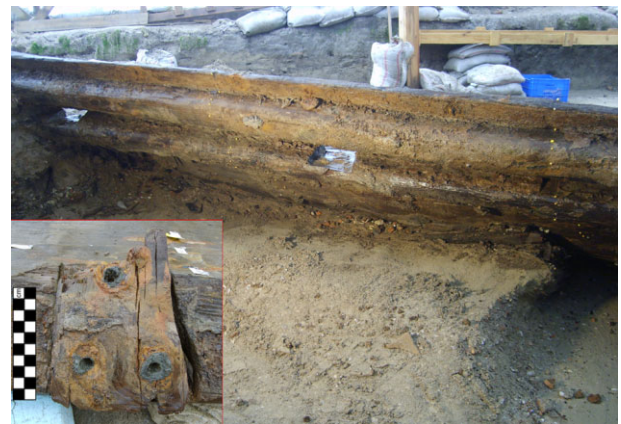
Figure 32. View from the exterior of galley YK 4, with bench notches visible above the lowest wale; inset photo shows an *in situ* fragment of a rower's bench; February 2007. (Photo K. Bircan/INA)

The port-side planking of YK 4 includes three wales, also of European black pine. On the lowest wale, shallow sockets, cut into the timber's upper face, would have accommodated the ends of wide, flat through-beams that doubled as rowers' benches or thwarts. While only small fragments of such benches were preserved in association with the YK 4 hull (including fragments of three bench ends found *in situ* in the lowest wale's sockets), those found in association with

galley YK 2 are probably close parallels (Fig. 32). Nine such bench sockets were preserved on the lowest YK 4 wale. The centre-to-centre spacing between these bench sockets shows a significant variation that ranges between 0.874 and 1.048 m, but averaging 0.96 m. It appears that the builders could make minor adjustments to the locations of the benches along the length of the ship where necessary by placing the bench

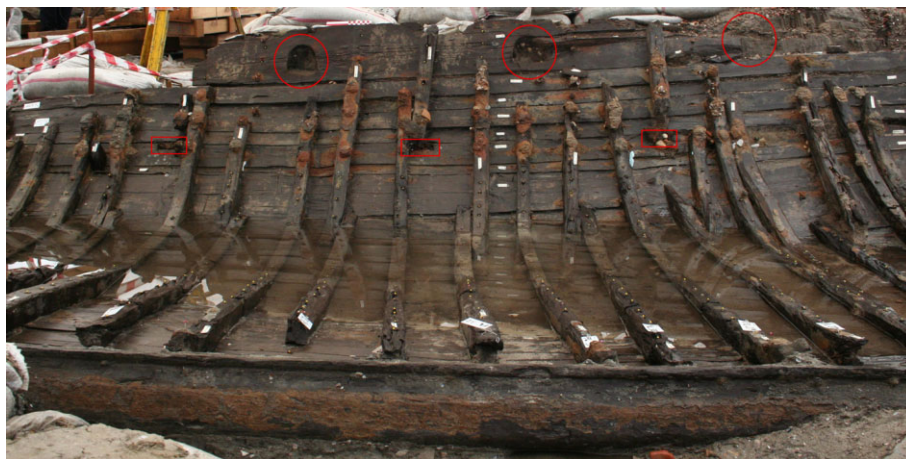
Figure 33. Port side of galley YK 4, view from interior; oar-ports are circled, and bench notches are highlighted with rectangles; November 2006. (Photo M. Jones/INA)

These features indicate the approximate locations of the seated rowers in relation to other hull features. In addition to the position and attachment of the rowers' benches, the partially preserved oar-port strake of YK 4, the uppermost preserved strake on the vessel, provides several key details which allow for a more complete understanding of the ergonomics of rowing these ships (Fig. 33). Although only two complete oar-ports and part of a third were preserved, the oar-port plank reveals the spacing between oar-ports, and thus between the rowers themselves, to be an average of 0.945 m. This distance corresponds closely to three Byzantine feet (based on the Byzantine *pous*, or foot, equal to 312.3 mm) as well as the *interscalmum* distance (the distance between *skalmoi*, or tholepins) for rowers on classical warships, the minimum practical distance required for effective rowing (Schilbach, 1970: 13–6; Morrison *et al.*, 2000: 245–46, 268–69; Pryor and Jeffreys, 2006: 287, 291). Furthermore, placement of the oar-ports and the wale sockets that accommodated the rowers' benches reveals the approximate vertical height from the upper face of the benches to the centre of the oar-ports as 410 and 440 mm, and the approximate offset distances between the oars and the rowers' benches as 450 and 480 mm, measured from the approximate centre of the oar-port to the edge of the bench forward of the oar-port. Wear patterns in the lower corners of the two fully preserved oar-ports indicate the direction the rowers faced, and, therefore, the orientation of the bow and stern of the vessel. Finally, the presence of staining and small, tack-like fastener holes on the outer face of the oar-port strake provided archaeological evidence of leather sleeves, fastened outboard of the oar-ports, that prevented water from entering the hull (Fig. 34); these features, known as *askōmata* on ancient warships and *manikellia* on

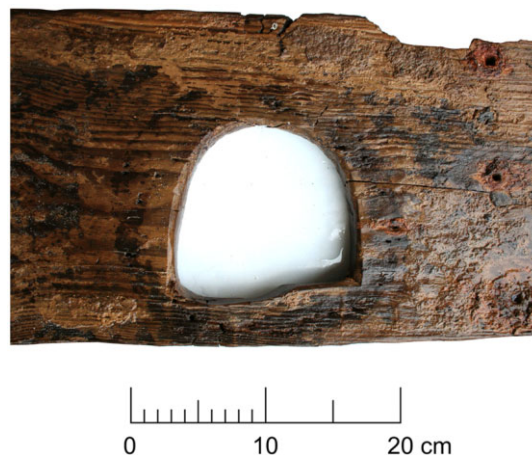
Figure 34. Exterior of YK 4 oar-port strake, with small tack holes and staining denoting the location of a leather sleeve. Note the wear from rowing at the lower left-hand side of the oar-port. (Photo R. Ingram/INA)
